# **AM Services**

## **Property Inspection Report**

~~1815 Midland Ave, Glenwood Springs, Co 81601~~

Date of Inspection: 4/21/2023 Time: 9:04am

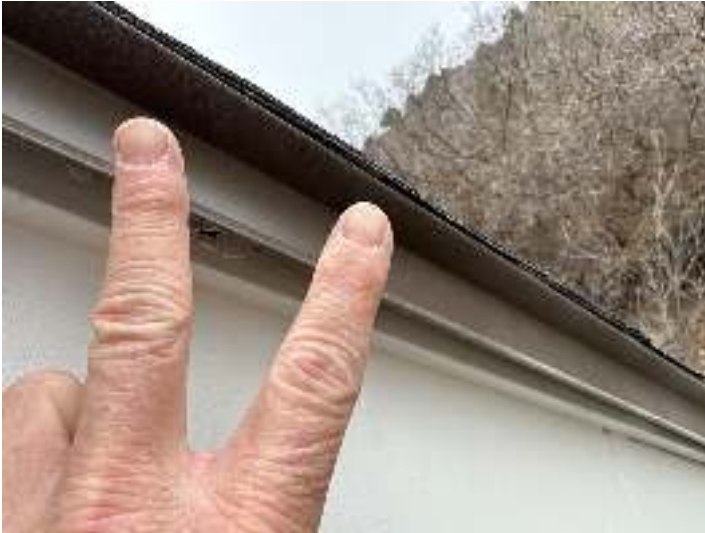
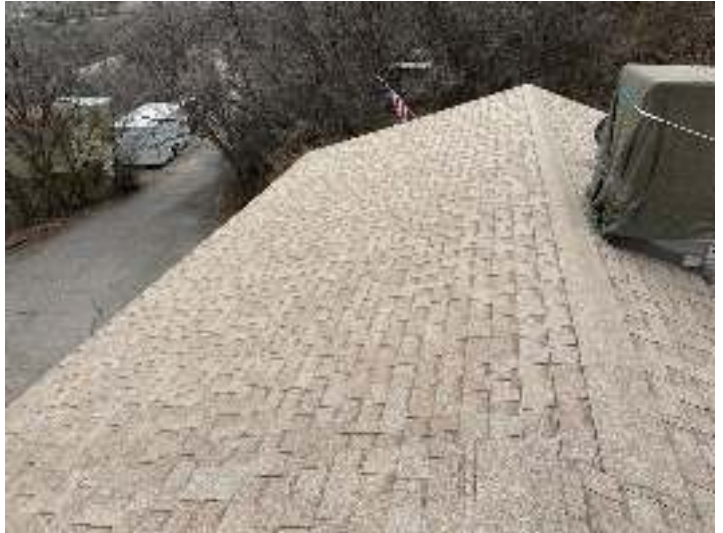
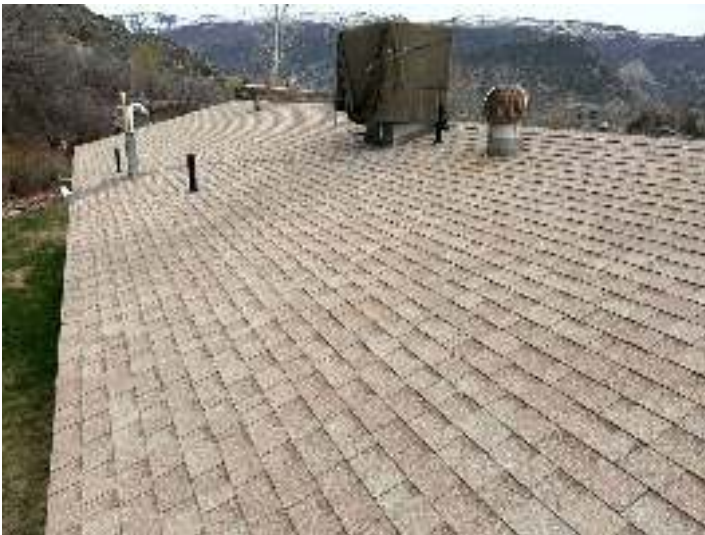
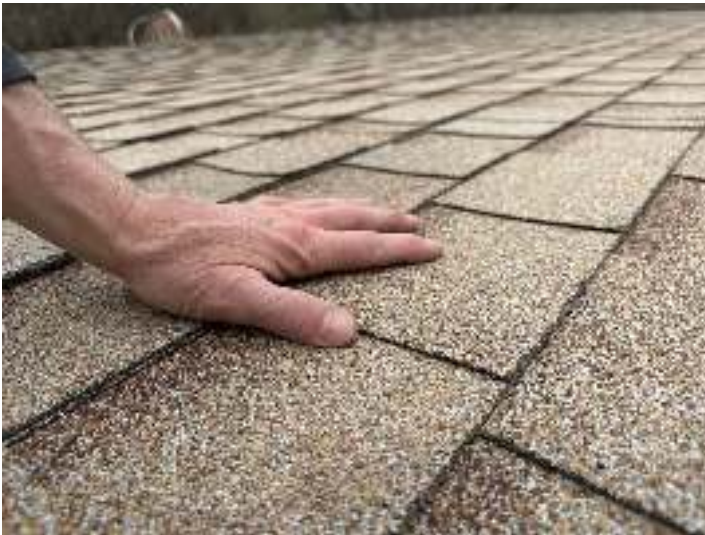
- This roof was observed to have more than one layer of roofing material. Multiple layers of roof covering material can cause excess heat buildup and exceed the load capacity for the structure. Inspector does not recommend multiple roof covering layers even though the jurisdiction allows up to three layers of roof covering material.

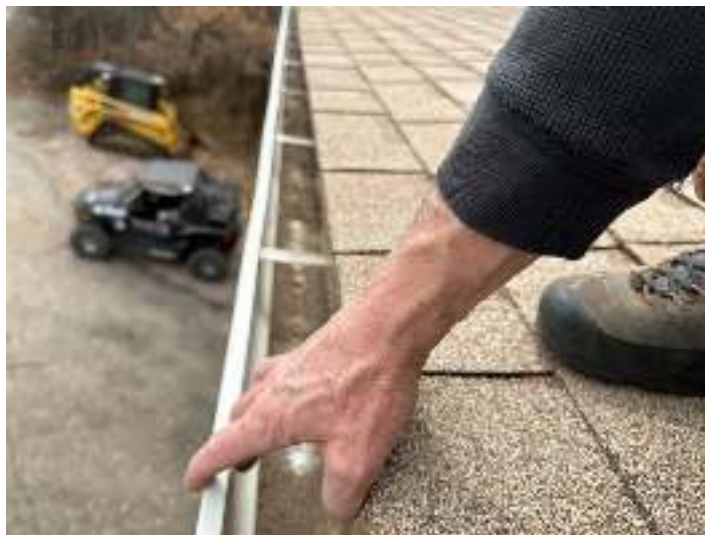
### Roof Drainage Systems

- The roof drainage system consisted of conventional gutters hung from the roof edges feeding downspouts, which route run-off away from the property foundation. The roof drainage system appeared to be in serviceable condition at the time of the inspection. The gutters appear intact, but due to the lack of recent rain, determining if gutters leak at seams or spill water was not possible at the time of the inspection.

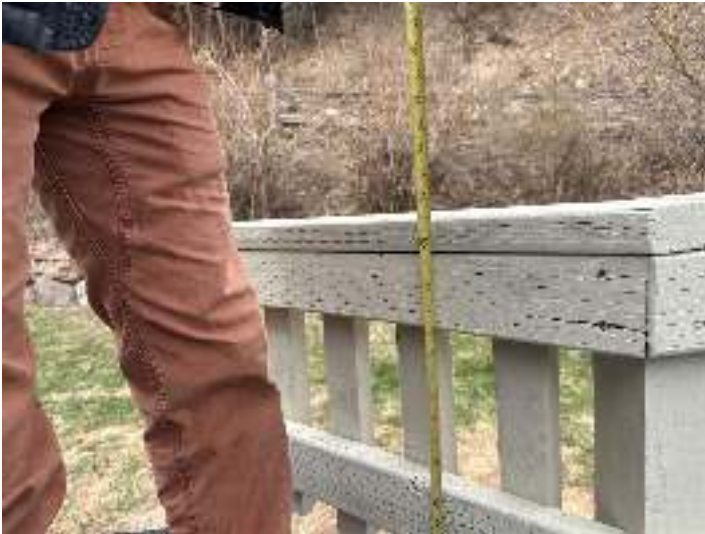
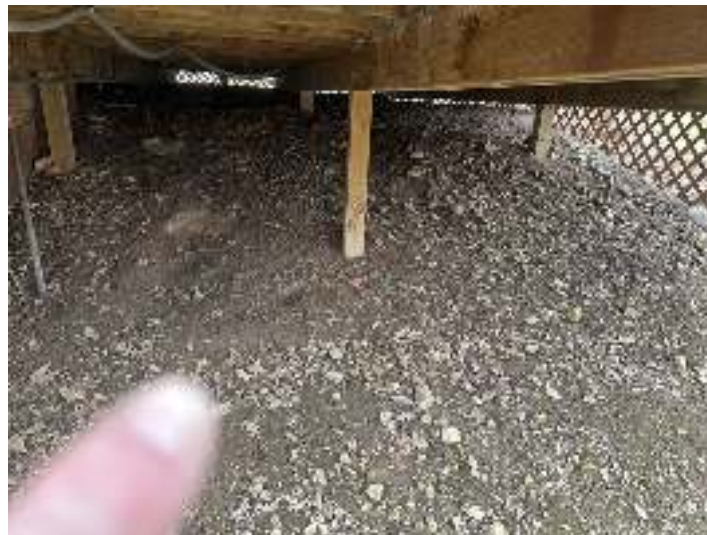
## Decks & Balconies

- The deck area is not accessible time of the inspection (lattice installed). The inspector did no structural with supports in direct contact with soil. This may cause untimely deterioration. A qualified contractor should evaluate and repair or replace as necessary.
- The North deck railing, guard/hand rail was too low and could cause a trip or fall. The minimum height for a railing is 36", this railing does not meet the minimum standard. This is a safety hazard. A fall or injury could occur if not corrected. A qualified contractor should evaluate and repair or replace as necessary.

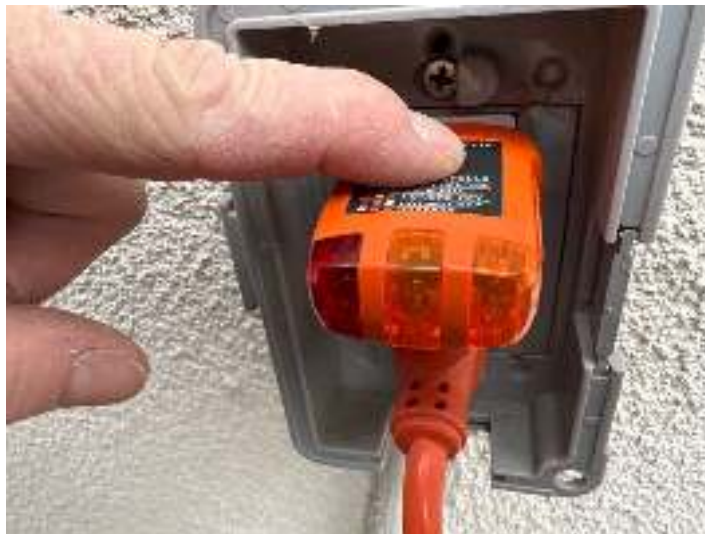
### Exterior Electrical Outlets

Observations: Exterior outlets were **GFCI** protected, enclosed in weatherproof covers, responded to testing and appeared in serviceable condition at the time of the inspection.

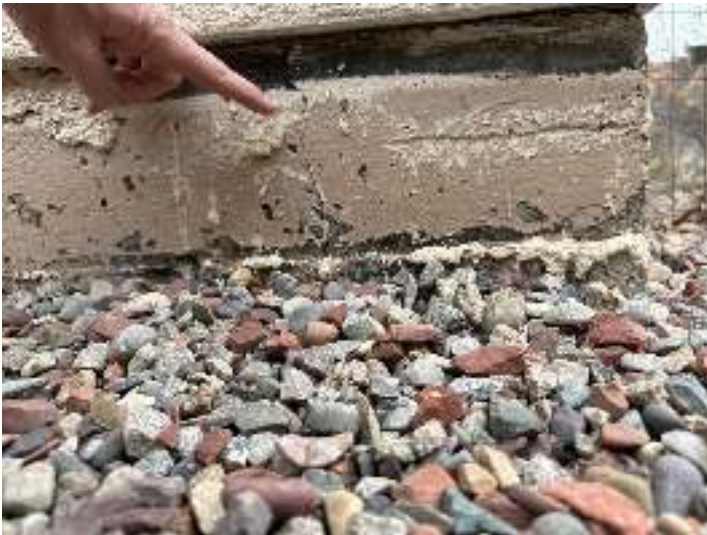
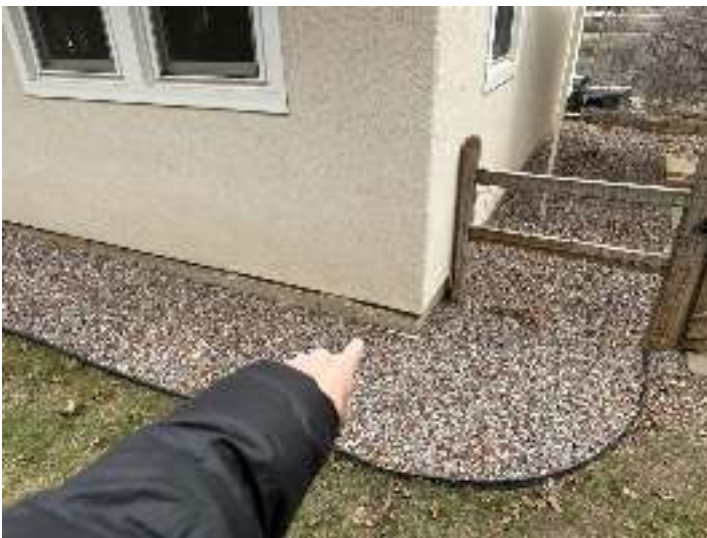
### Exterior Foundation Wall

Observations: The majority of the foundation wall was obscured by the grade and siding at the time of the inspection. One minor crack was noted at the time of the inspection at the South West corner of the structure.

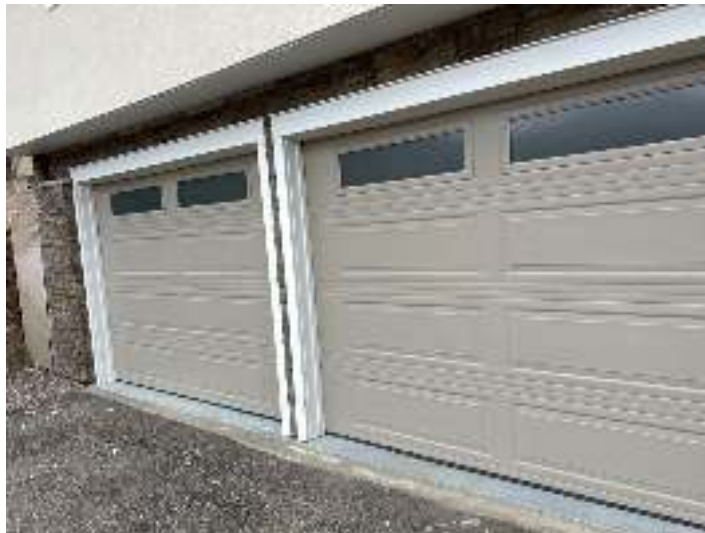
### Garage Door Exterior

Observations: Metal

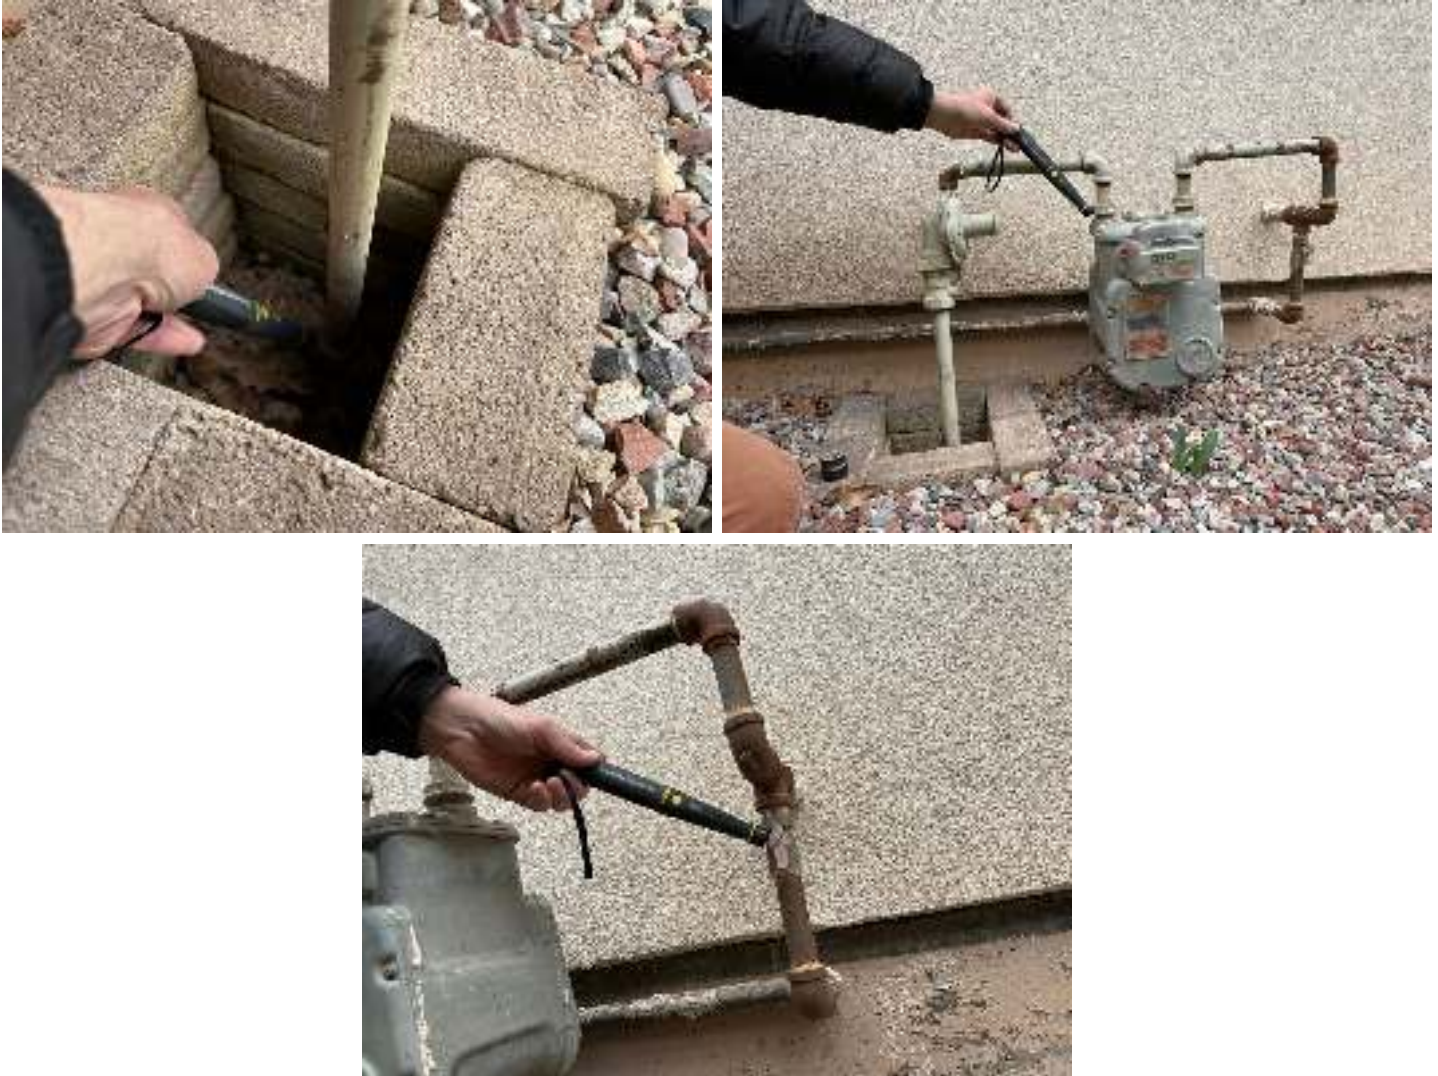
Observations: Main gas valve inspected. No leaks detected at the time of the inspection. Inspector would recommend cleaning out this well the better access shut off valve in case of emergency.

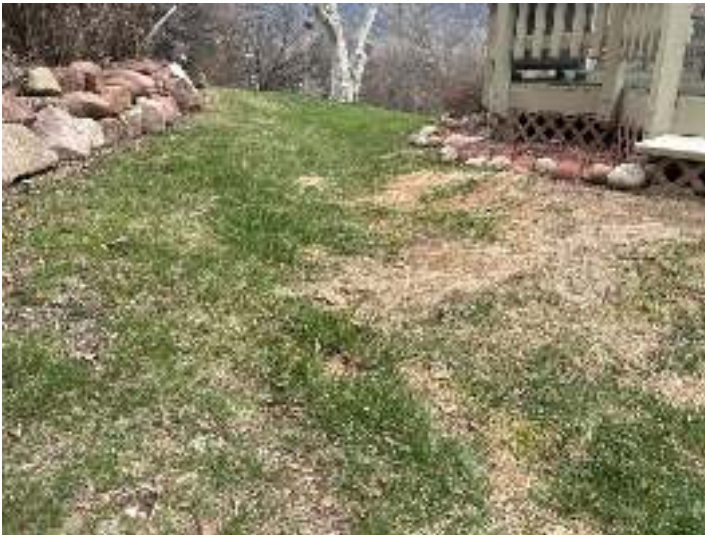
### Vegetation, Surface Drainage, Retaining Walls & Grading

Observations: I observed indication of a defect at the retaining wall. Retaining wall missing. Correction and further evaluation is recommended.

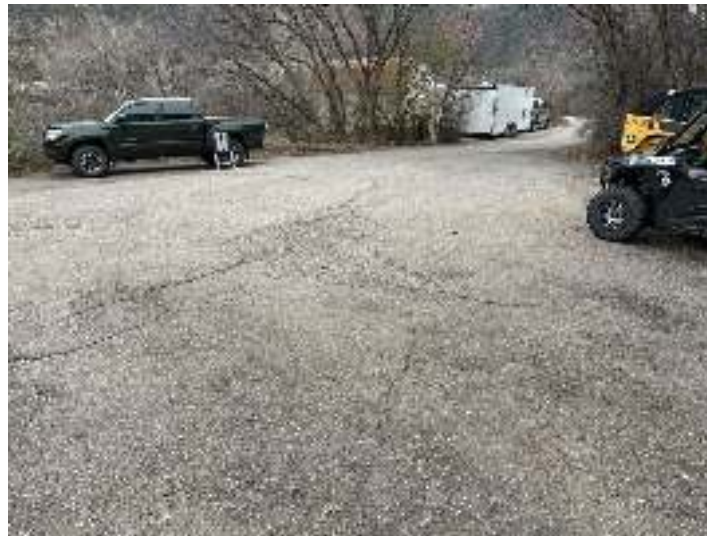
### Walkways & Driveways

- I inspected the walkways and driveways that were adjacent to the structure. The walkways, driveways, and parking areas were observed to be in serviceable condition at the time of the inspection.
- I observed minor cracking and no major damage at the driveway. Monitoring is recommended.

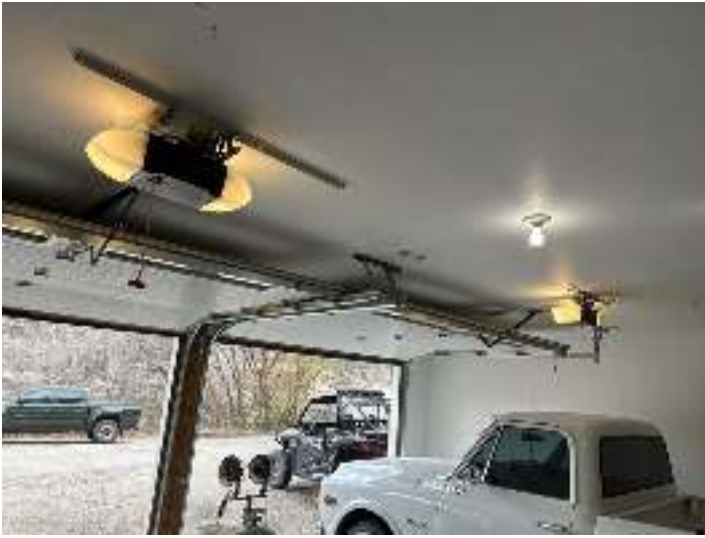
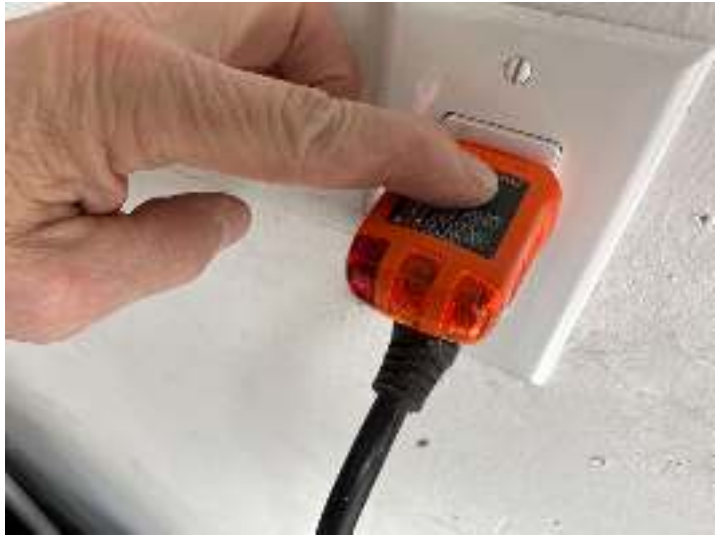
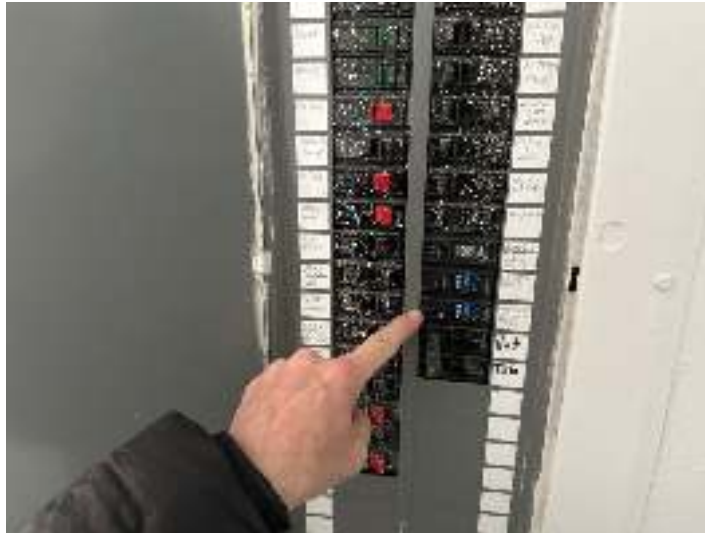
- Garage electrical outlets were Ground Fault Circuit Interrupter (GFCI)-protected and responded to testing and appeared to be in serviceable condition at the time of the inspection. Reset located in Basement electrical service panel.

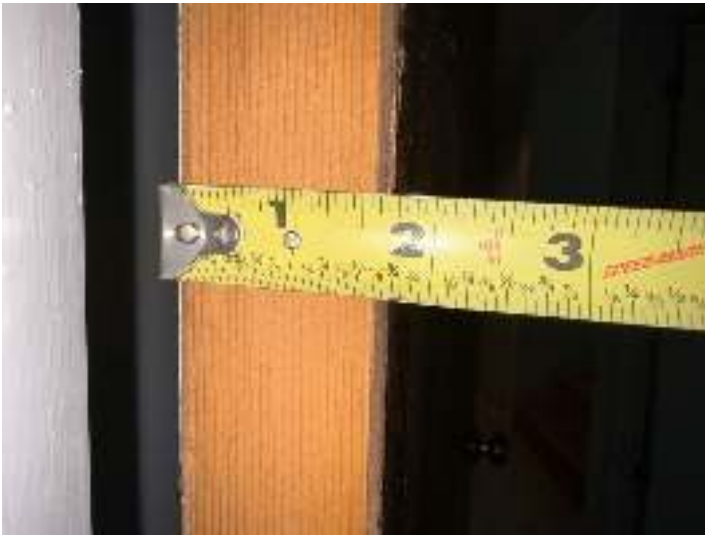
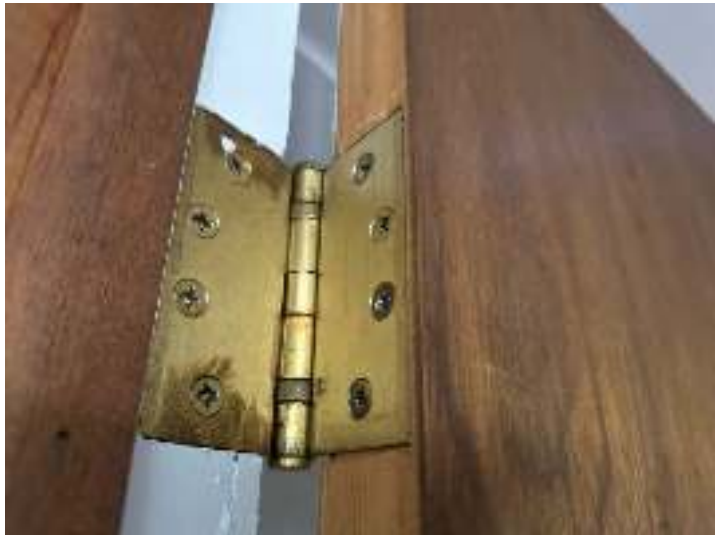
- The door between the garage and the living space was not a fire-rated door. This is a fire hazard. The door between the garage and the house should be a solid wood door at least 1-3/8 inches thick, a solid or honeycomb-core steel door at least 1-3/8 inches thick, or a 20-minute fire-rated door. This means that should a fire occur in garage, the occupant door does not afford protection until firemen arrive. A qualified contractor should evaluate and repair or replace as necessary.
- The door between the garage and the living space failed to close by itself. Modern safety requirements require that the door between the home interior and the garage be self-closing for safety reasons related to fire hazard and toxic fumes. A qualified contractor should evaluate and repair or replace as necessary.

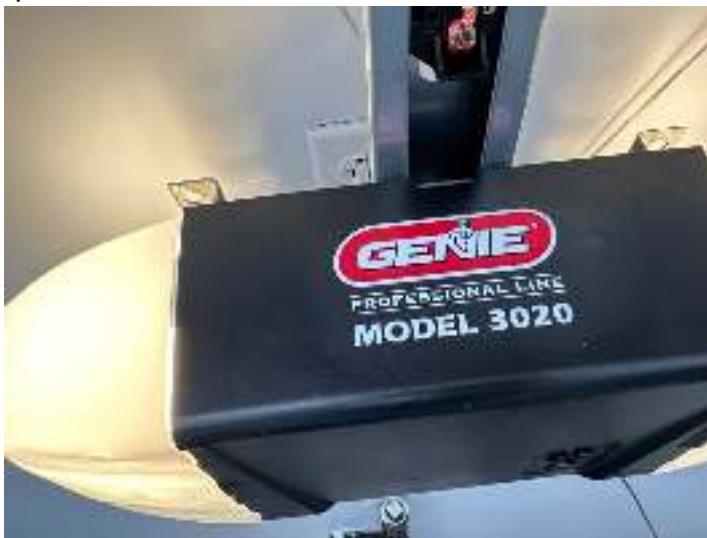
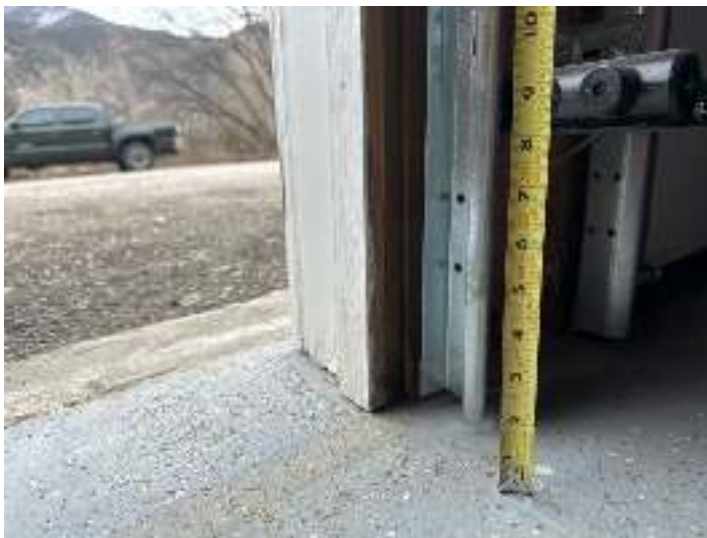
- I observed that the photo-electric eyes are installed too high from the garage floor surface. The vertical distance between the photo-eye beam and the floor should be no more than 6 inches.

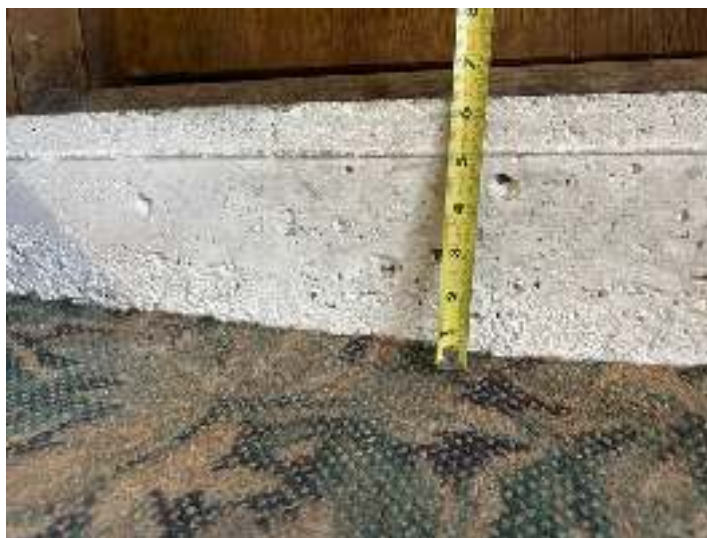
- I inspected the stairs, steps, stoops, stairways and ramps that were within the scope of my home inspection. All treads should be level and secure. Riser heights and tread depths should be as uniform as possible. As a guide, stairs must have a maximum riser of 7-3/4 inches and a minimum tread of 10 inches.

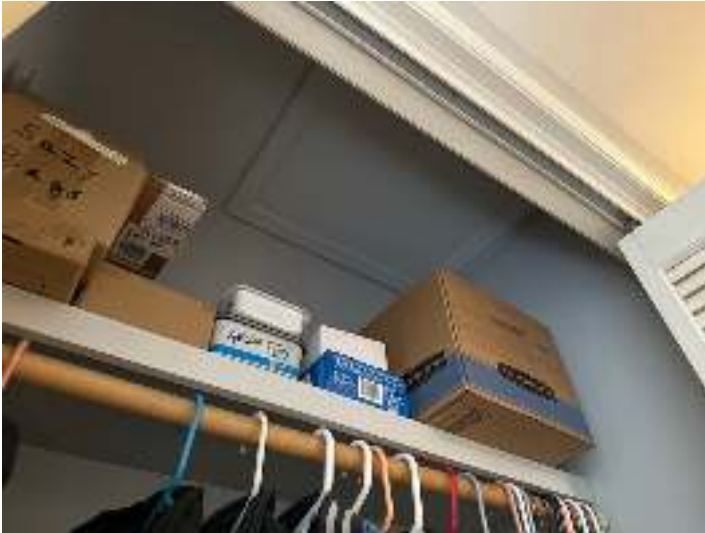
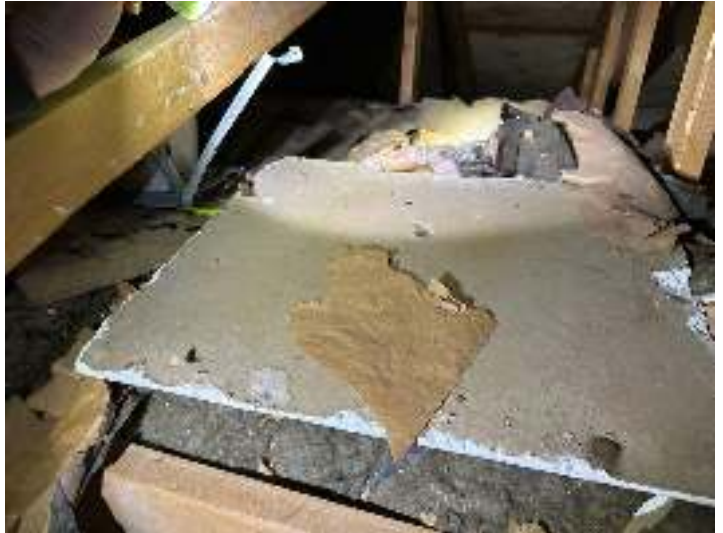
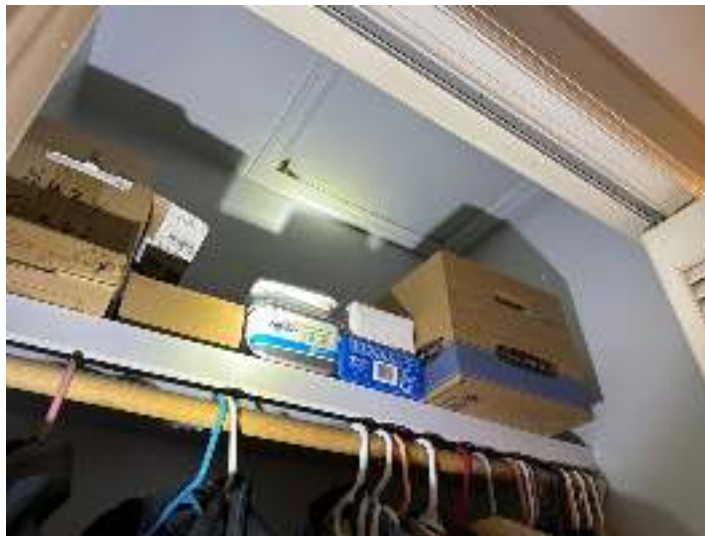
- The attic had a proper access opening that was in serviceable condition and insulated properly.
- The attic access hatch was not properly insulated. A qualified contractor should evaluate and repair or replace as necessary.

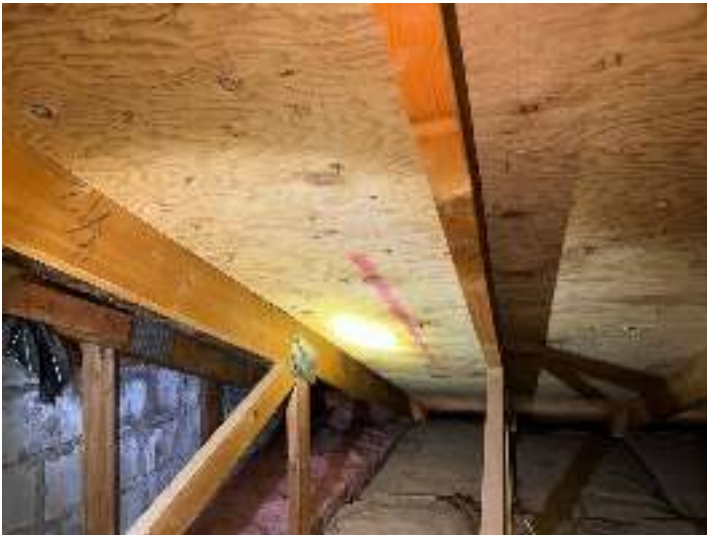
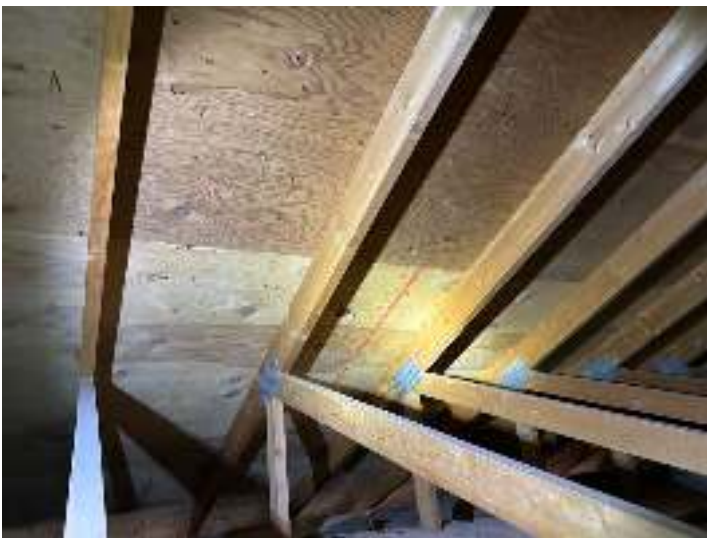
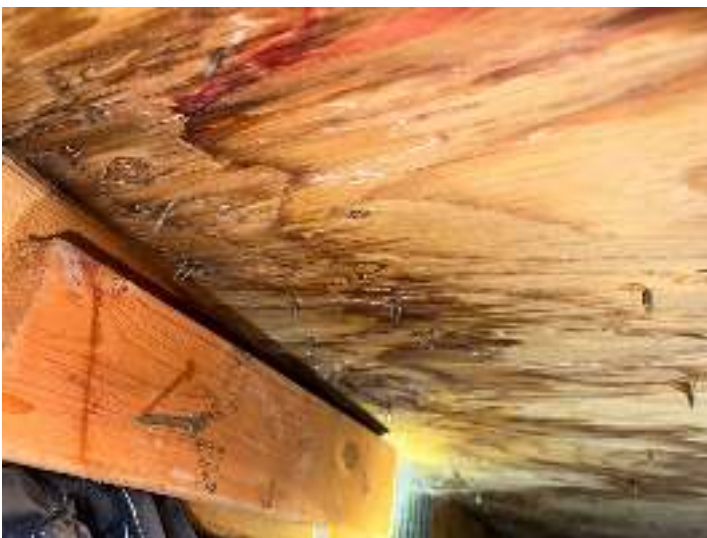
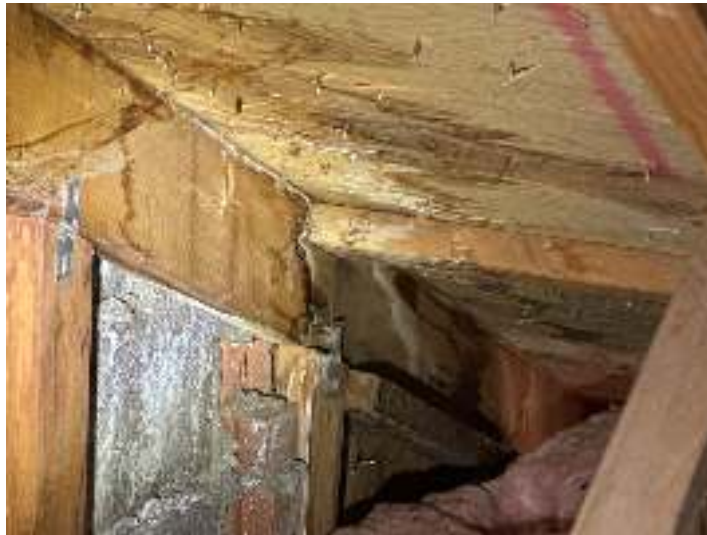
- Visible signs of water intrusion in the attic are present on sheathing and rafters at the North end at the CMU chimney. Water intrusion can lead to more costly repairs and increase damage if not corrected. The extent of intrusion or how often it occurs could not be determined. A qualified contractor should evaluate and repair or replace as necessary.

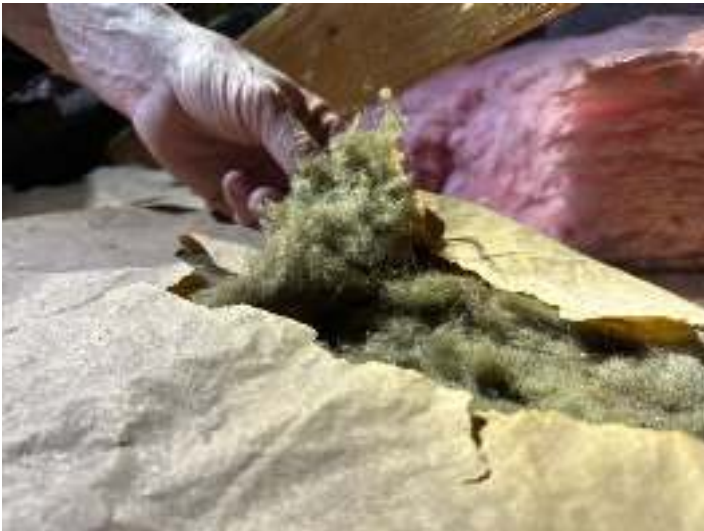
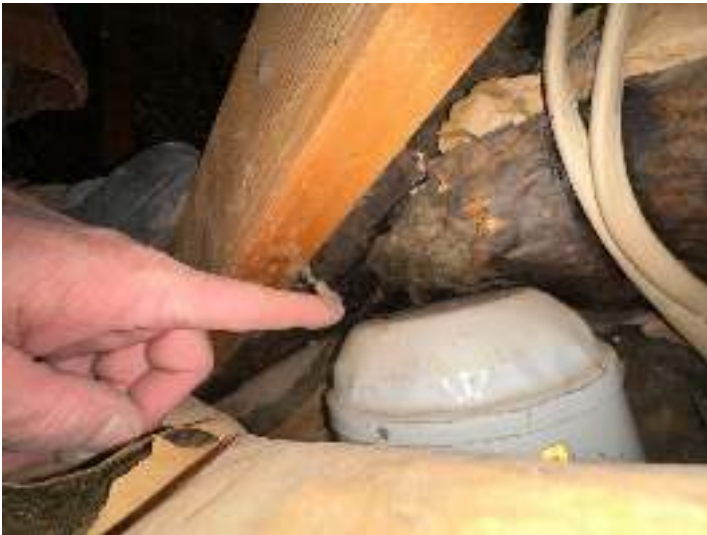
- Insulation levels are specified by R-Value. R-Value is a measure of insulation's ability to resist heat traveling through it. The higher the R-Value the better the thermal performance of the insulation. Current standards for existing wood-framed buildings for this climate and location are R38-R60. Recommend increasing insulation to achieve current standards as necessary. Current R-30

- The insulation should be adjusted to maintain a clearance around recessed lights (can lights) to avoid potential heat build-up. This is a possible fire hazard.

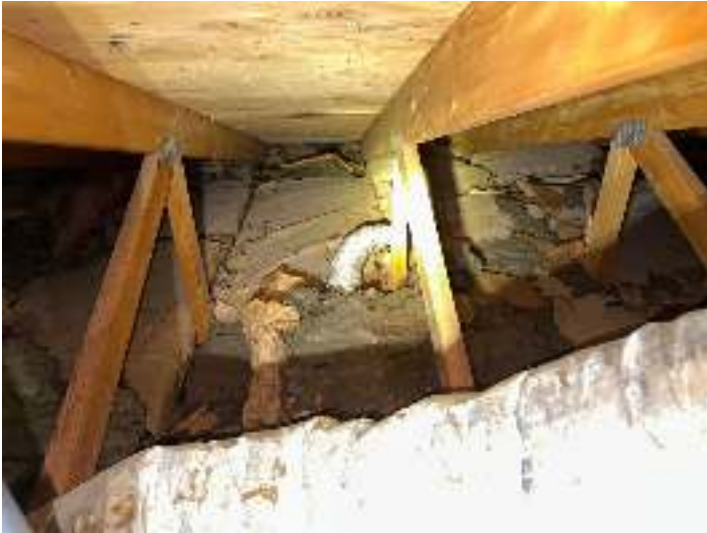
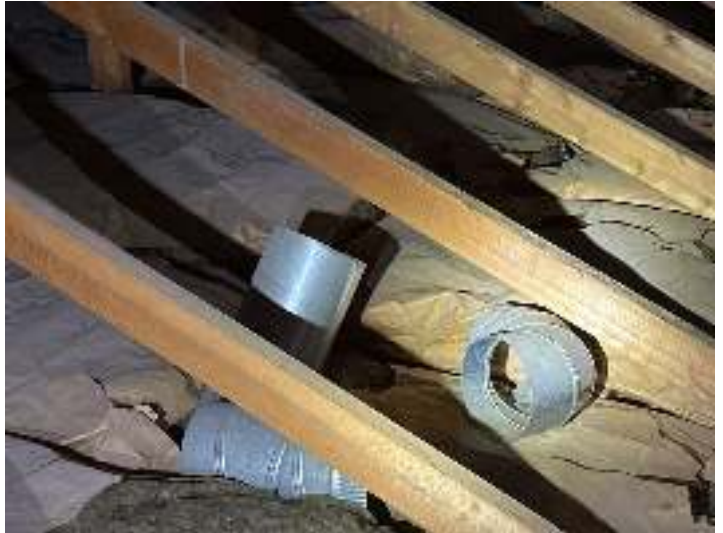
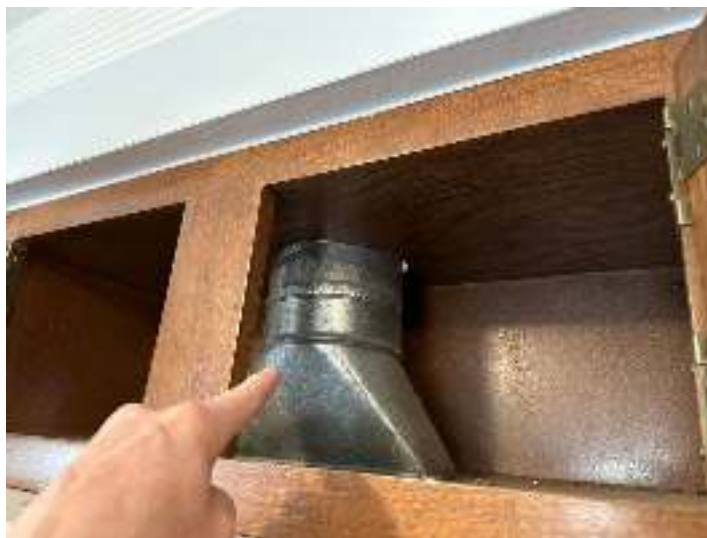
- Bathroom vent duct and the kitchen vent terminated in the attic and did not vent to the exterior of property.

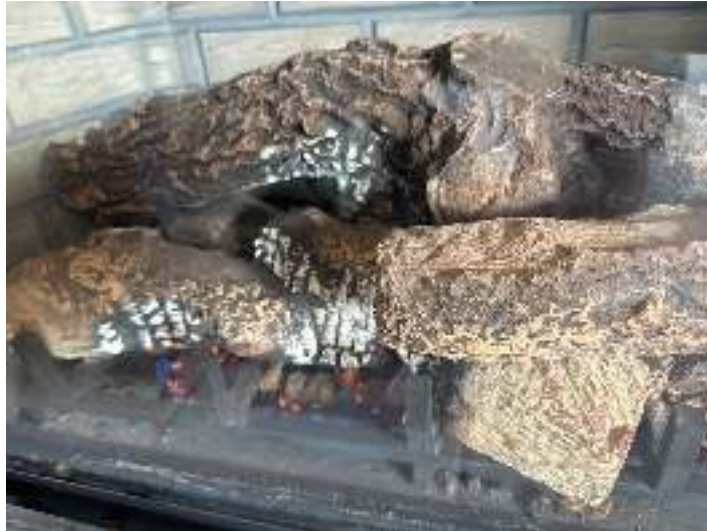
- The property had a gas-fueled fireplace that appeared to be in serviceable condition and responded to the controls. The fireplace had a gas shutoff valve present. No gas leaks were detected. Inspector recommends labeling wall switch to prevent inadvertent activation or deactivation.

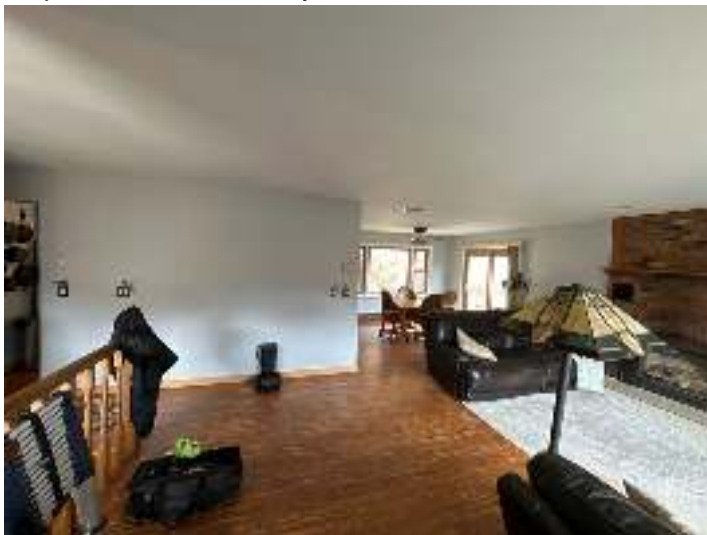
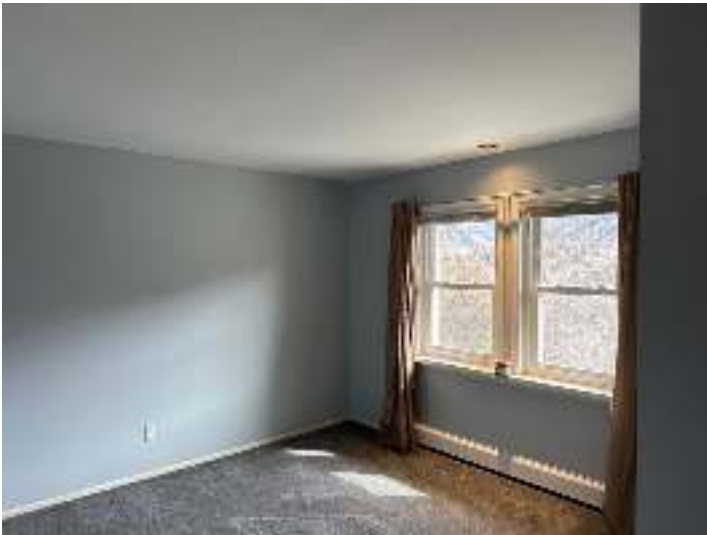
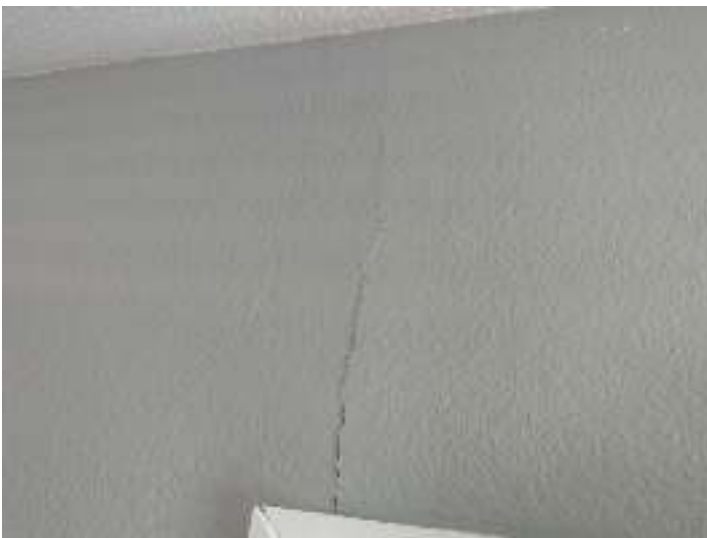
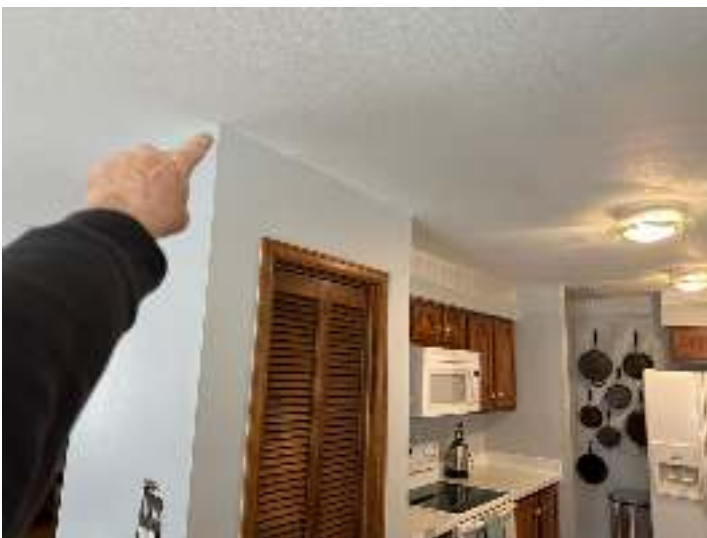
- Minor cracking was visible on the interior ceilings at the hip intersections. A qualified contractor should evaluate and repair or replace as necessary.

- Minor cracking was visible on the interior walls. A qualified contractor should evaluate and repair or replace as necessary.
- The walls had signs of previous repair. A qualified contractor should evaluate and repair or replace as necessary.

- The ceilings had signs of previous repair. A qualified contractor should evaluate and repair or replace as necessary.

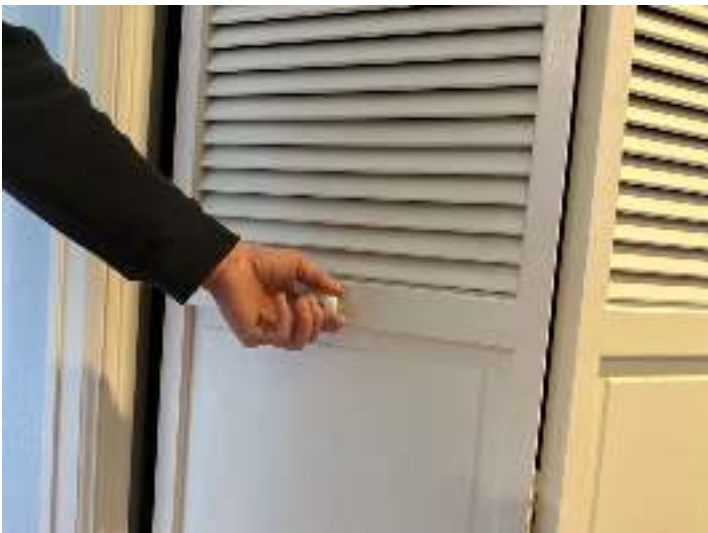
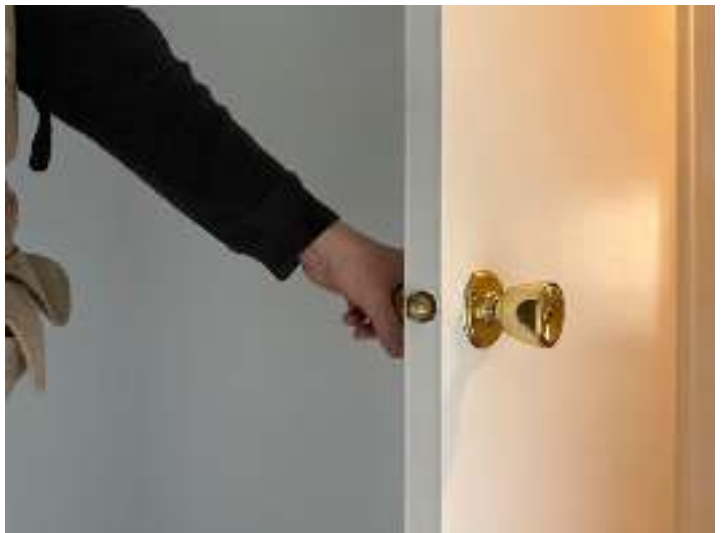
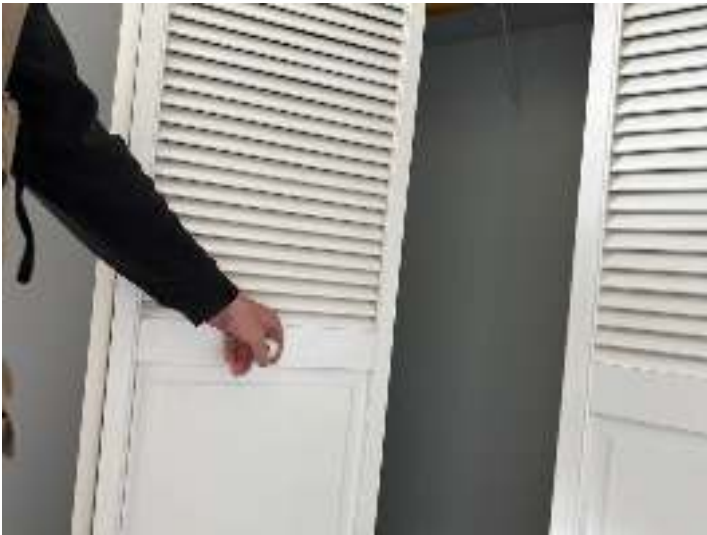
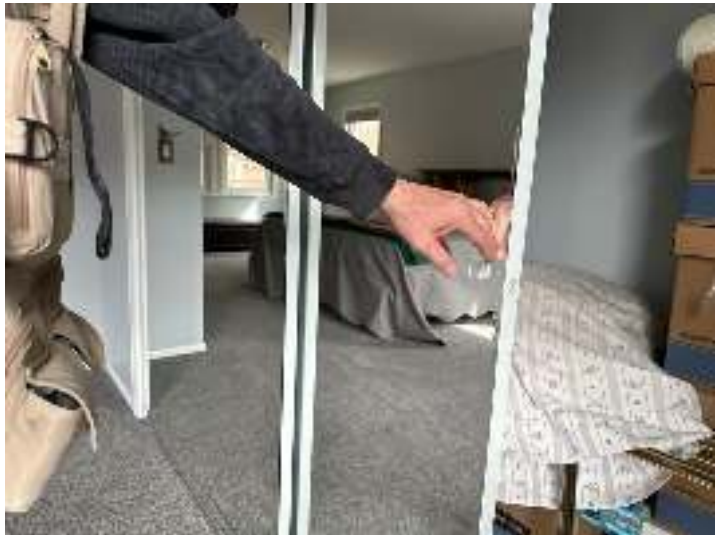
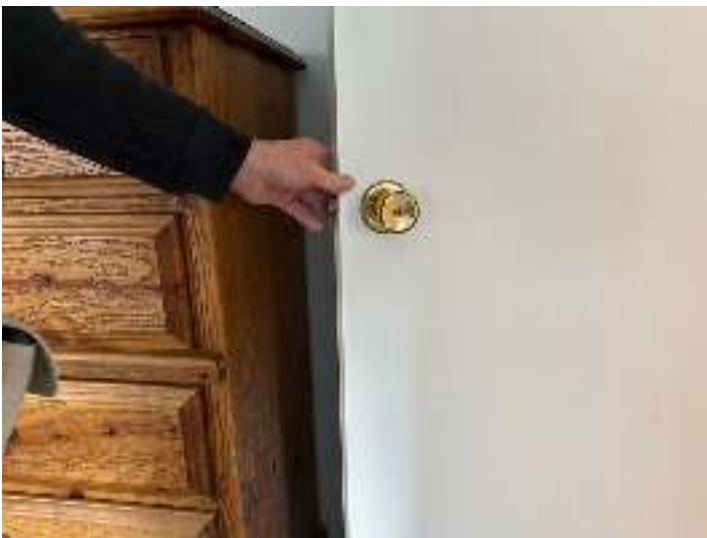
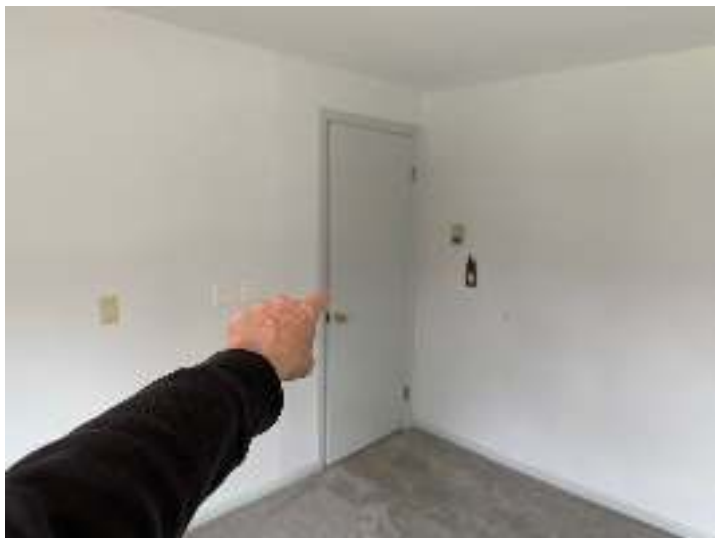
- Interior hollow core doors and hardware appeared to be in satisfactory condition at the time of inspection. Door inspection includes examination for proper installation, operation and condition.

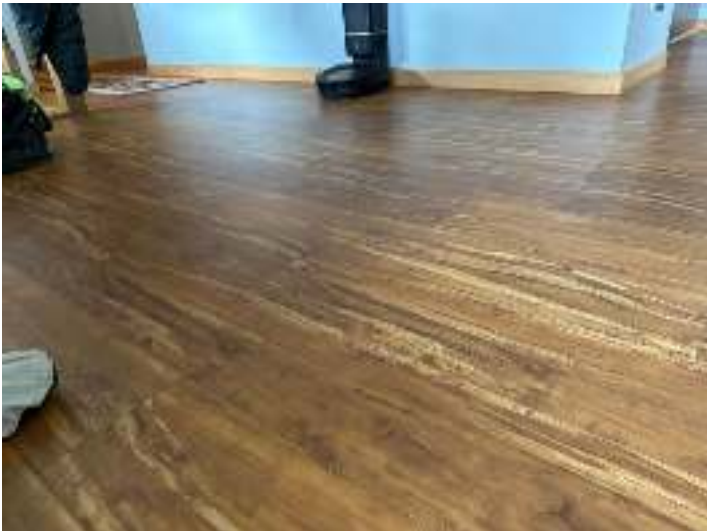
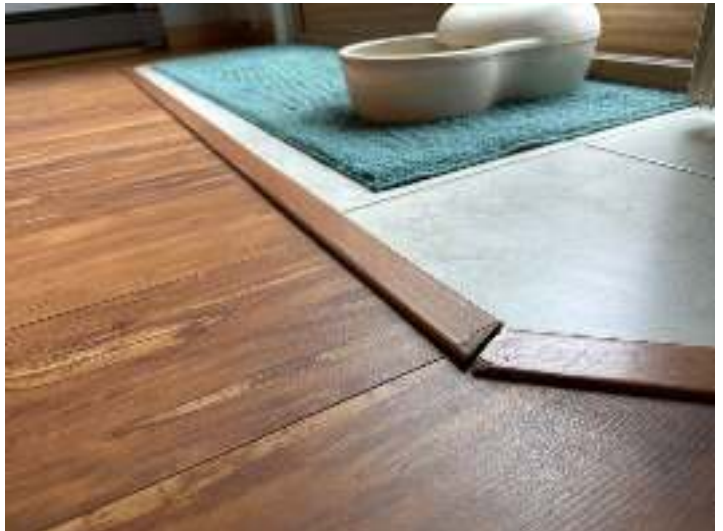
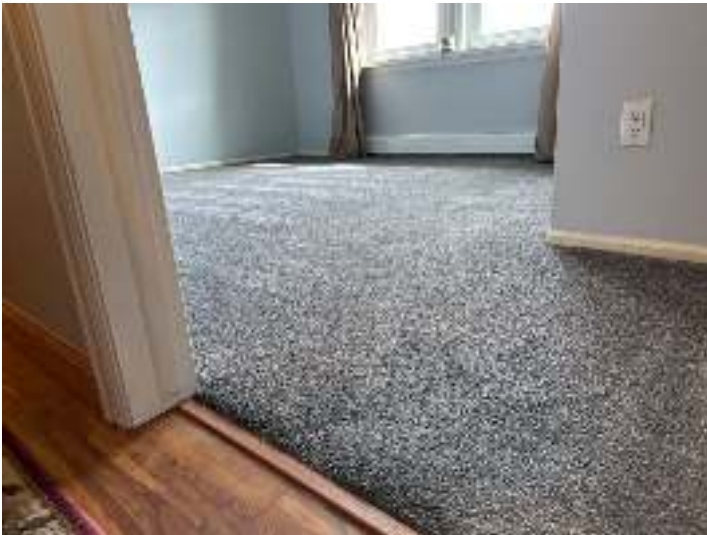
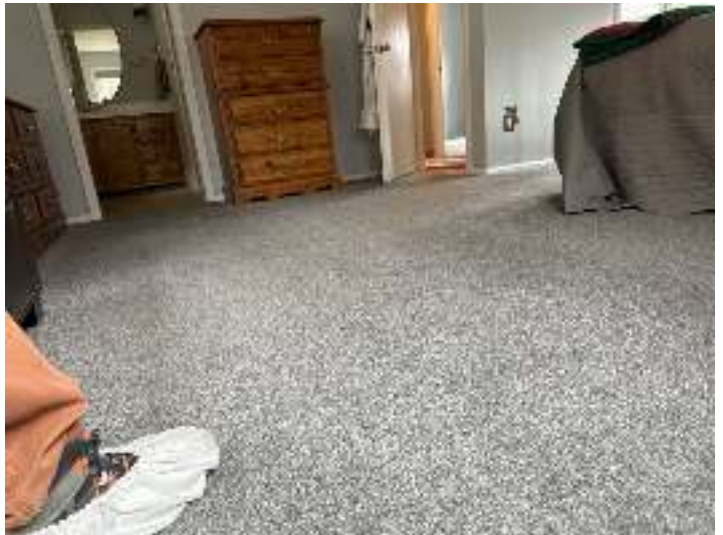
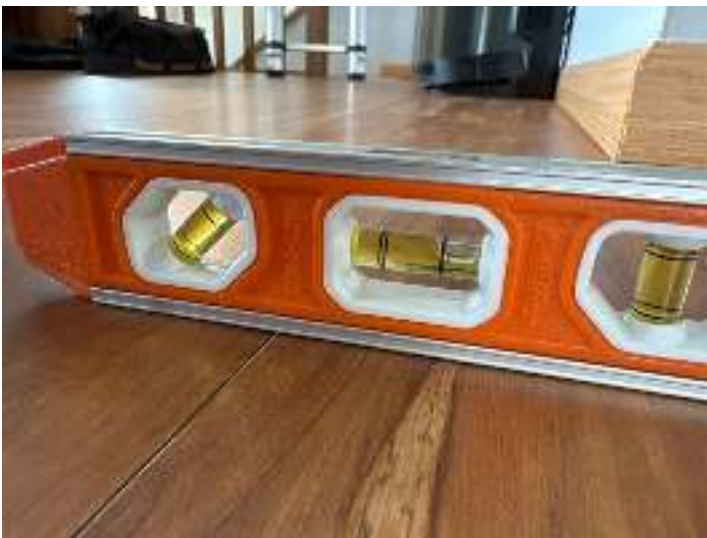
- The carpet and LVP (laminated vinyl plank) floors in the interior rooms appeared to be in satisfactory condition at the time of inspection.
- The floor had a noticeable hump or rise. A qualified contractor should evaluate and repair or replace as necessary.
