# **AM Services**

## **Property Inspection Report**

~~1815 Midland Ave, Glenwood Springs, Co 81601~~

Date of Inspection: 4/21/2023 Time: 9:04am

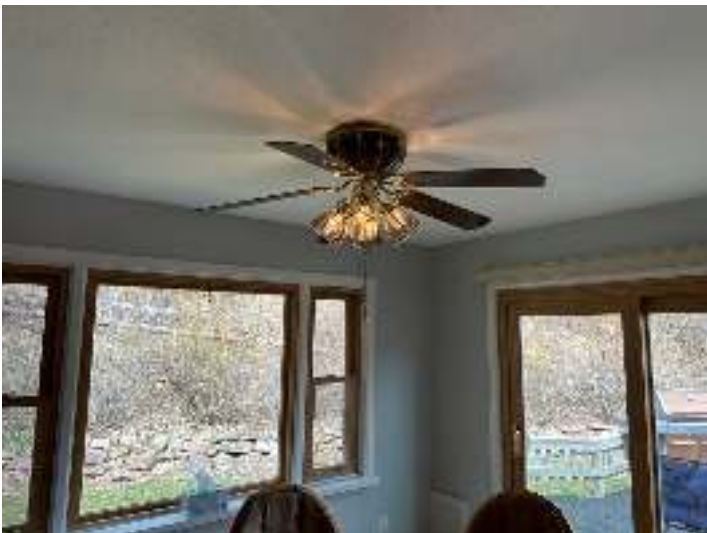
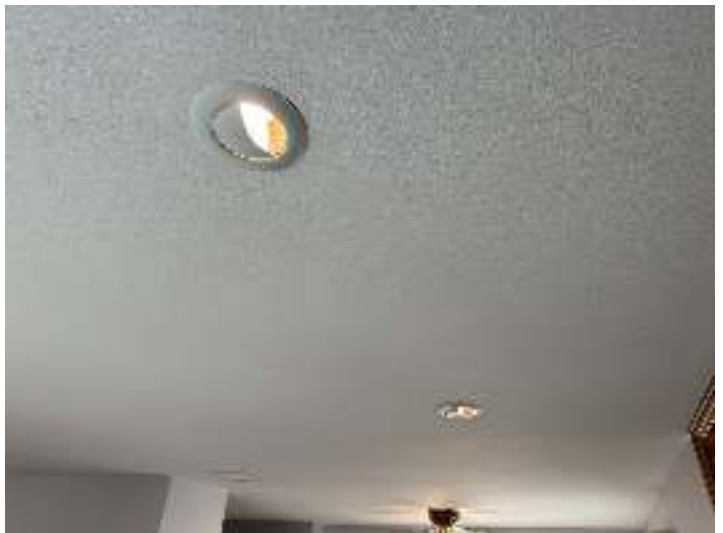
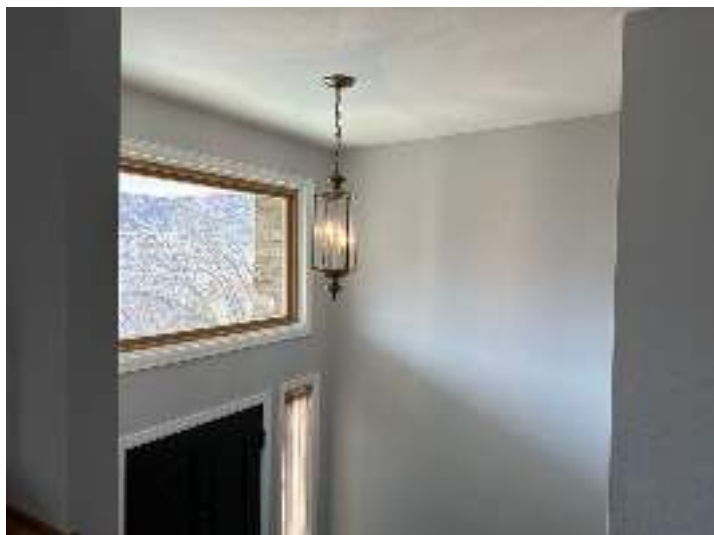
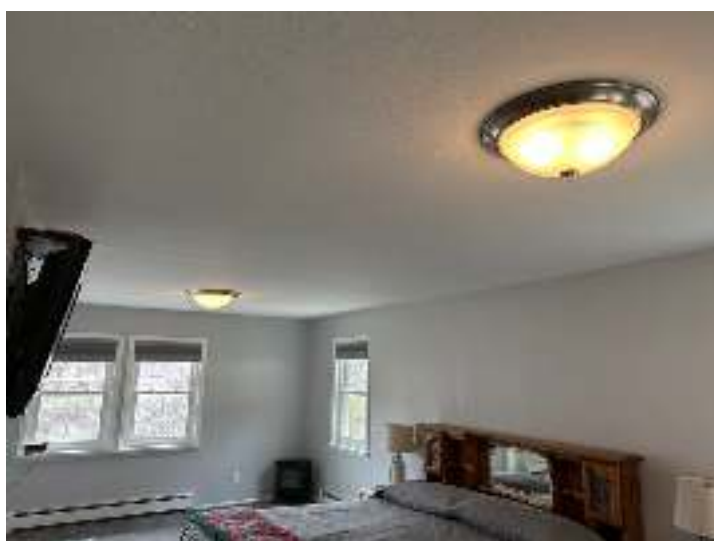
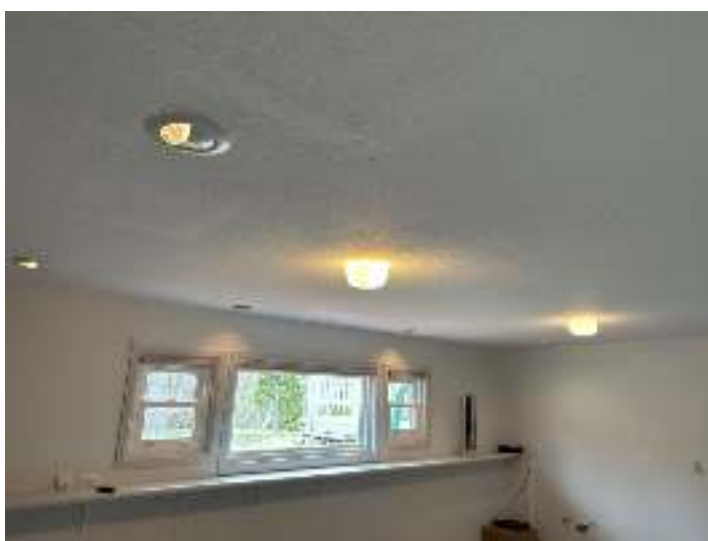
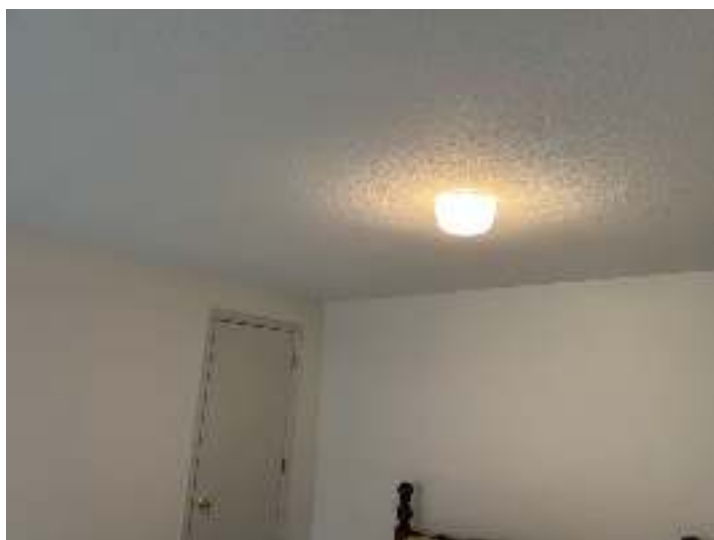
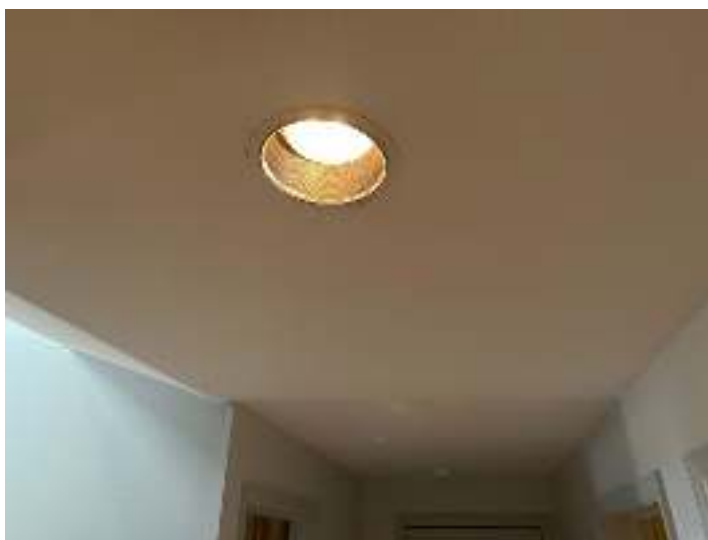
- Light fixtures mounted in the interior rooms responded to the switches and appeared to be in serviceable condition at the time of inspection.

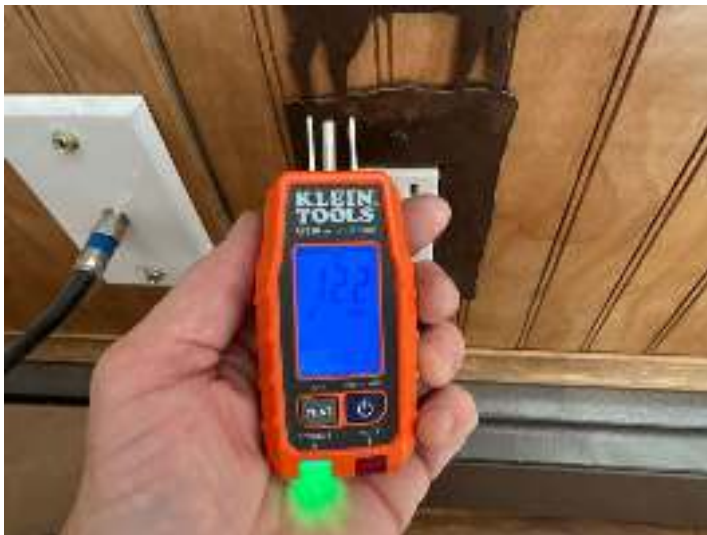
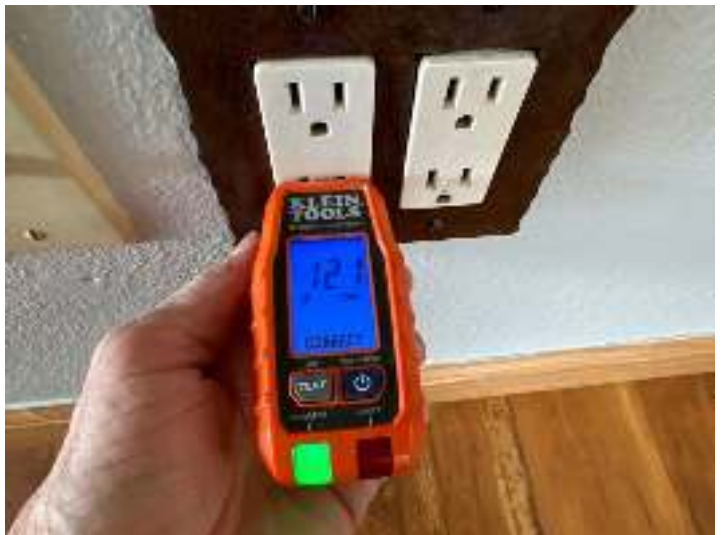
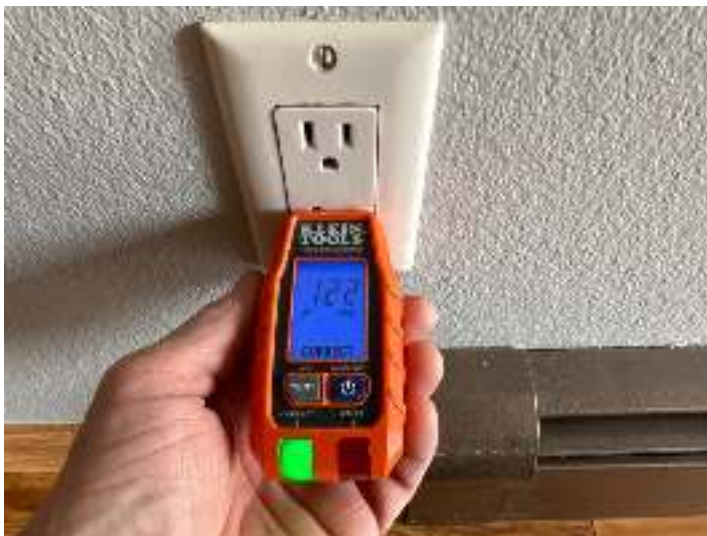
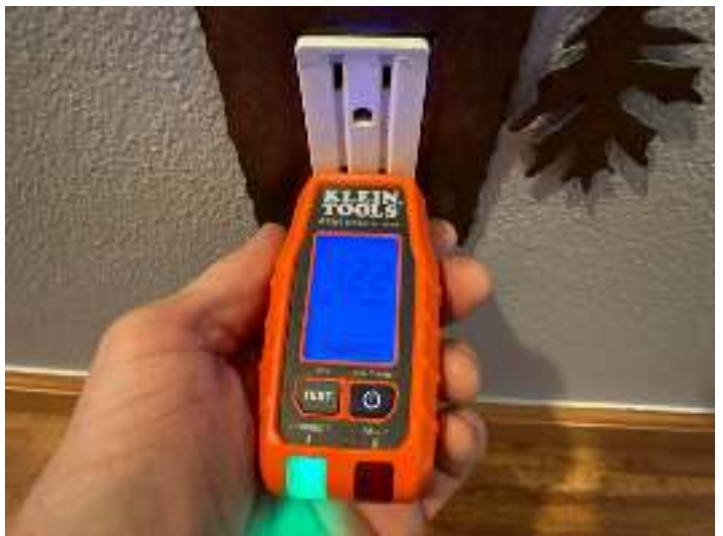
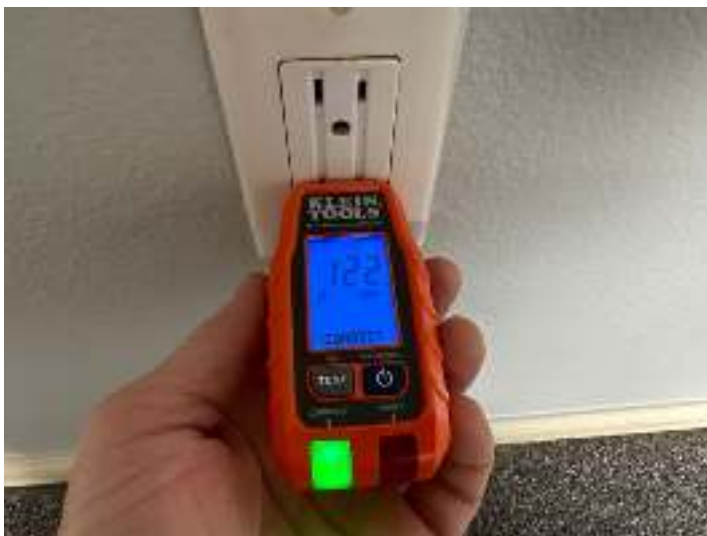
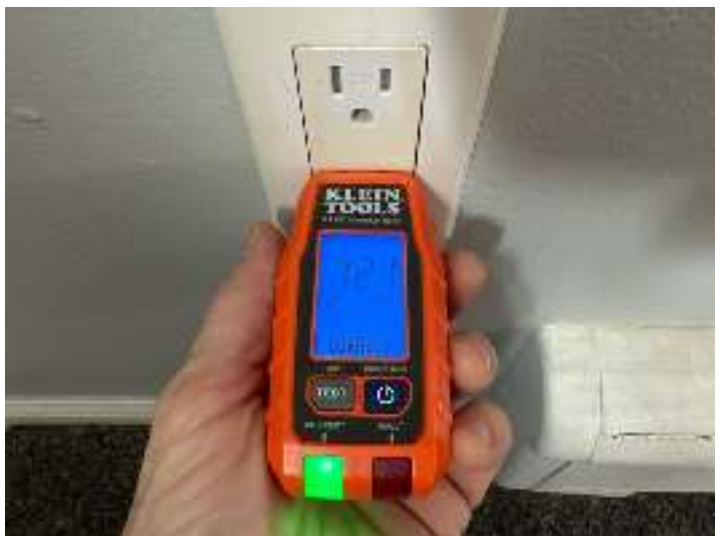
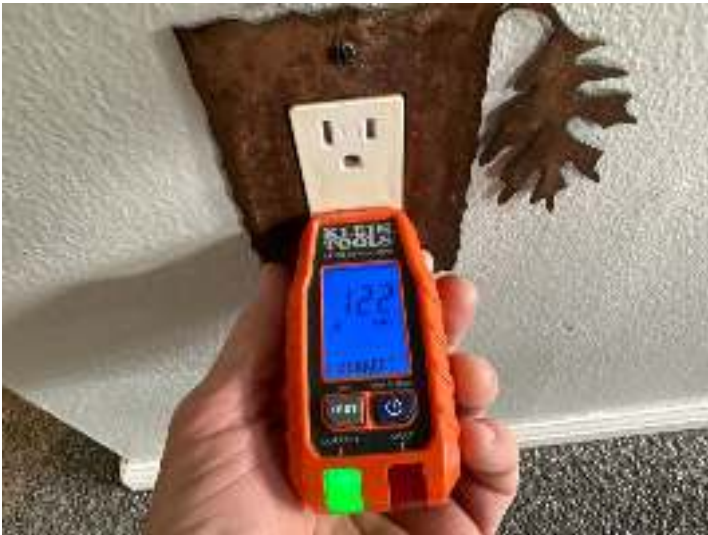
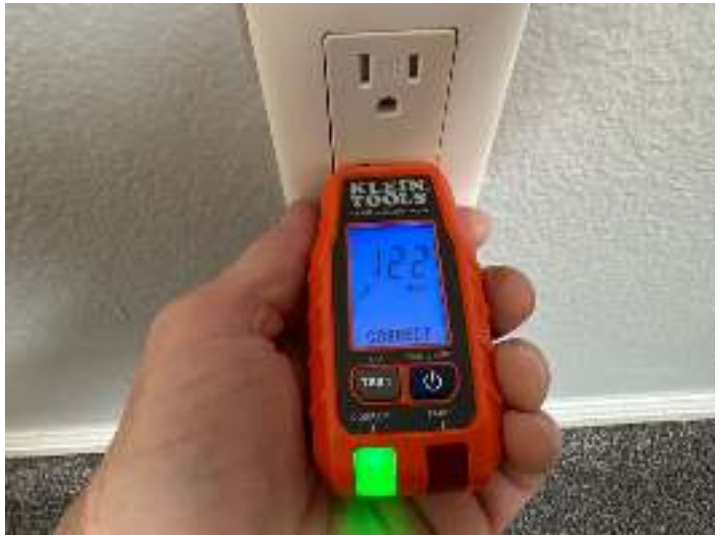
- Electrical outlets in the property appeared to be in serviceable condition at the time of inspection. Notable exceptions will be listed in this report. A representative number of outlets were tested.

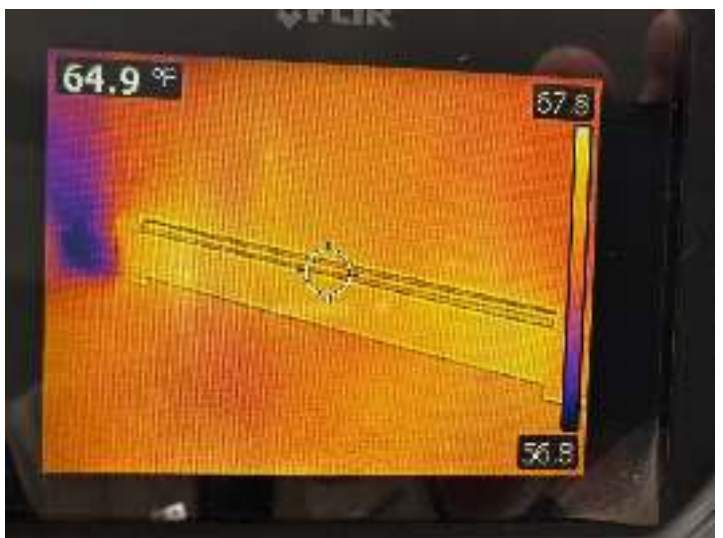
- The heating system was turned on using normal operating controls and all interior rooms had a heat source installed (bathrooms, kitchens, laundry rooms and unfinished spaces do not require heat sources). Inspection of air flow and/or distribution is beyond the scope of the inspection. We are not able to determine the supply adequacy of the heating system during the course of a general home inspection. As a courtesy to the client the inspector tested a representative number of heat registers throughout the property.

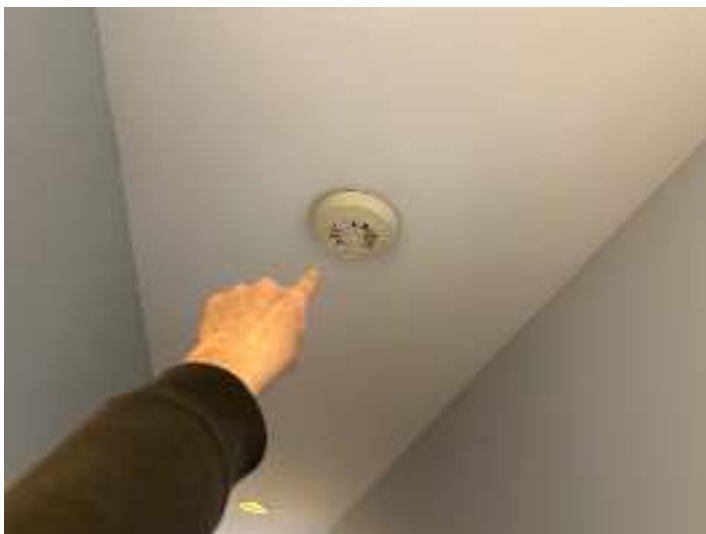
- The smoke detectors appeared to be old and beyond expected life. A qualified person should repair or replace as needed. The existing smoke detectors were tested if present, but they are only noted as to presence and operation as of date of inspection. Smoke detectors may work today but not work when you need them to work. This is why it is important for you to test them on a regular basis, monthly at least. Smoke detectors are recommended by the U.S. Product Safety Commission to be installed inside each bedroom and adjoining hallway and on each living level of the property and basement level.

- Carbon monoxide detectors were not installed within a specified distance of each room lawfully used for sleeping purposes. The inspector recommends installation of carbon monoxide detectors in appropriate locations. Colorado House bill 1091 became effective on July 1, 2009 that requires Carbon Monoxide detectors to be installed in most properties that has a fuel-burning heater or appliance, a fireplace, or an attached garage. Inspector recommends installing separate cover monoxide detectors at floor level to best indicate dangerous levels of carbon monoxide gas.

- The smoke detector did not work when tested. A qualified person should repair or replace as needed. The existing smoke detectors were tested if present, but they are only noted as to presence and operation as of date of inspection. Smoke detectors may work today but not work when you need them to work. This is why it is important for you to test them on a regular basis, monthly at least. Smoke detectors are recommended by the U.S. Product Safety Commission to be installed inside each bedroom and adjoining hallway and on each living level of the property and basement level.

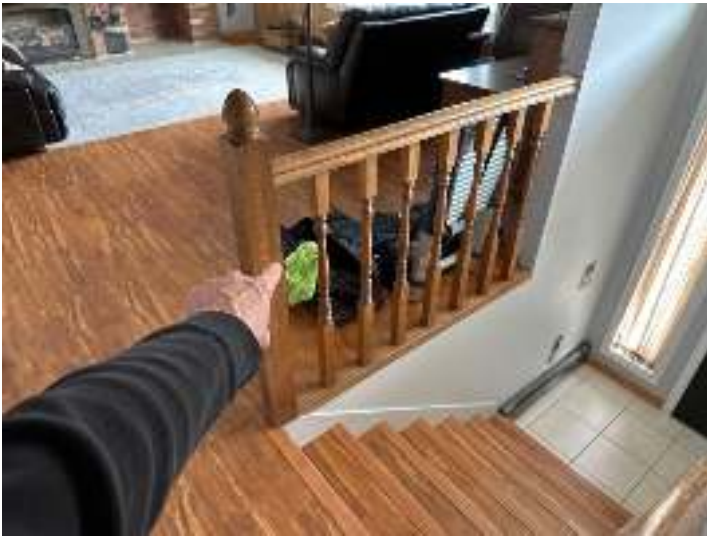
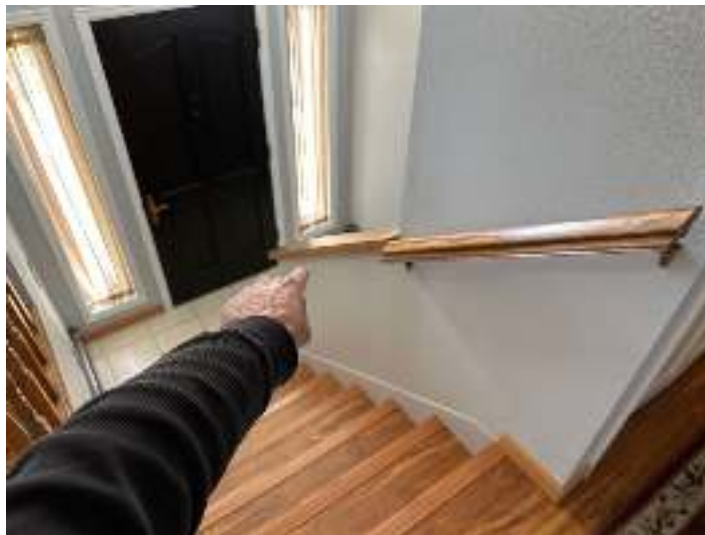
- The guard/hand rail for the interior stairs was secure, and balusters, if present, had a maximum spacing of 4 inches. The rails were installed at a acceptable height greater than 32 inches. Step treads and risers meet depth and height requirements. All stairway components are in serviceable condition.
- At the interior stairs, the upper handrail was not grippable. A fall or injury could occur if not corrected. A qualified contractor should evaluate and repair or replace as necessary.
- At the interior stairs, the handrail had spacing between components that were too far apart. Spacing of more than 4 " could allow a child or pet to fall through. A fall or injury could occur if not corrected. A qualified contractor should evaluate and repair or replace as necessary.

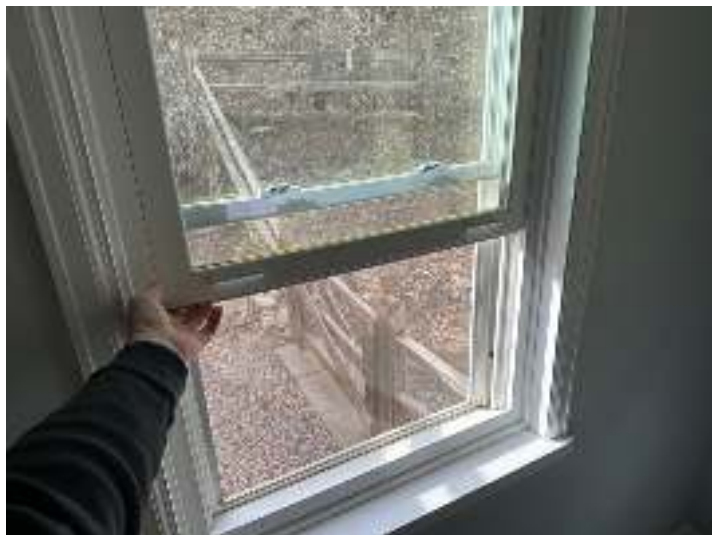
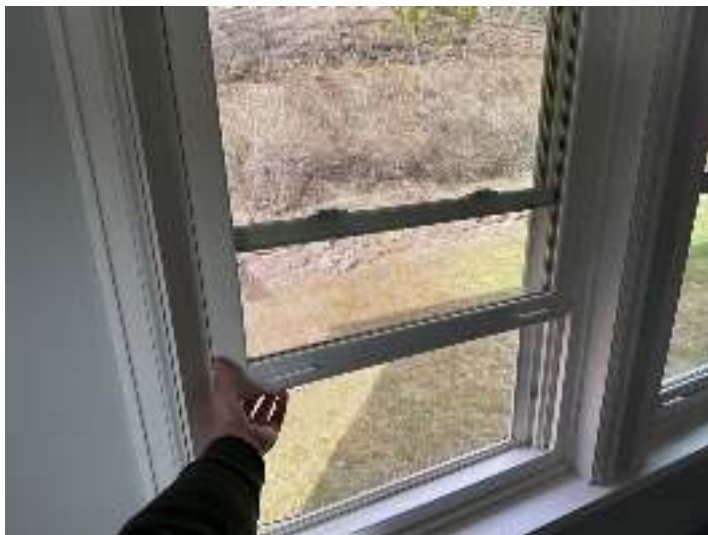
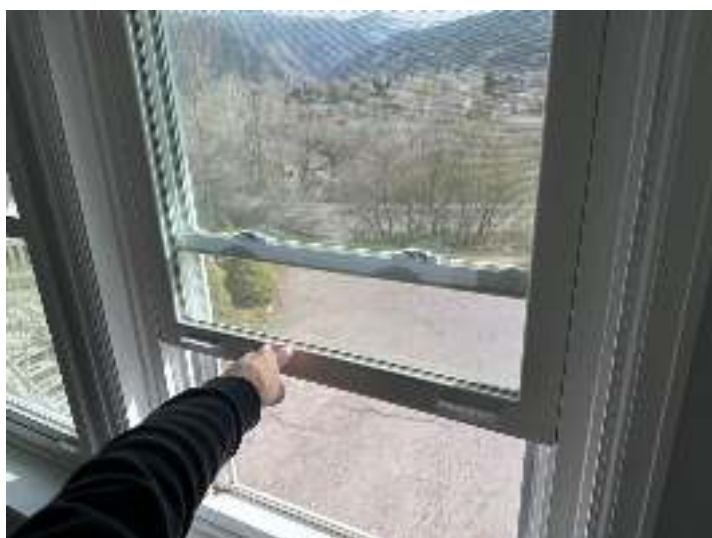
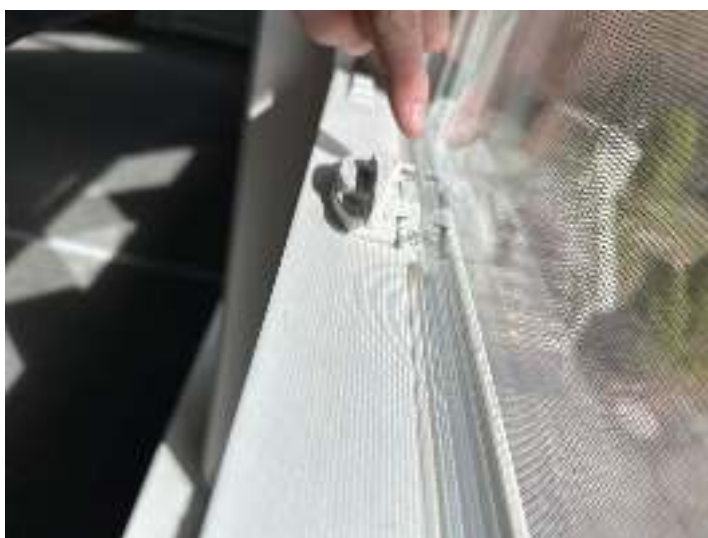
- The newer vinyl clad double hung style windows appeared to be in satisfactory condition at the time of inspection. Windows are inspected for proper operation, condition of sill, sash, hardware and the condition of weather sealing components. Windows in the home may have damaged thermal seals but they may not have been evident at the time of this inspection. Dirt on the windows, the presence of screens, exterior and interior lighting may make thermal seal damage difficult to see. Evidence of damaged seals can appear and disappear as temperature and humidity changes. For a more thorough evaluation of window seals, the inspector recommends that the windows be professionally cleaned and reinspected by a professional window contractor.
- The primary bedroom window did not close completely and lock. A qualified contractor should evaluate and repair or replace as necessary.

- At the time of the inspection, the property did not have emergency escape and rescue openings in the basement which met generally-accepted current standards. Egress opening requirements: For safety reasons, all sleeping room and basements greater than 200 square feet and new properties should meet the generally-accepted current standards for emergency escape and rescue openings, which include the following requirements: 1. Sill height shall not exceed 44 inches above the floor. 2. Minimum net clear opening shall be 5.7 square feet; exception - grade level windows may have a minimum clear opening of 5 square feet. 3. Minimum net clear opening height shall be 24 inches. 4. Minimum net clear opening width shall be 20 inches.

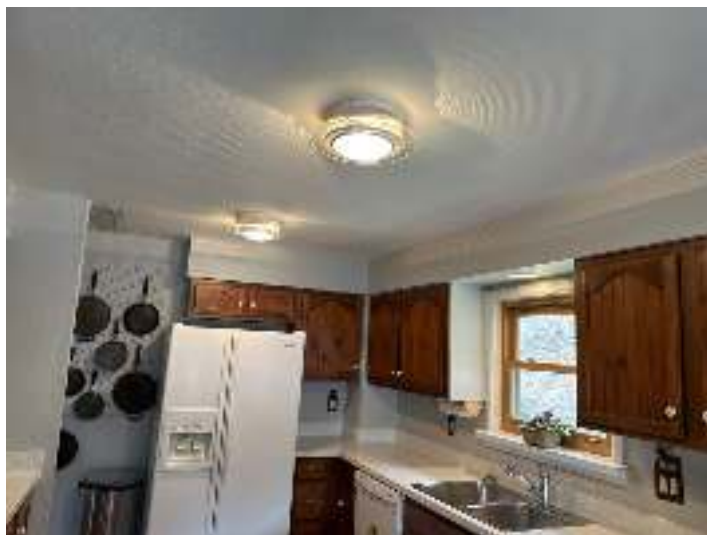
- An outlet did not provide Ground Fault Circuit Interrupter (GFCI) protection. Although GFCI protection of circuits may not have been required at the time in which this home was built, as general knowledge of safe building practices has improved with the passage of time, building standards have changed to reflect current understanding. The inspector recommends updating the existing electrical circuits to include GFCI protection. A qualified contractor should evaluate and repair or replace as necessary.

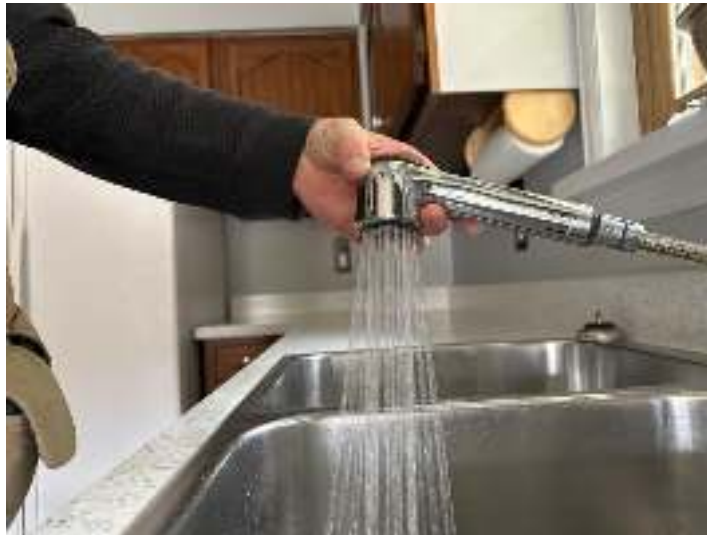
- The water shut off valves for the sink appeared to be in serviceable condition at the time of inspection. They were not operated but were visually inspected
- Inspector recommends replacing all plastic stemmed supply valves and supply lines. A qualified contractor should repair or replace as needed and according to current standards.

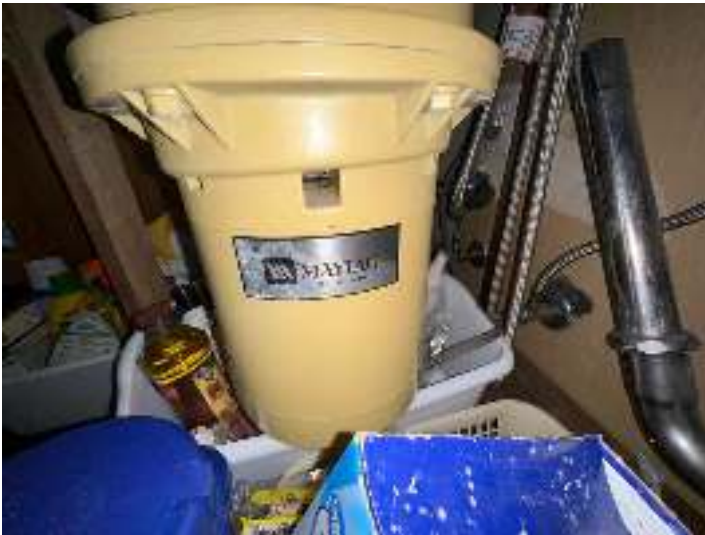
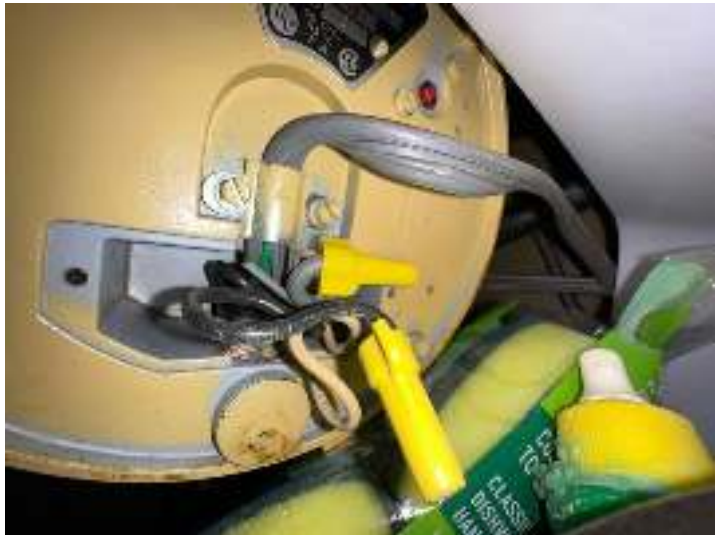
- The food waste disposer was operational, securely installed, electrical wiring was properly secured with romex connector and the drain lines were installed properly with no leaks at the time of inspection
- The food waste disposer had exposed or improper wiring. A qualified contractor should evaluate and repair or replace as necessary.

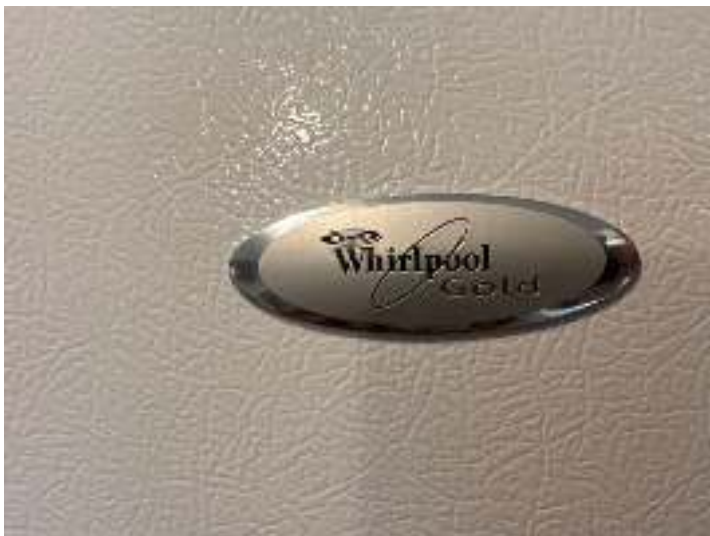
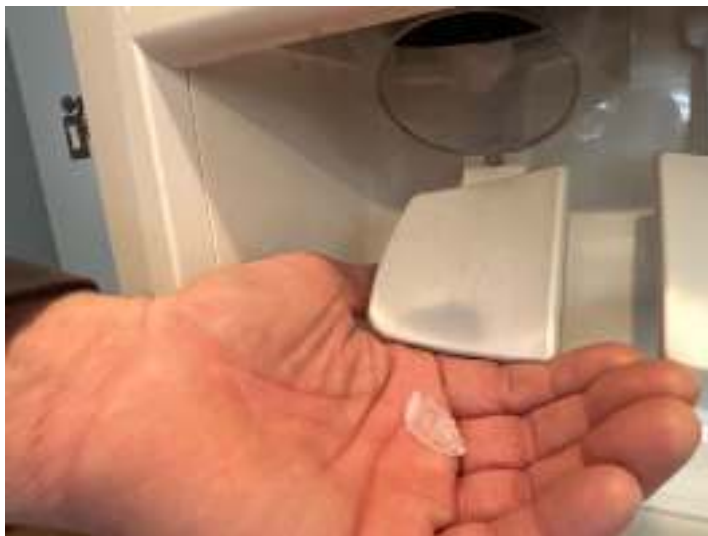
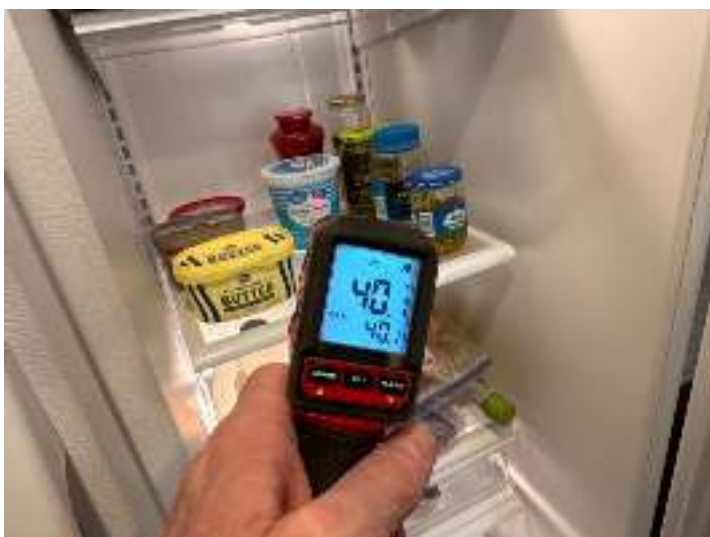
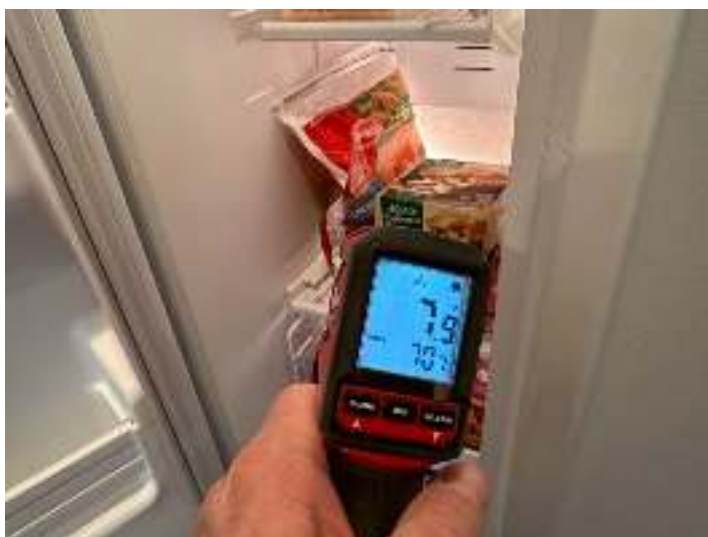
- The refrigerator was operational at the time of inspection.
- The refrigerator/freezer was not cooling at proper temperatures. It is recommended that a refrigerator cool around 38 degrees while a freezer cool around zero degrees. A qualified contractor should evaluate and repair or replace as necessary.

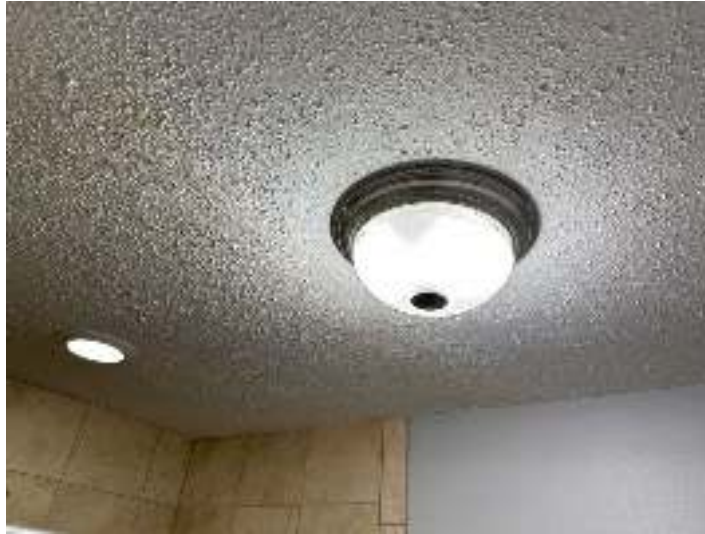
## Bathroom Exhaust Fan

- The bathroom exhaust fan vented directly in to another part of the home. A qualified contractor should evaluate and repair or replace as necessary.

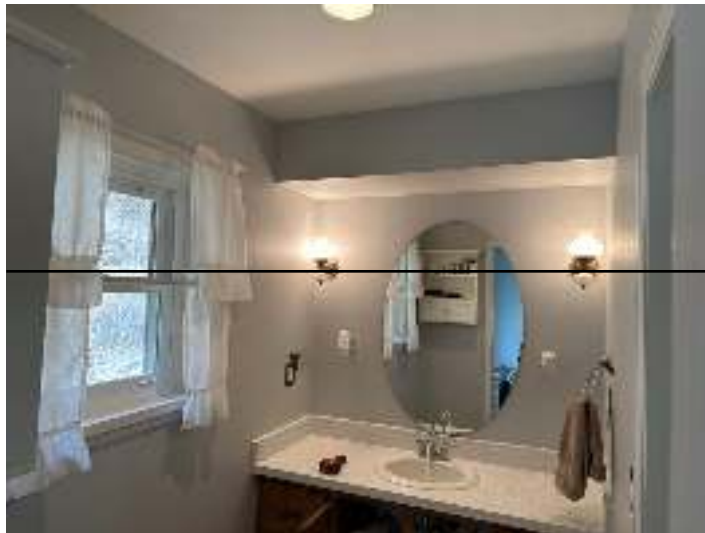
## Ceilings &amp; Walls

- The walls and ceilings in the interior rooms appeared to be in satisfactory condition at the time of inspection.

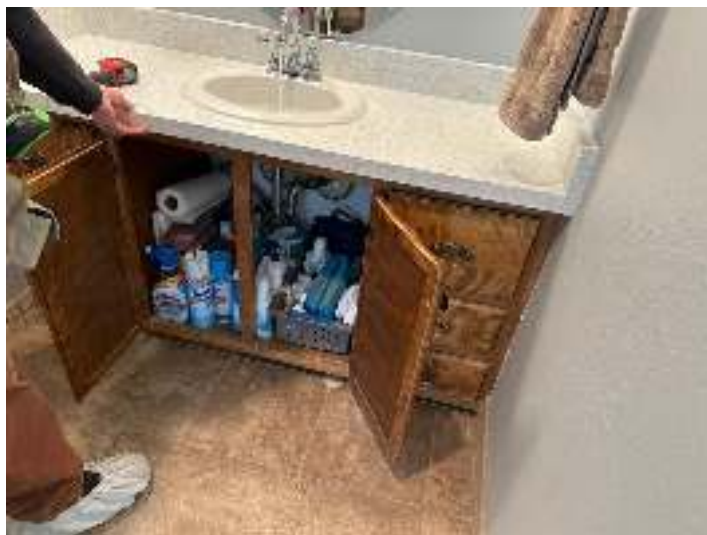
## Cabinets &amp; Counters

- The counter tops in this bathroom were properly installed, secured properly and in generally satisfactory condition.
- The cabinets/shelves in the bathroom were properly installed, secured with proper hardware, doors and drawers (if present) were operational and in generally satisfactory condition.

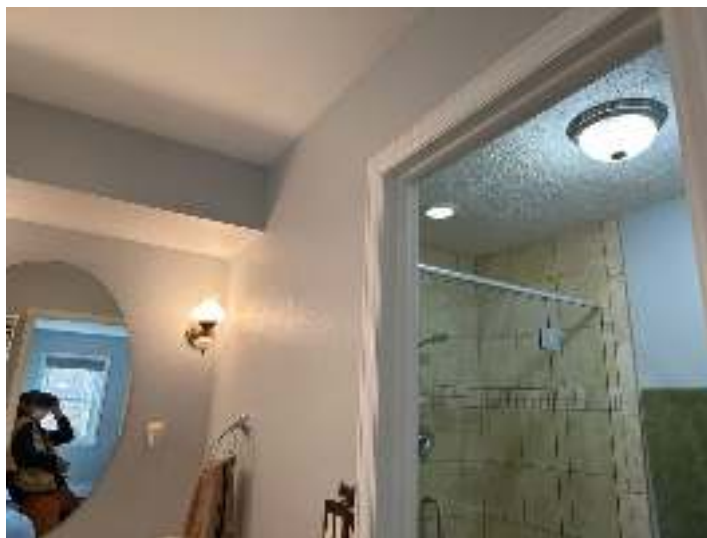
### Electrical Fixtures & Switches

- Light fixtures mounted in the interior rooms responded to the switches and appeared to be in serviceable condition at the time of inspection.
- The light fixture is not rated for use in wet areas. A qualified contractor should evaluate and repair or replace as necessary.

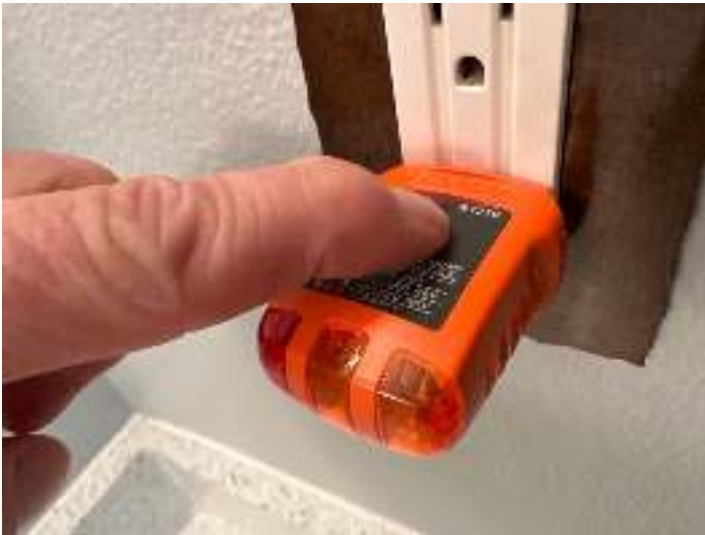
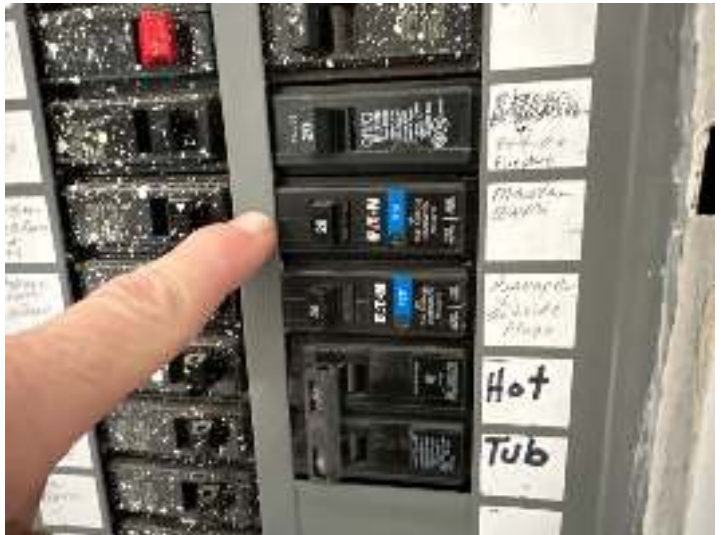
### Electrical Outlets

- Bathroom electrical outlets were ground fault circuit interrupter (GFCI) protected, responded to testing and appeared to be in serviceable condition at the time of inspection. Reset located at basement electrical service panel.

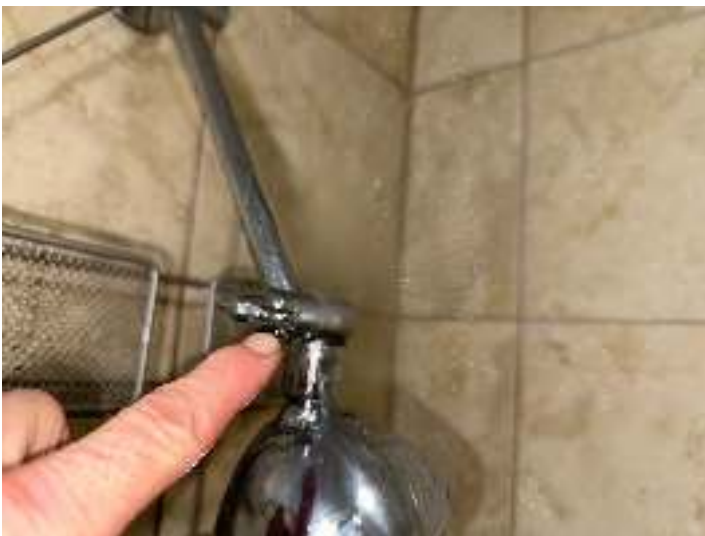
### Plumbing Fixtures

- The visible water supply piping in this bathroom was in satisfactory condition and was function as designed and intended. All functional plumbing fixtures were operated during the inspection and were secured properly, no signs of active leaks were present and were functioning as designed and intended. Evaluation of extra fixtures is outside the scope of the inspection.
- The finish on the mirror is damaged. A qualified contractor should evaluate and repair or replace as necessary.
- The shower head union sprayed water on the ceiling during activation at the time of inspection. A qualified contractor should evaluate and repair or replace as necessary.

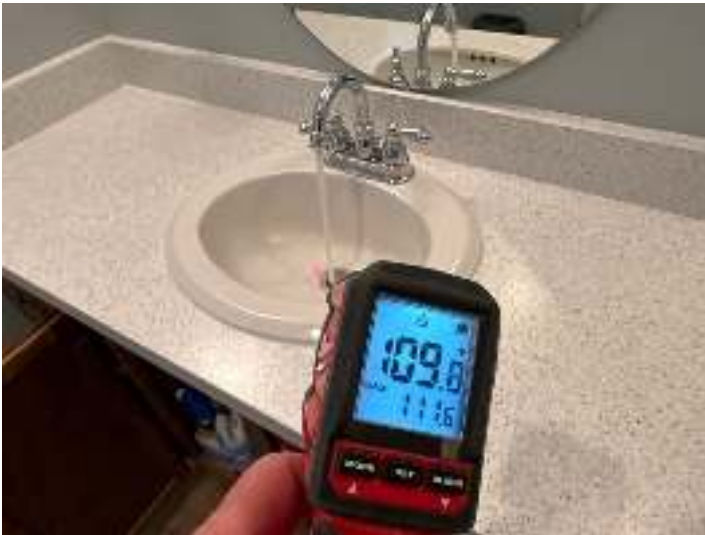
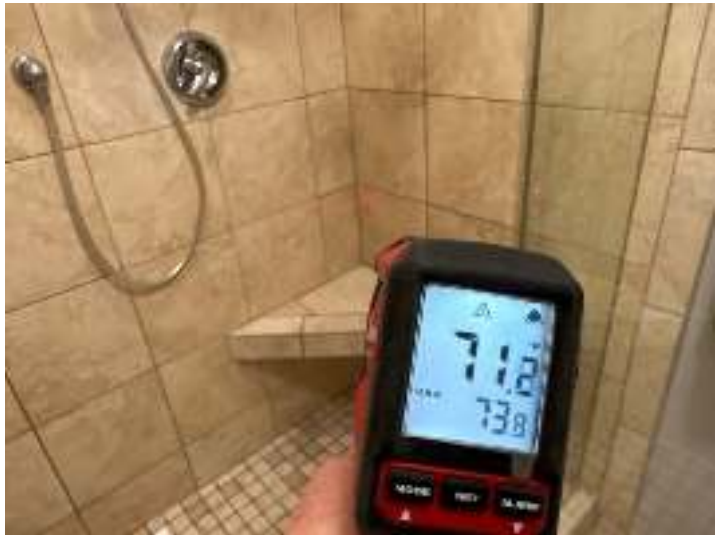
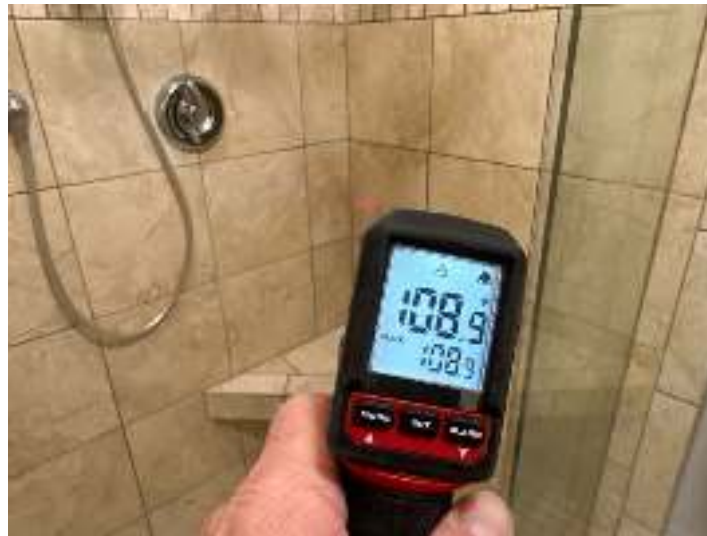
### Fixture Valve Installation And Temperature

- The water supply valves and supply lines at the fixtures were installed correctly and were functioning as designed and intended. Hot and cold water temperatures were within an acceptable range and supply lines were connected to the correct faucet valves according to current standards.

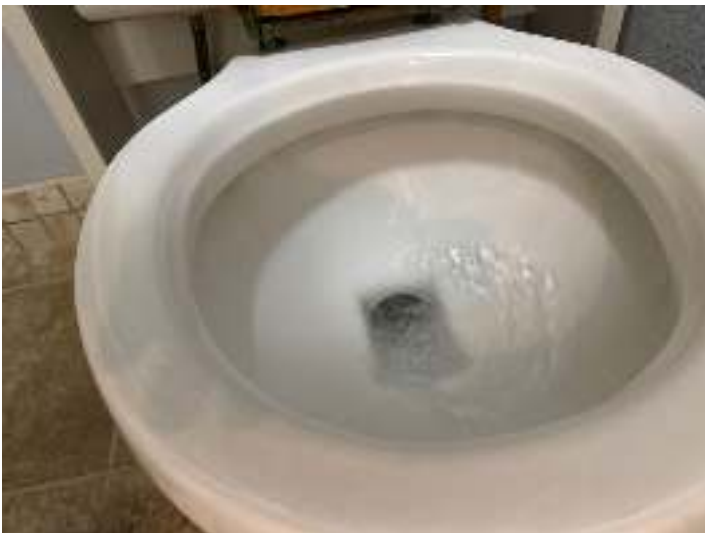
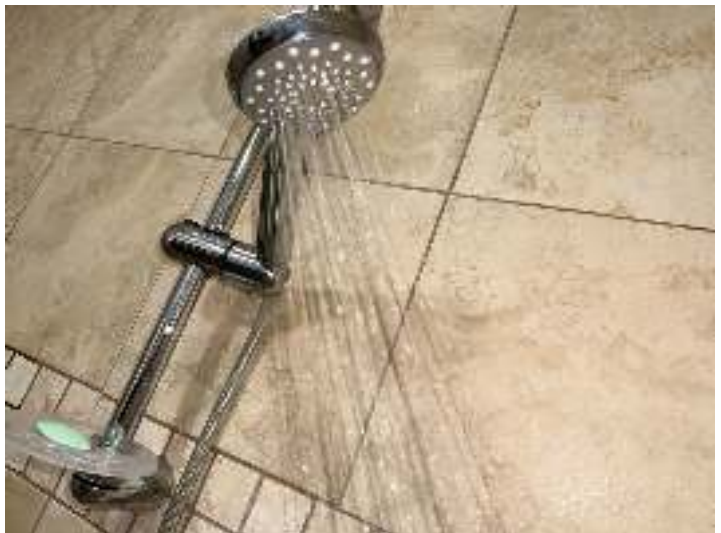
#### Water Supply Functional Flow

- The overall water pressure was good and had acceptable "functional Flow." This is determined by viewing the flow when two fixtures are operated simultaneously.

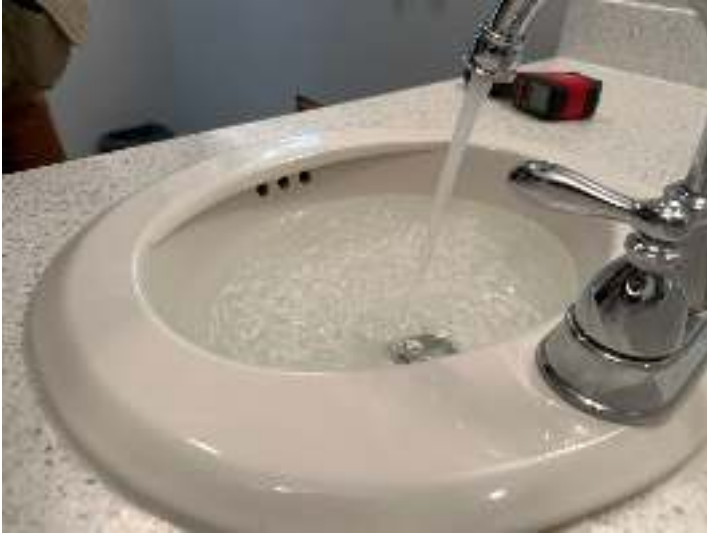
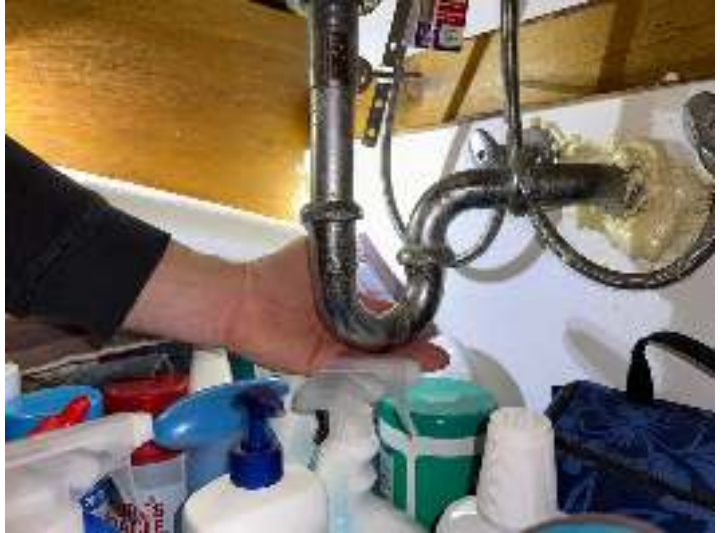
### Plumbing, Drain Waste and Vent System

- The visible drain, waste and vent piping material in this bathroom was in satisfactory condition and was functioning as designed and intended. The drains from all functional fixtures were tested during the inspection and emptied in a reasonable amount of time and did not overflow when other fixtures were drained simultaneously.

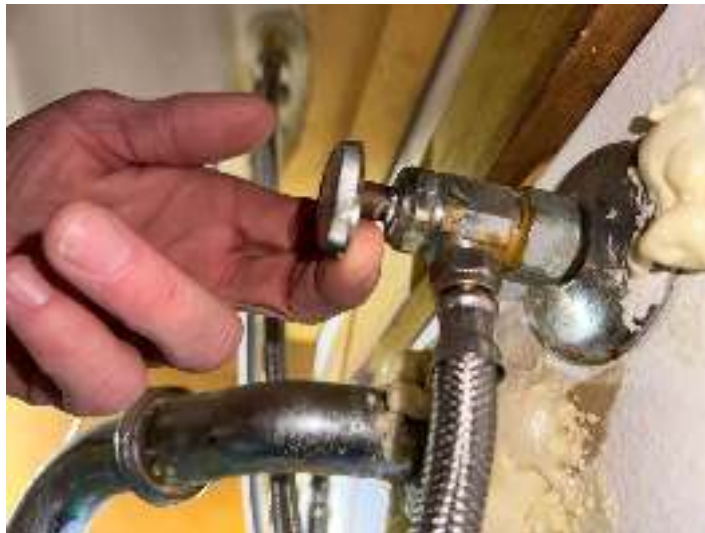
### Plumbing Water Supply Shutoff Valves

- The water shut off valves for the sink appeared to be in serviceable condition at the time of inspection. They were not operated but were visually inspected
- Inspector recommends replacing all plastic stemmed supply valves and supply lines. A qualified contractor should repair or replace a needed and according to current standards.

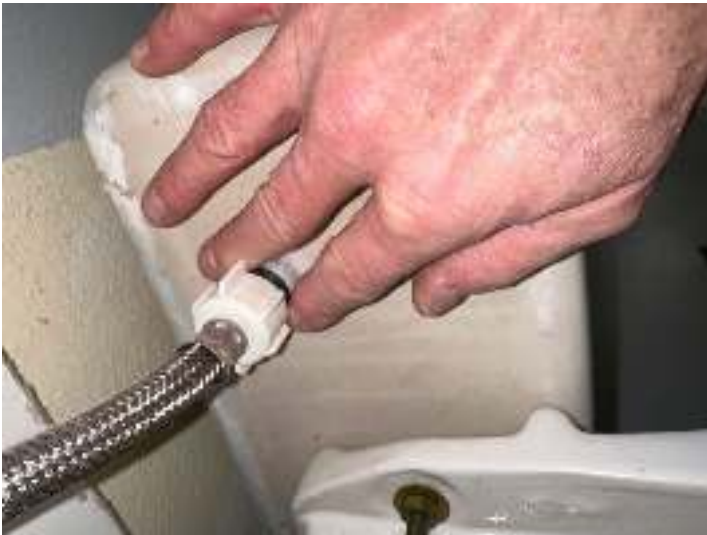
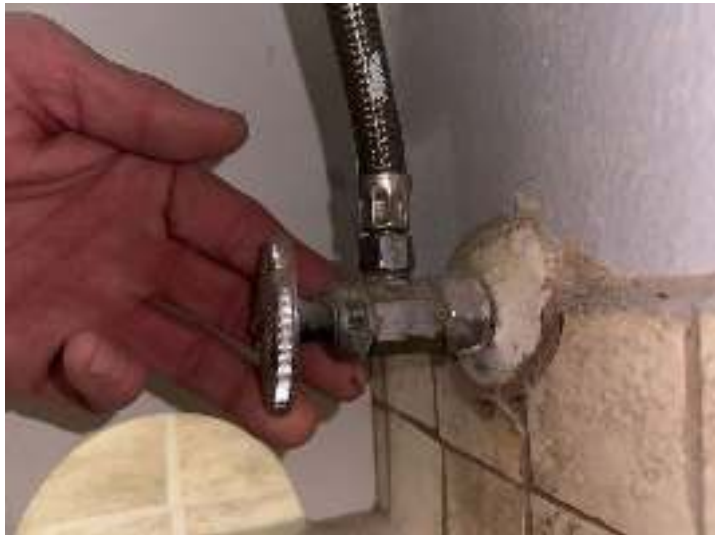
### Toilets

- The visible components of the toilet were in satisfactory condition and functioning as designed and intended. The toilet was secured properly to the floor, no visible evidence of leaking was present and the toilet emptied in a reasonable amount of time.
- Inspector recommends replacing all plastic stemmed supply valves and supply lines. A qualified contractor should repair or replace a needed and according to current standards.

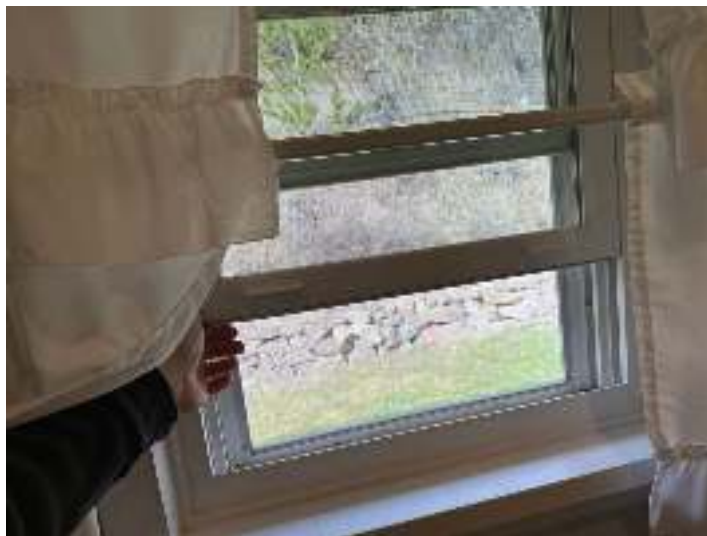
### Windows

- The windows appeared to be in satisfactory condition at the time of inspection. Windows are inspected for proper operation, condition of sill, sash, hardware and the condition of weather sealing components. Windows in the home may have damaged thermal seals but they may not have been evident at the time of this inspection. Dirt on the windows, the presence of screens, exterior and interior lighting may make thermal seal damage difficult to see. Evidence of damaged seals can appear and disappear as temperature and humidity changes. For a more thorough evaluation of window seals, the inspector recommends that the windows be professionally cleaned and reinspected by a professional window contractor.

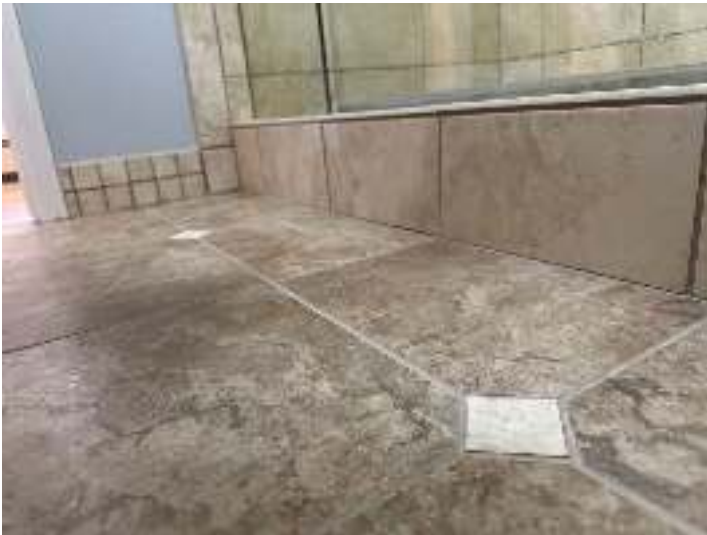
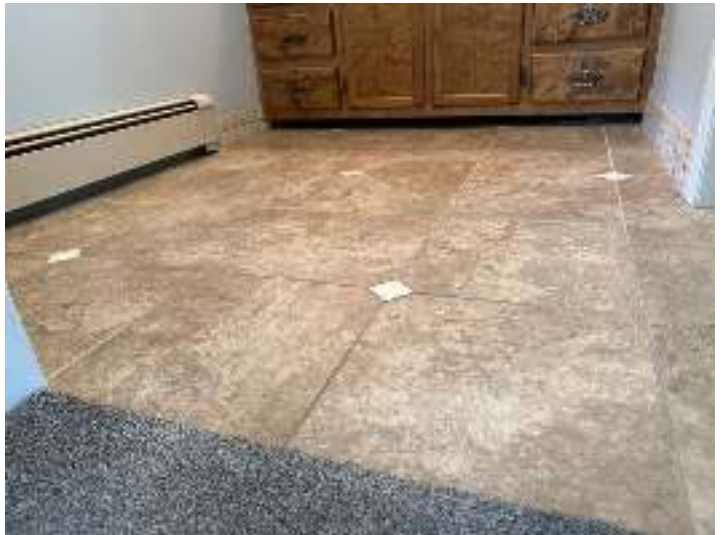
### Floors

- The tile floors in the interior rooms appeared to be in satisfactory condition at the time of inspection.

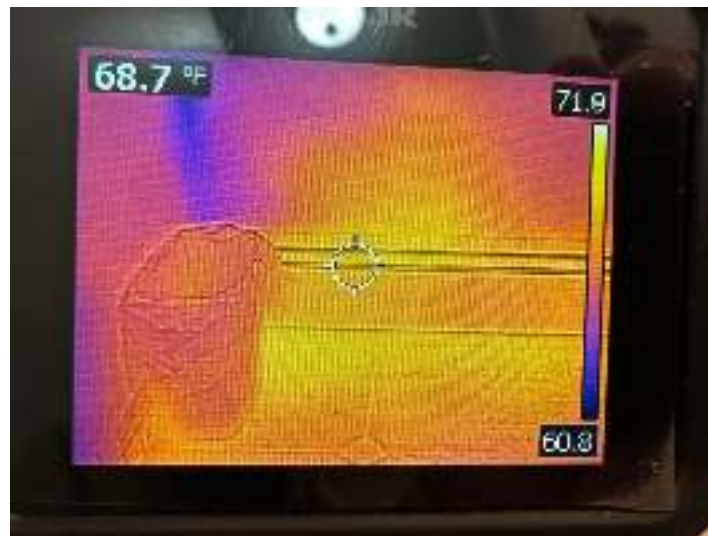
#### Presence Of Installed Heat Source

- The heating system was turned on using normal operating controls and all interior rooms had a heat source installed (bathrooms, kitchens, laundry rooms and unfinished spaces do not require heat sources). Inspection of air flow and/or distribution is beyond the scope of the inspection. We are not able to determine the supply adequacy of the heating system during the course of a general home inspection. As a courtesy to the client the inspector tested a representative number of heat registers throughout the property.
