# **AM Services**

## **Property Inspection Report**

~~1815 Midland Ave, Glenwood Springs, Co 81601~~

Date of Inspection: 4/21/2023 Time: 9:04am

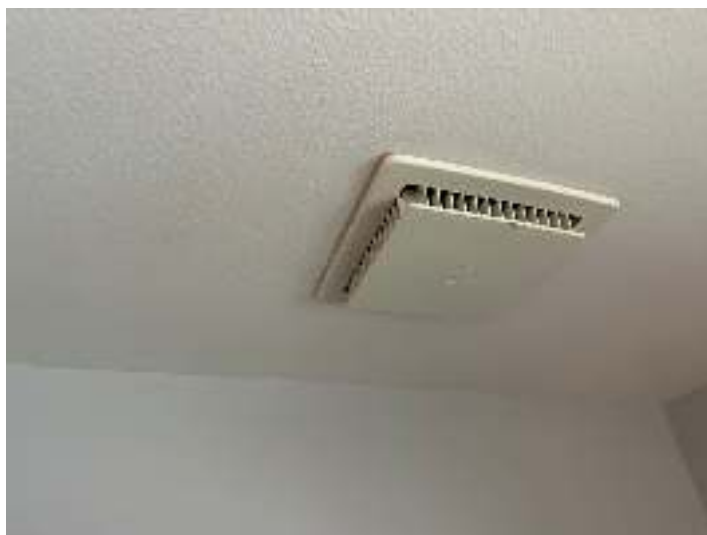
## Bathroom Exhaust Fan

- The exhaust fan in this bathroom operated properly and appeared to be in serviceable condition at the time of inspection.
- The bathroom exhaust fan vented directly in to another part of the home. A qualified contractor should evaluate and repair or replace as necessary.

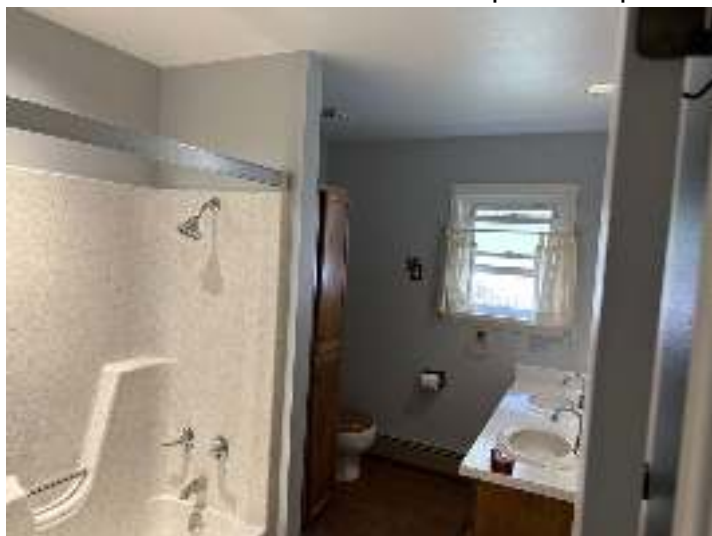
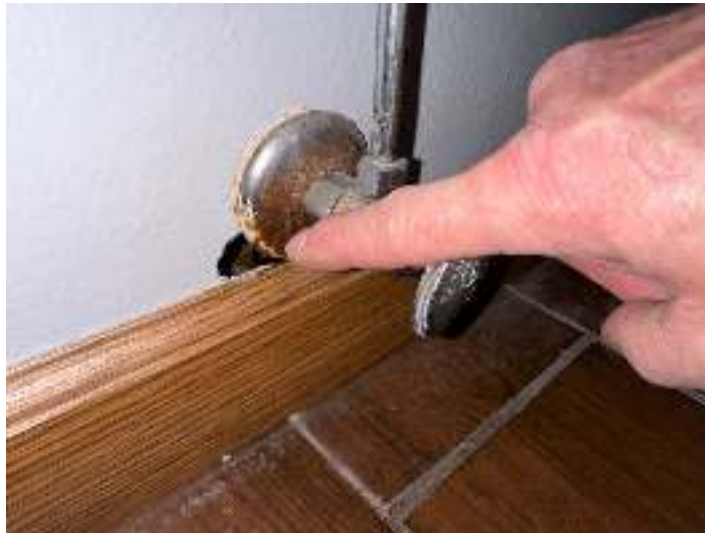
## Ceilings &amp; Walls

- The walls and ceilings in the interior rooms appeared to be in satisfactory condition at the time of inspection.
- The wall was damaged or dented from the robe hook. A qualified contractor should evaluate and repair or replace as necessary.
- The drywall and/or trim was not finished properly (at the toilet water supply). A qualified contractor should evaluate and repair or replace as necessary.

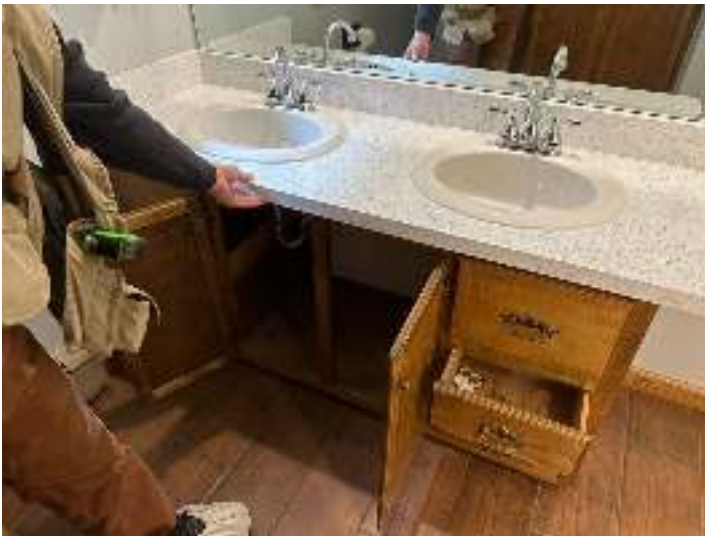
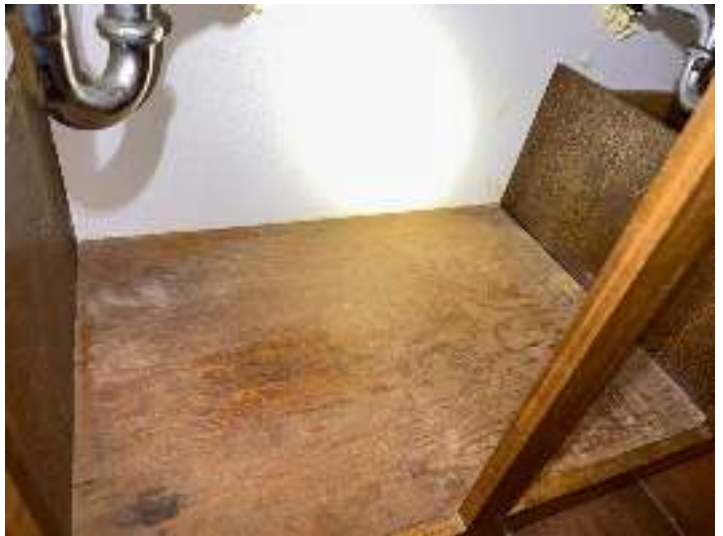
### Cabinets & Counters

- The counter tops in this bathroom were properly installed, secured properly and in generally satisfactory condition.
- The cabinets/shelves in the bathroom were properly installed, secured with proper hardware, doors and drawers (if present) were operational and in generally satisfactory condition.

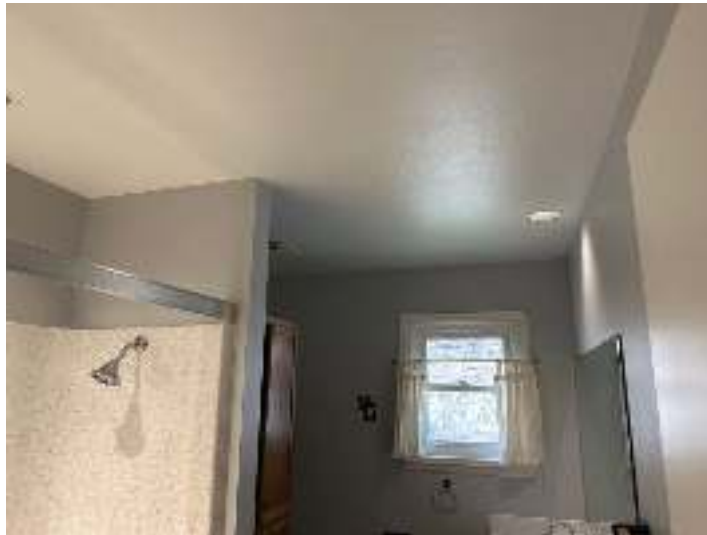
### Electrical Fixtures & Switches

- Light fixtures mounted in the interior rooms responded to the switches and appeared to be in serviceable condition at the time of inspection.

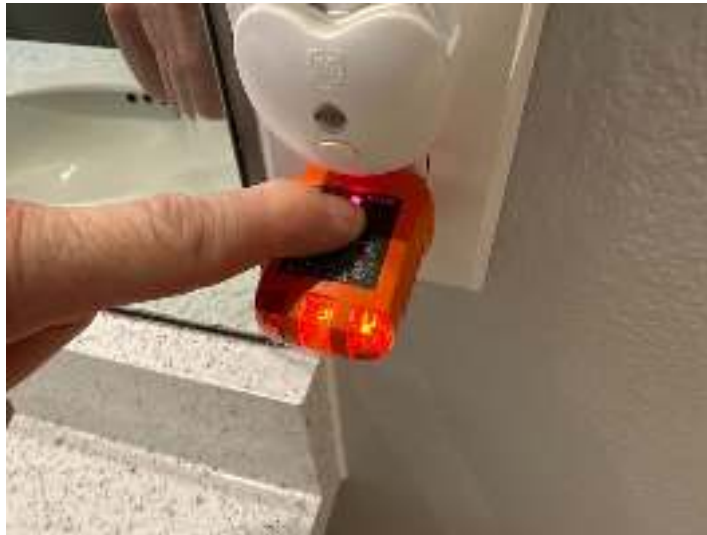
### Electrical Outlets

- An outlet did not provide Ground Fault Circuit Interrupter (GFCI) protection. Although GFCI protection of circuits may not have been required at the time in which this home was built, as general knowledge of safe building practices has improved with the passage of time, building standards have changed to reflect current understanding. The inspector recommends updating the existing electrical circuits to include GFCI protection. A qualified contractor should evaluate and repair or replace as necessary.

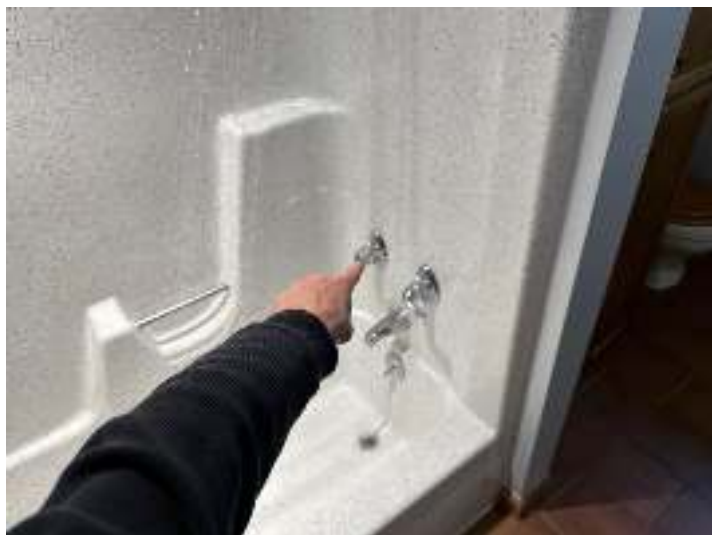
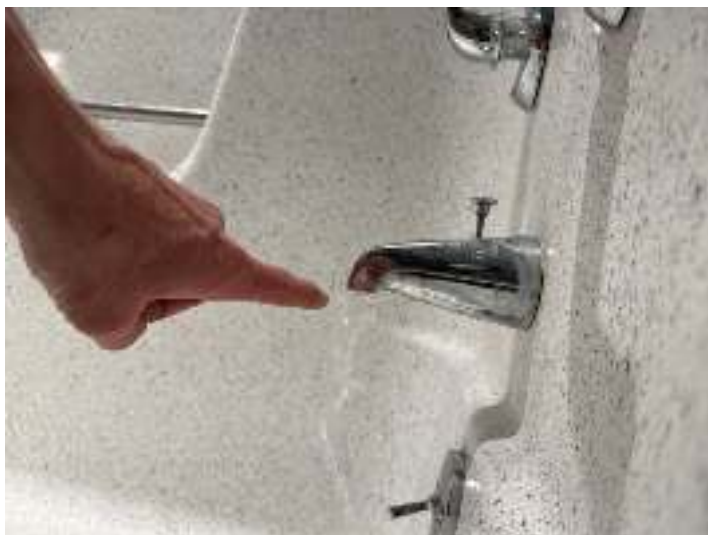
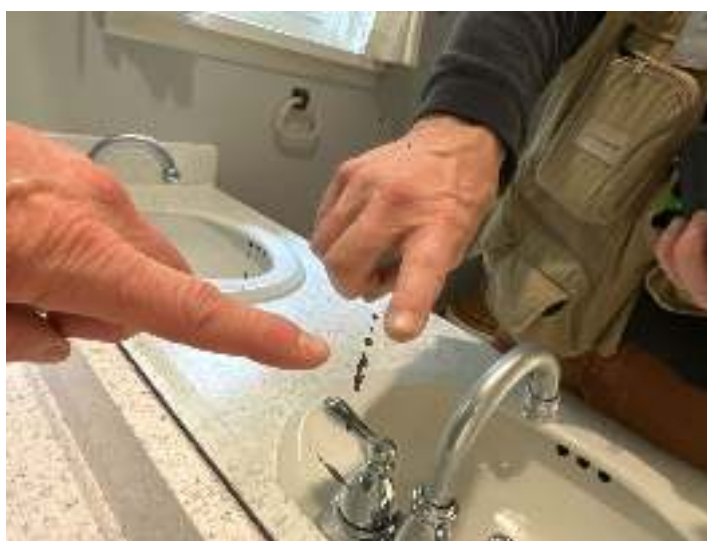
### Plumbing Fixtures

- The visible water supply piping in this bathroom was in satisfactory condition and was function as designed and intended. All functional plumbing fixtures were operated during the inspection and were secured properly, no signs of active leaks were present and were functioning as designed and intended. Evaluation of extra fixtures is outside the scope of the inspection.
- The shower diverter did not divert all of the water to the shower and a stream of water passed though bathtub spout when the shower was on. A qualified contractor should evaluate and repair or replace as necessary.
- The shower/tub control lever or knob did not have a lever stop at the off position and continually spins. A qualified contractor should evaluate and repair or replace as necessary.

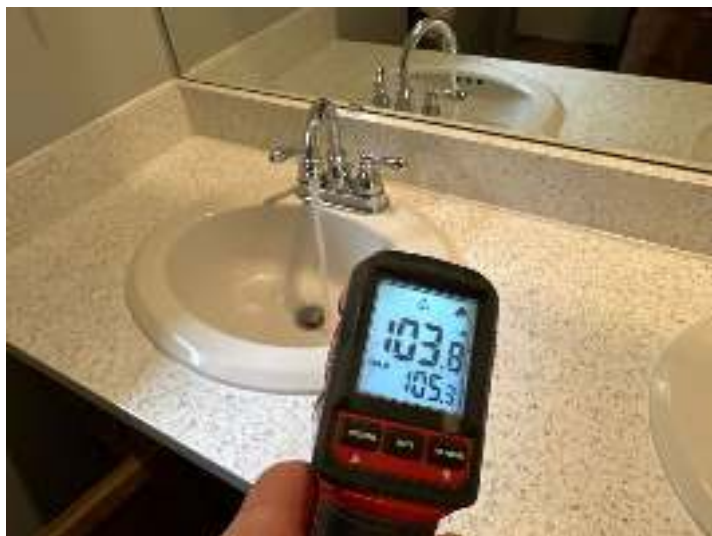
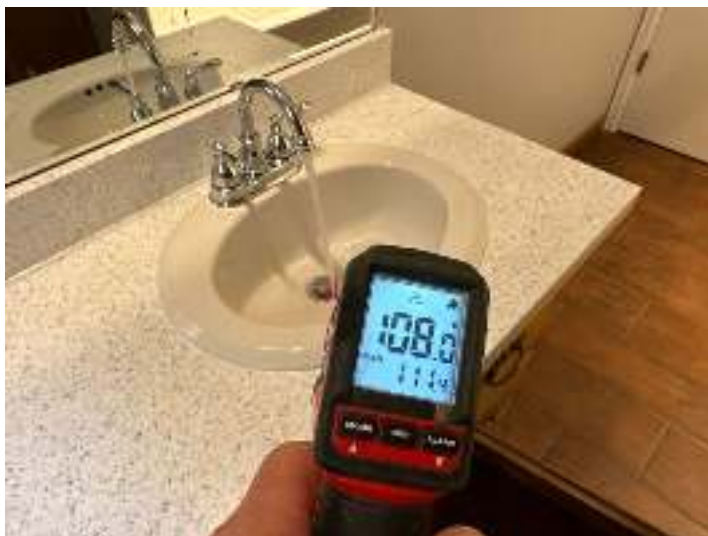
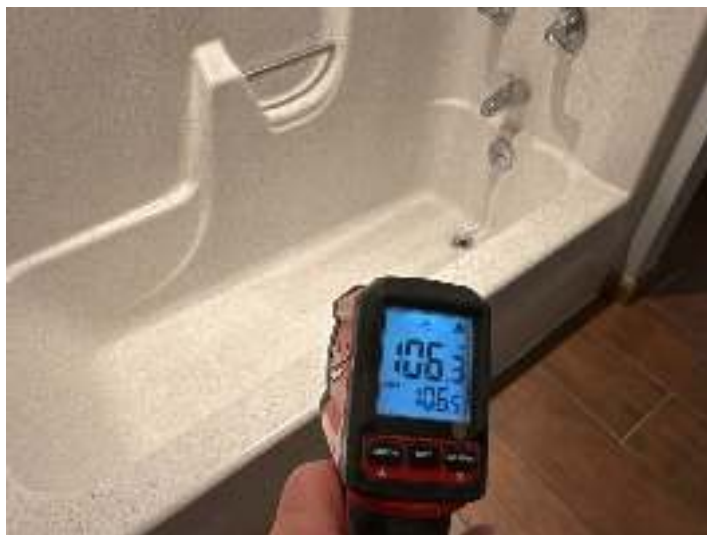
#### Fixture Valve Installation And Temperature

- The water supply valves and supply lines at the fixtures were installed correctly and were functioning as designed and intended. Hot and cold water temperatures were within an acceptable range and supply lines were connected to the correct faucet valves according to current standards.

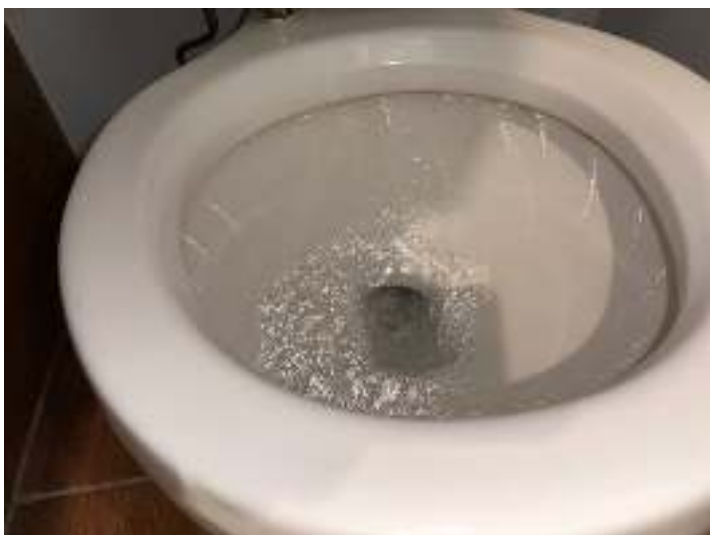
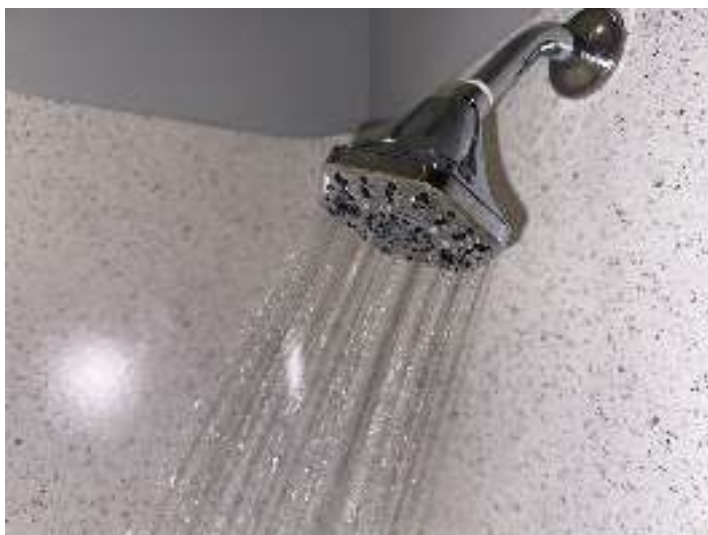
#### Water Supply Functional Flow

- The overall water pressure was good and had acceptable "functional Flow." This is determined by viewing the flow when two fixtures are operated simultaneously.

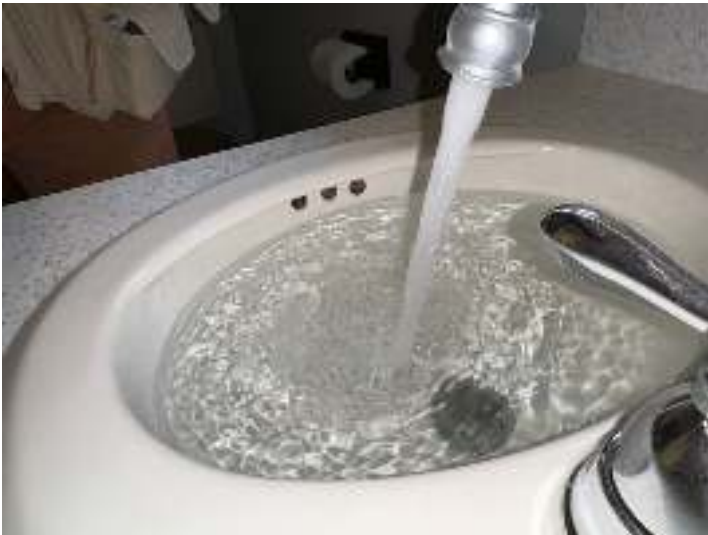
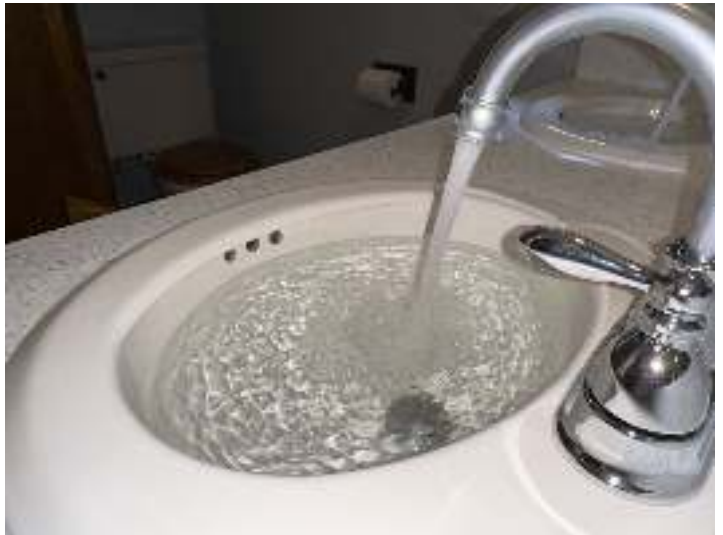
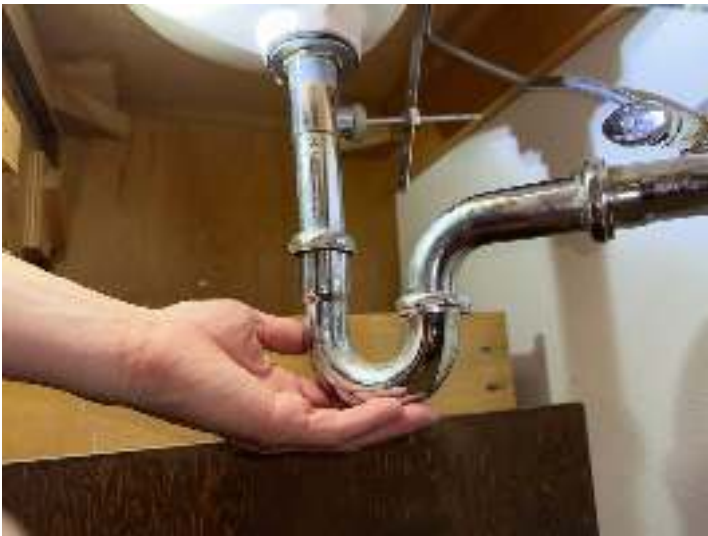
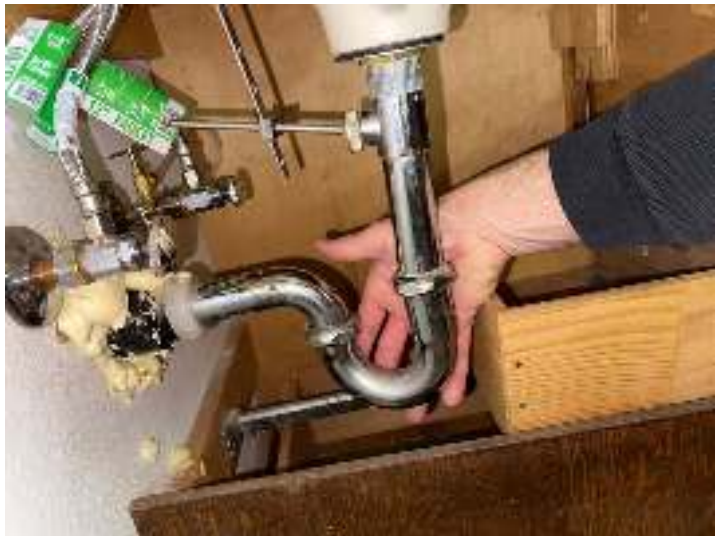
#### Plumbing, Drain Waste and Vent System

- The visible drain, waste and vent piping material in this bathroom was in satisfactory condition and was functioning as designed and intended. The drains from all functional fixtures were tested during the inspection and emptied in a reasonable amount of time and did not overflow when other fixtures were drained simultaneously.

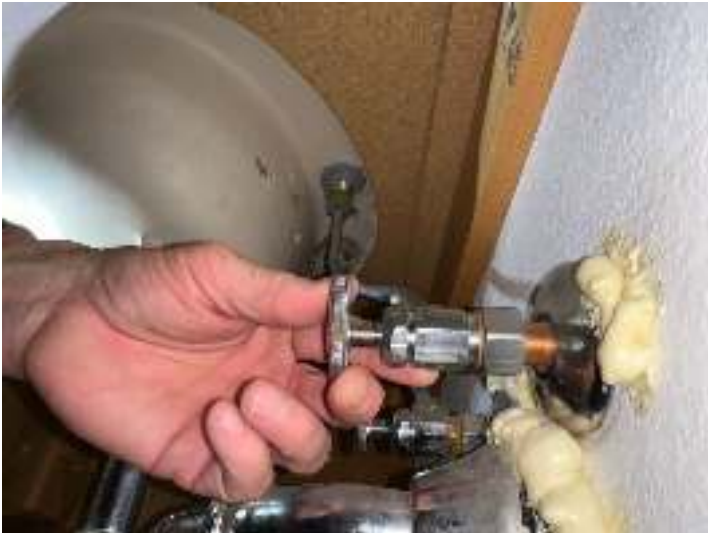
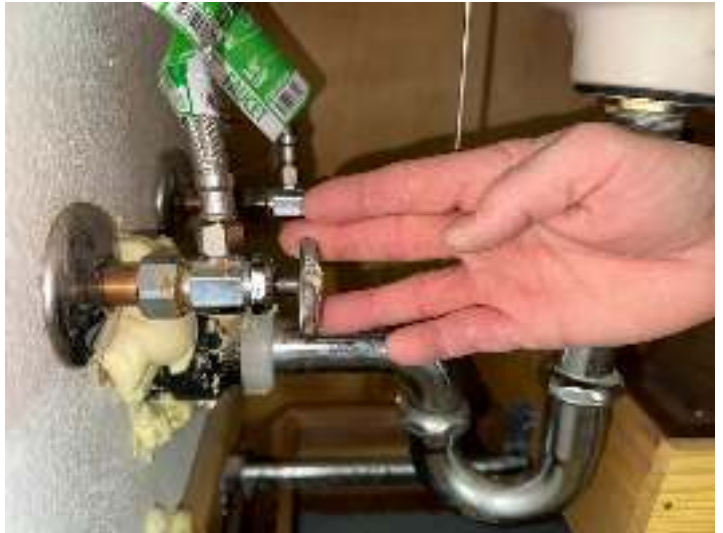
### Plumbing Water Supply Shutoff Valves

- The water shut off valves for the sink appeared to be in serviceable condition at the time of inspection. They were not operated but were visually inspected
- Inspector recommends replacing all plastic stemmed supply valves and supply lines. A qualified contractor should repair or replace a needed and according to current standards.

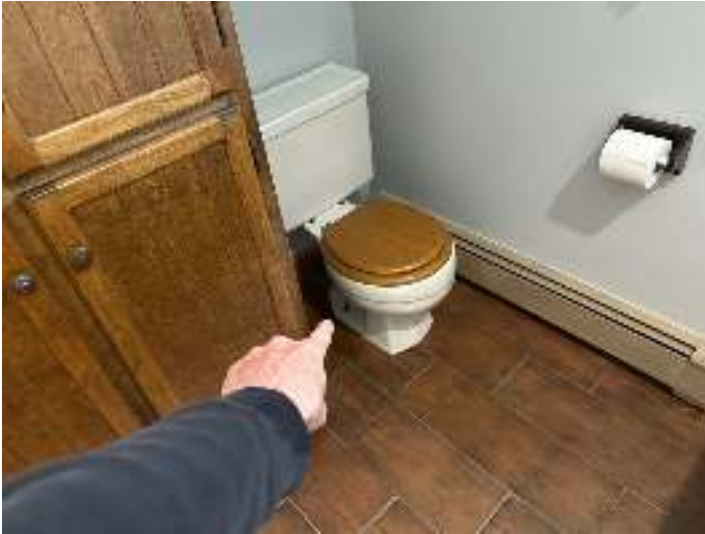
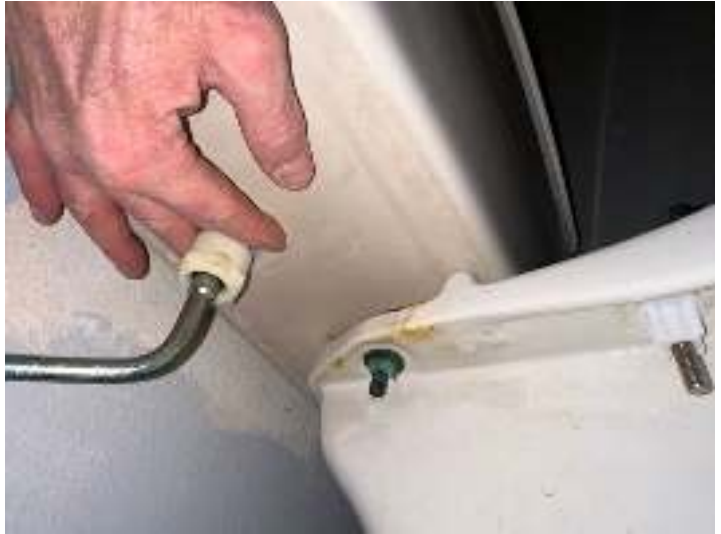
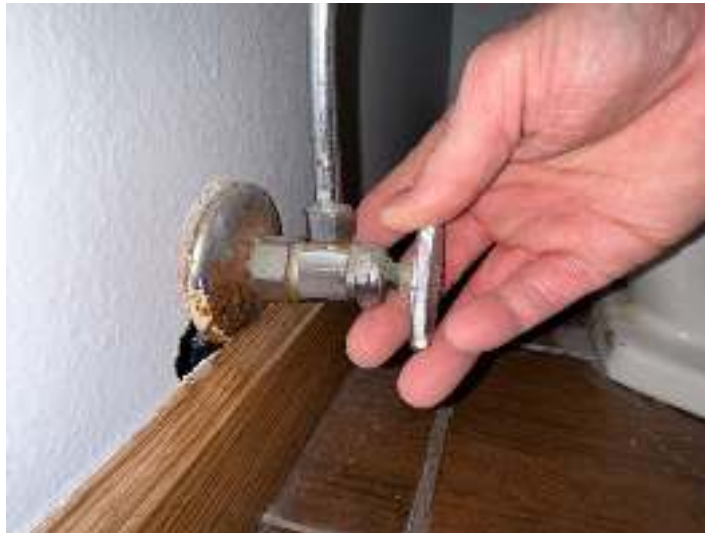
### Toilets

- The visible components of the toilet were in satisfactory condition and functioning as designed and as intended. The toilet was secured properly to the floor, no visible evidence of leaking was present and the toilet emptied in a reasonable amount of time.
- Inspector recommends replacing all plastic stemmed supply valves and supply lines. A qualified contractor should repair or replace as needed and according to current standards.
- The toilet was loose at the floor. This condition typically is caused by loose bolts or nuts and/or missing floor seals. Loose toilet can result in leaks, water damage, and mold, as well as damage to the toilet, water supply lines, bolts, and drainage pipes. A qualified contractor should evaluate and repair or replace as necessary.

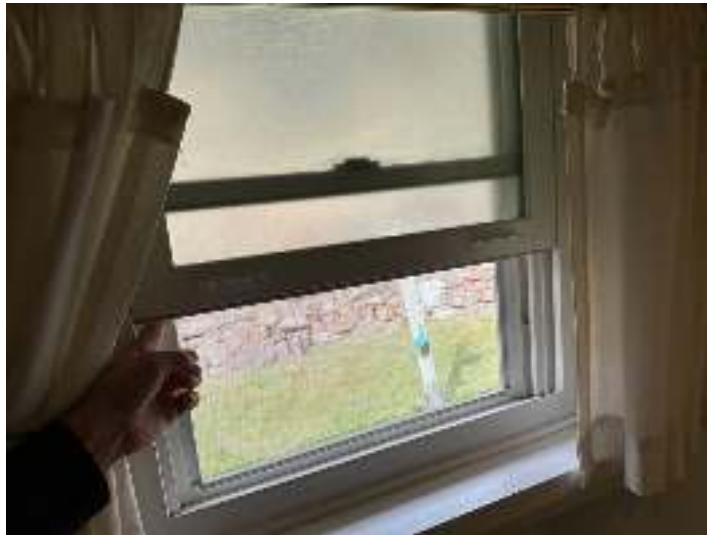
### Windows

- The windows appeared to be in satisfactory condition at the time of inspection. Windows are inspected for proper operation, condition of sill, sash, hardware and the condition of weather sealing components. Windows in the home may have damaged thermal seals but they may not have been evident at the time of this inspection. Dirt on the windows, the presence of screens, exterior and interior lighting may make thermal seal damage difficult to see. Evidence of damaged seals can appear and disappear as temperature and humidity changes. For a more thorough evaluation of window seals, the inspector recommends that the windows be professionally cleaned and reinspected by a professional window contractor.

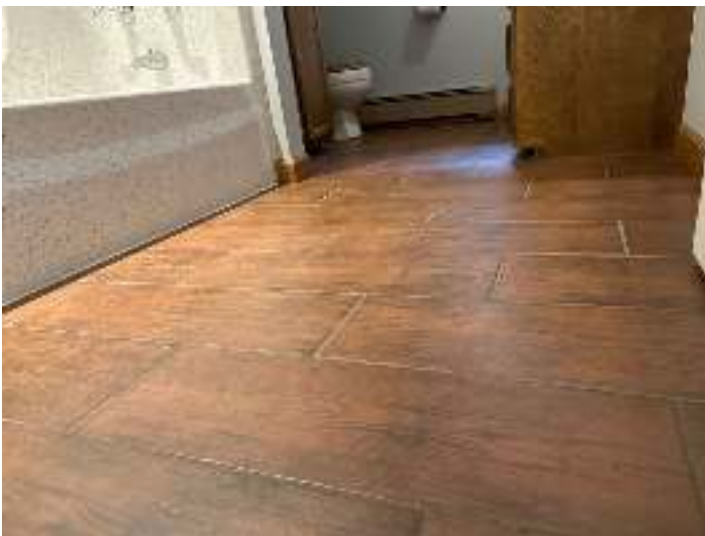
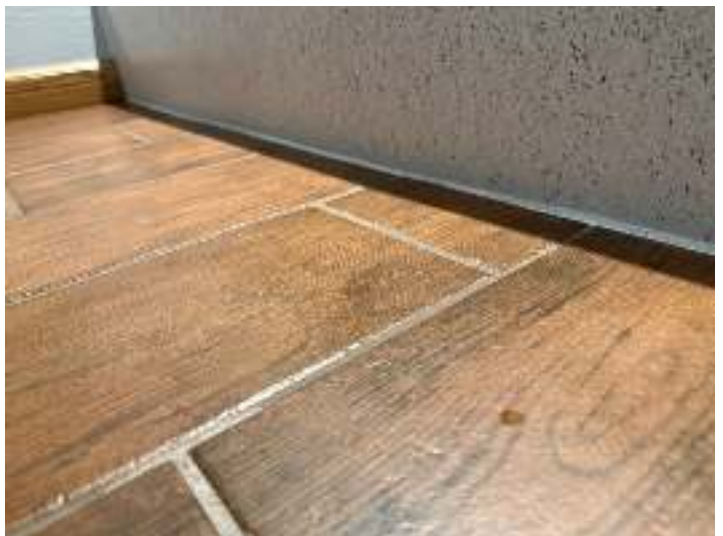
### Floors

- The tile floors in the interior rooms appeared to be in satisfactory condition at the time of inspection.

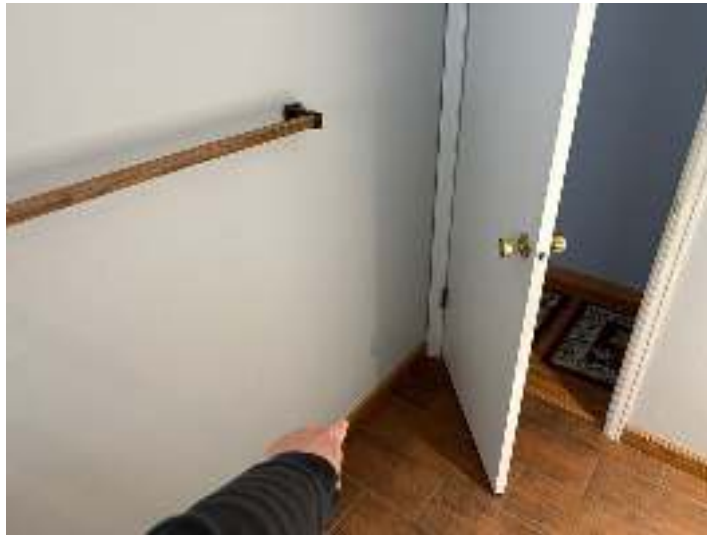
### Doors

- Interior hollow core doors and hardware appeared to be in satisfactory condition at the time of inspection. Door inspection includes examination for proper installation, operation and condition.
- The door had a damaged or missing doorstop. A qualified contractor should evaluate and repair or replace as necessary.

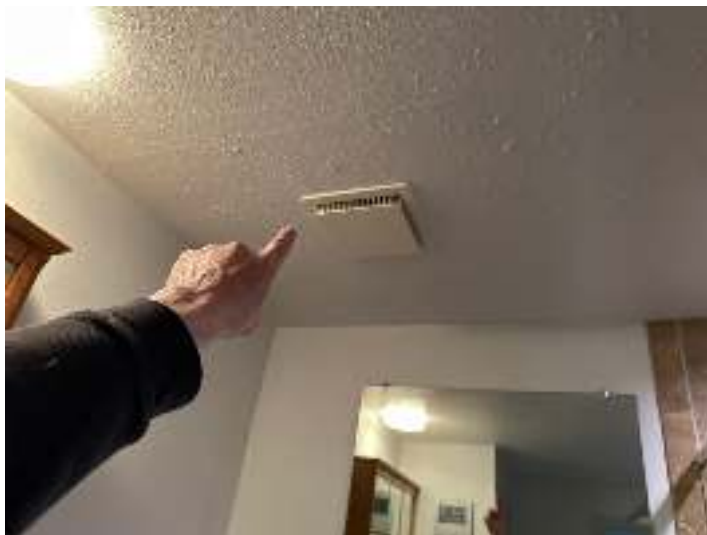
## Bathroom Exhaust Fan

- The bathroom exhaust fan was weak. A qualified contractor should evaluate and repair or replace as necessary.
- The bathroom exhaust fan vented directly in to another part of the home. A qualified contractor should evaluate and repair or replace as necessary.

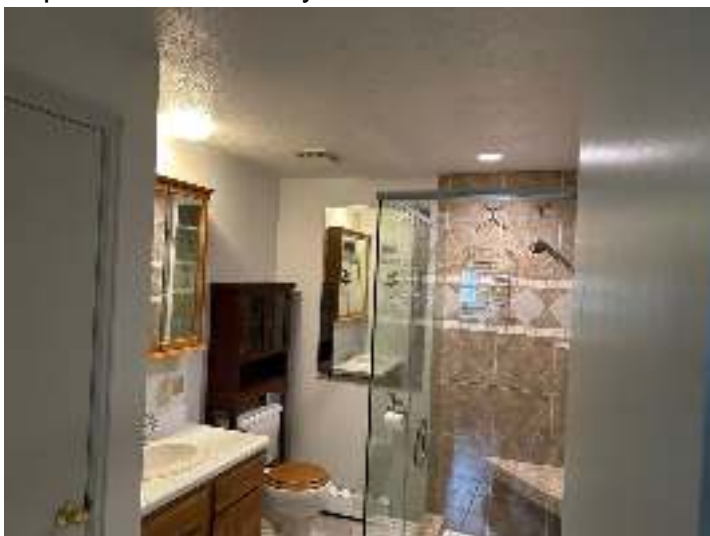
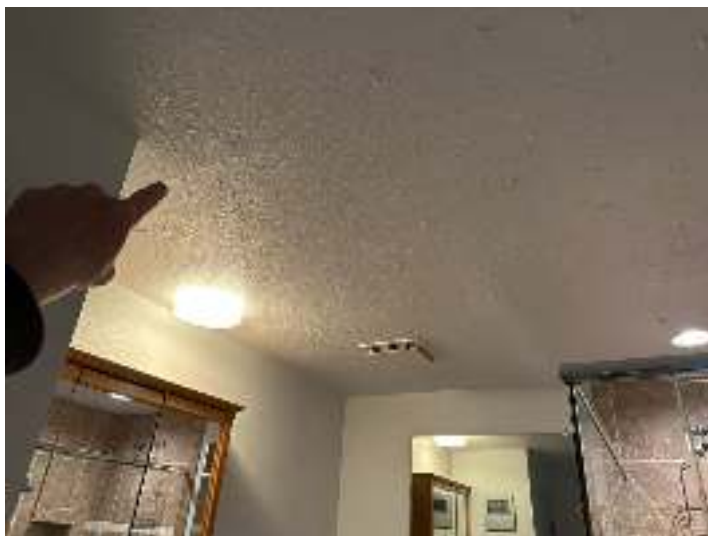
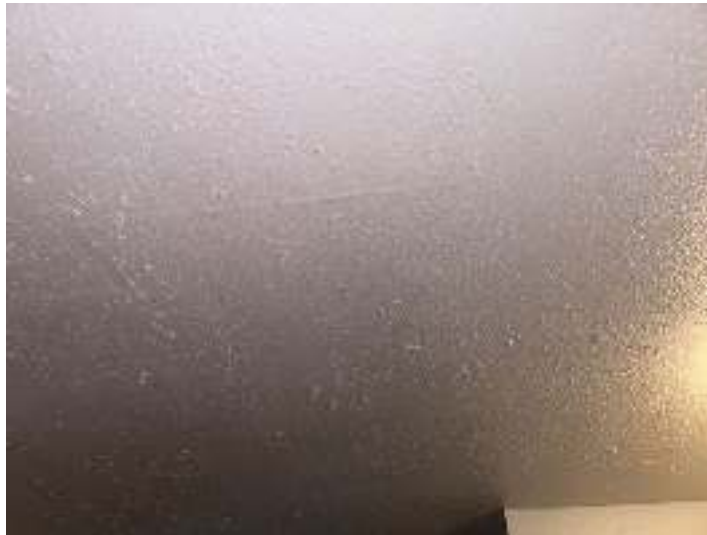
## Ceilings &amp; Walls

- The walls and ceilings in the interior rooms appeared to be in satisfactory condition at the time of inspection.
- Minor cracking was visible on the interior ceilings. A qualified contractor should evaluate and repair or replace as necessary.
- The ceilings had signs of previous repair. A qualified contractor should evaluate and repair or replace as necessary.

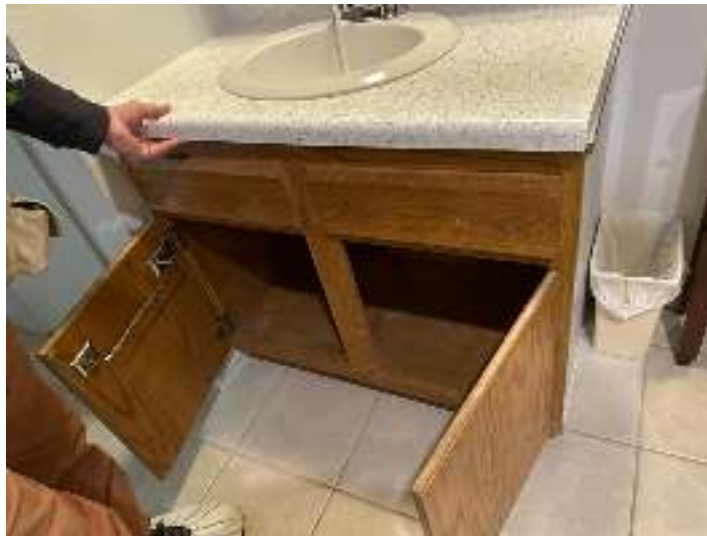
### Cabinets & Counters

- The counter tops in this bathroom were properly installed, secured properly and in generally satisfactory condition.
- The cabinets/shelves in the bathroom were properly installed, secured with proper hardware, doors and drawers (if present) were operational and in generally satisfactory condition.

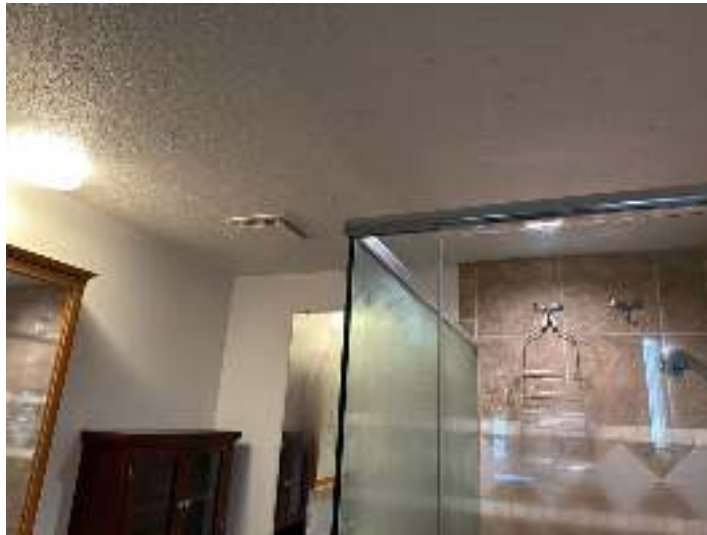
### Electrical Fixtures & Switches

- Light fixtures mounted in the interior rooms responded to the switches and appeared to be in serviceable condition at the time of inspection.

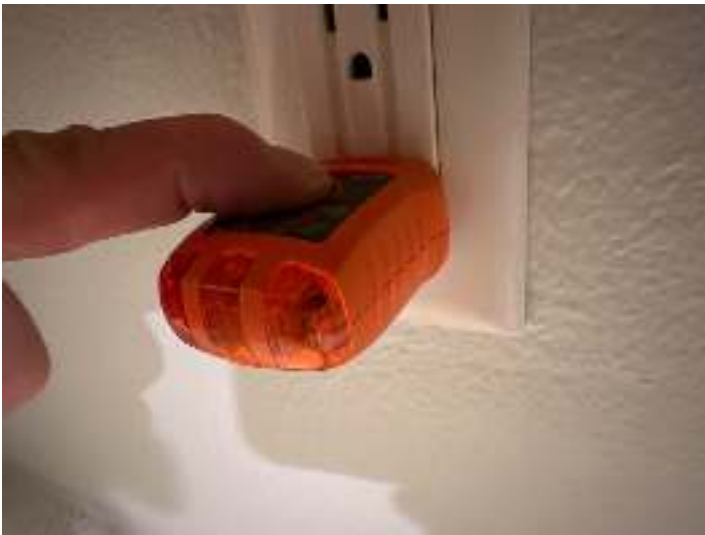
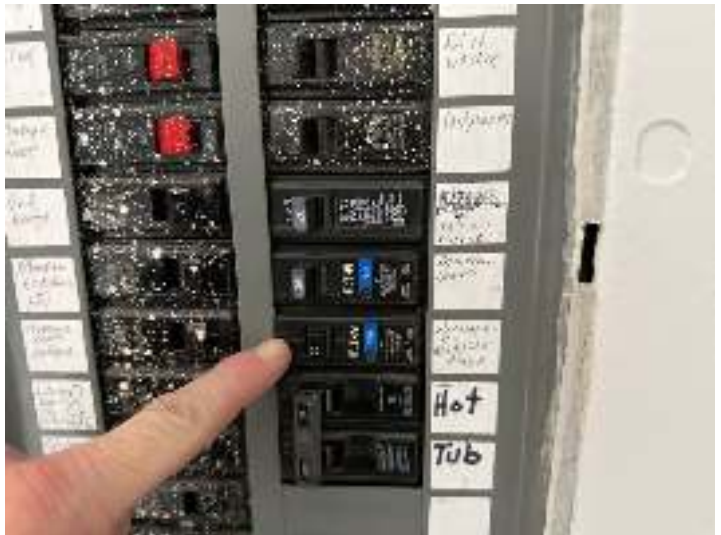
### Electrical Outlets

- Bathroom electrical outlets were ground fault circuit interrupter (GFCI) protected, responded to testing and appeared to be in serviceable condition at the time of inspection. Reset located in Basement electric service panel.

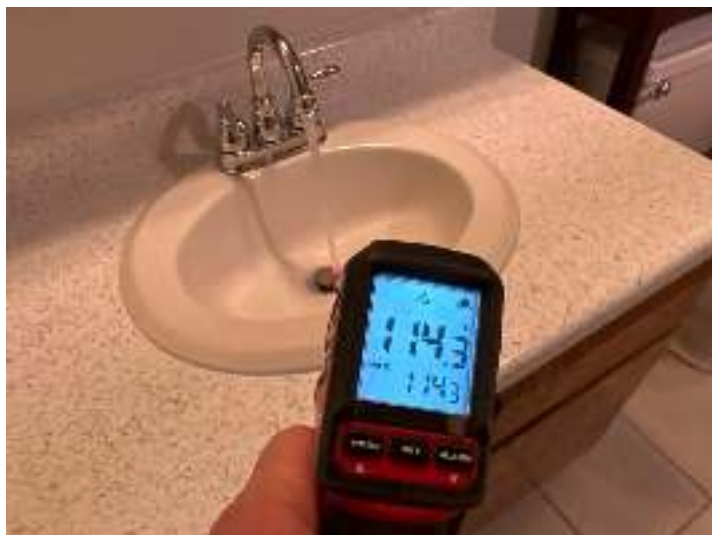
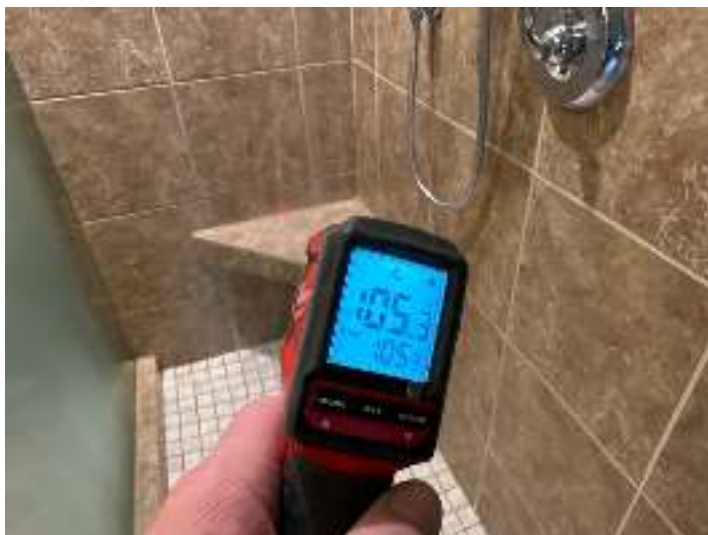
### Fixture Valve Installation And Temperature

- The water supply valves and supply lines at the fixtures were installed correctly and were functioning as designed and intended. Hot and cold water temperatures were within an acceptable range and supply lines were connected to the correct faucet valves according to current standards.

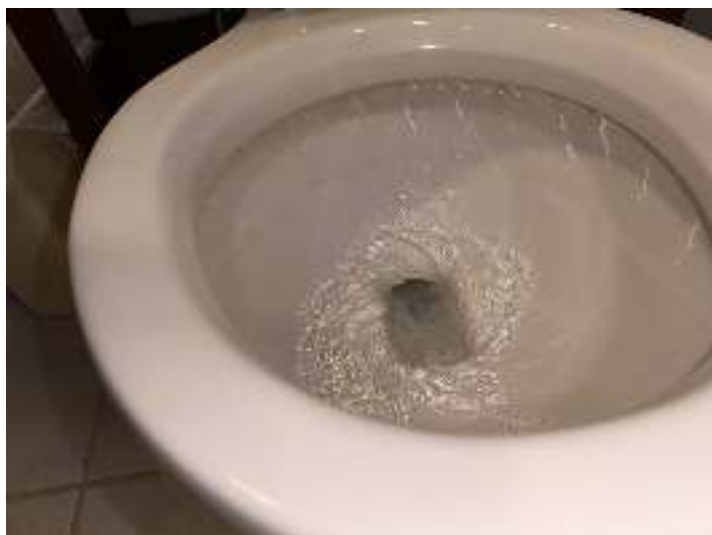
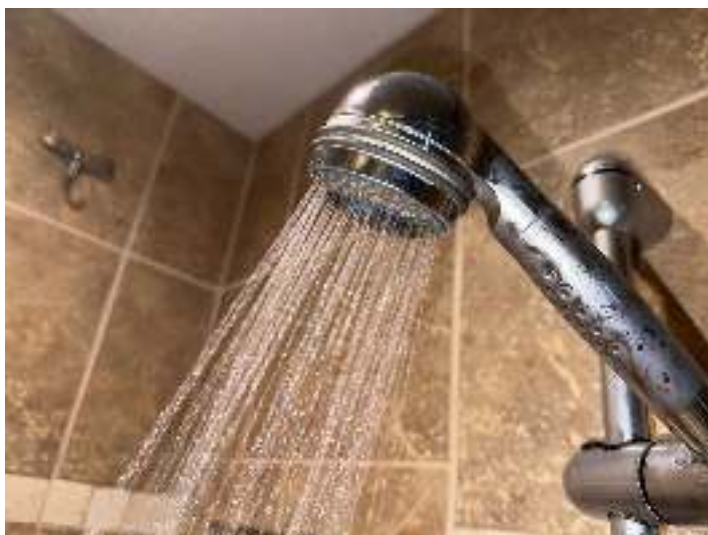
#### Water Supply Functional Flow

- The overall water pressure was good and had acceptable "functional Flow." This is determined by viewing the flow when two fixtures are operated simultaneously.

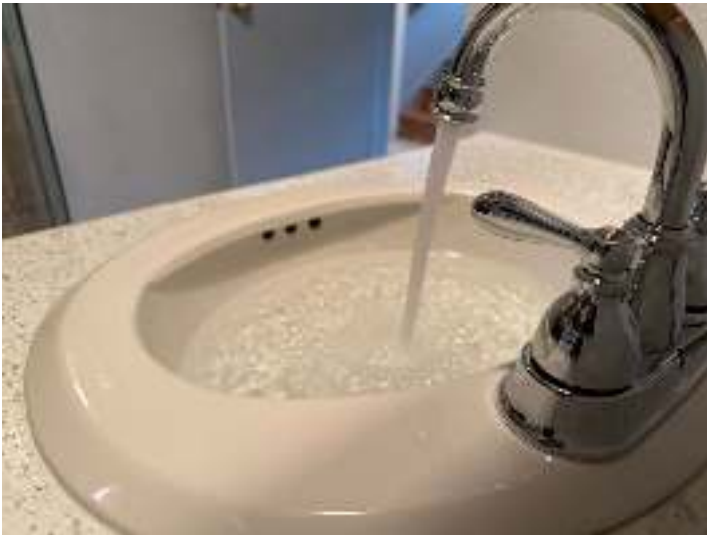
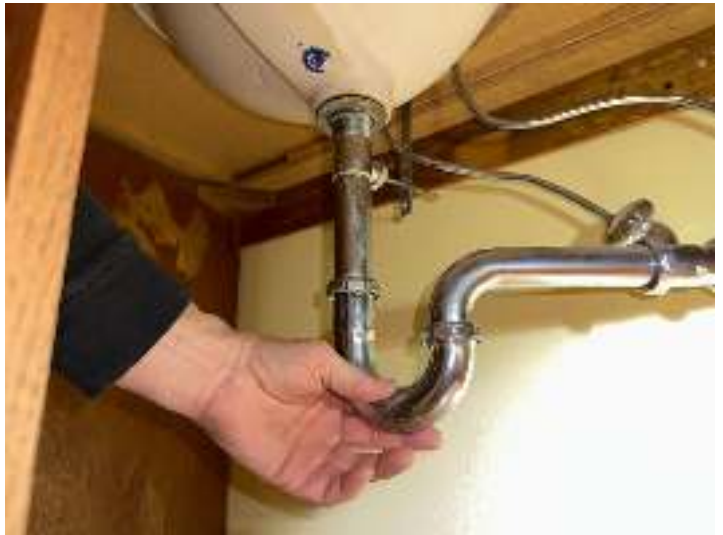
#### Plumbing, Drain Waste and Vent System

- The visible drain, waste and vent piping material in this bathroom was in satisfactory condition and was functioning as designed and intended. The drains from all functional fixtures were tested during the inspection and emptied in a reasonable amount of time and did not overflow when other fixtures were drained simultaneously.

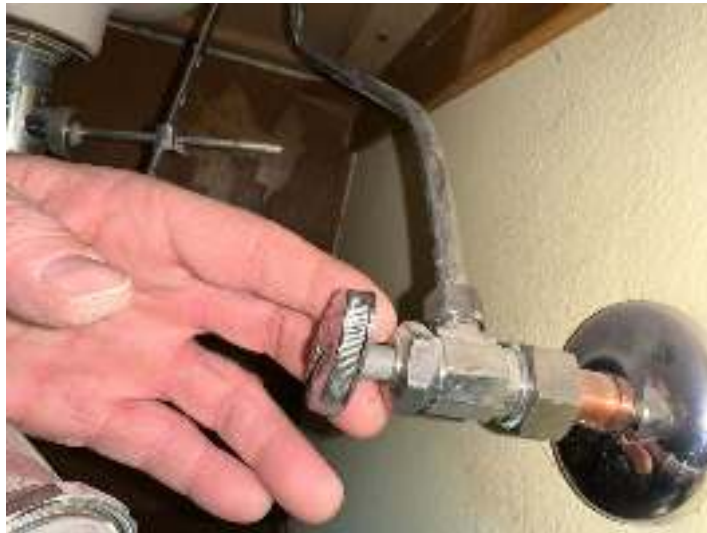
### Plumbing Water Supply Shutoff Valves

- The water shut off valves for the sink appeared to be in serviceable condition at the time of inspection. They were not operated but were visually inspected
- Inspector recommends replacing all plastic stemmed supply valves and supply lines. A qualified contractor should repair or replace a needed and according to current standards.

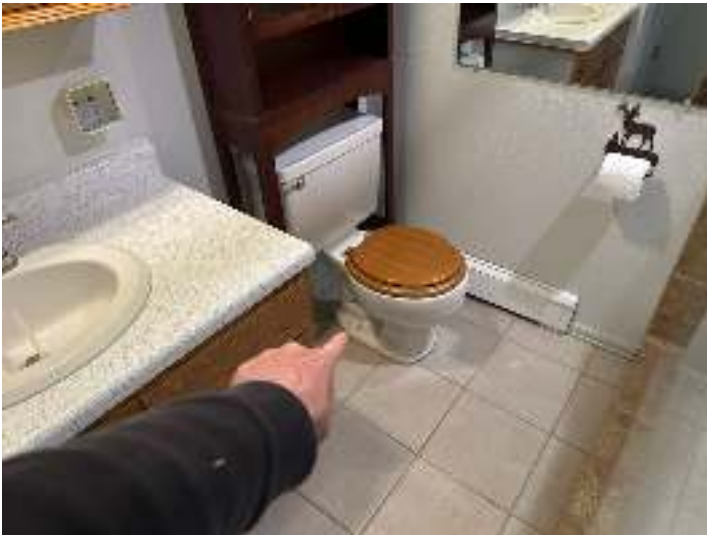
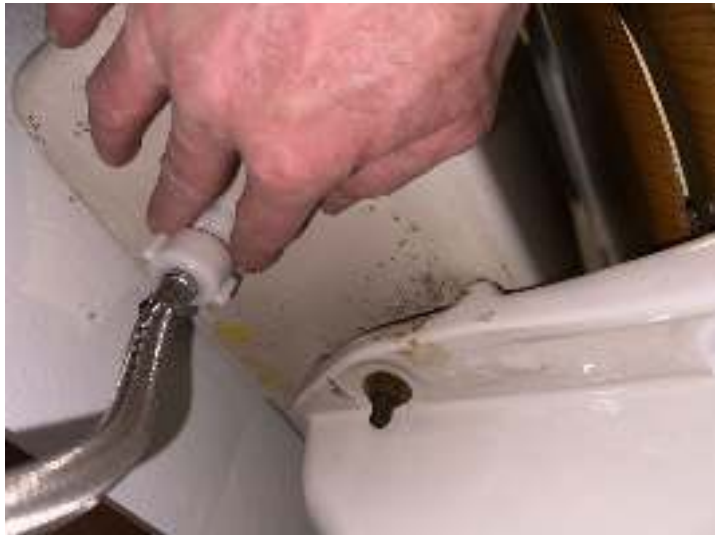
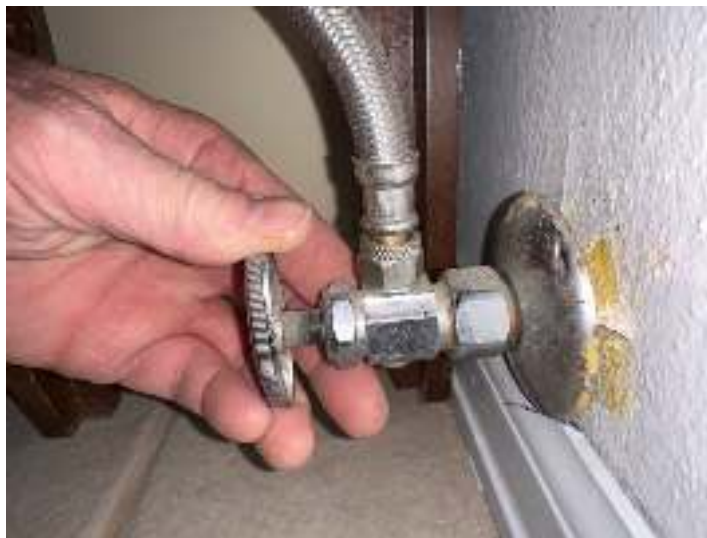
### Toilets

- The visible components of the toilet were in satisfactory condition and functioning as designed and as intended. The toilet was secured properly to the floor, no visible evidence of leaking was present and the toilet emptied in a reasonable amount of time.
- Inspector recommends replacing all plastic stemmed supply valves and supply lines. A qualified contractor should repair or replace a needed and according to current standards.
- **The toilet was loose at the floor. This condition typically is caused by loose bolts or nuts and/or missing floor seals. Loose toilet can result in leaks, water damage, and mold, as well as damage to the toilet, water supply lines, bolts, and drainage pipes. A qualified contractor should evaluate and repair or replace as necessary.**

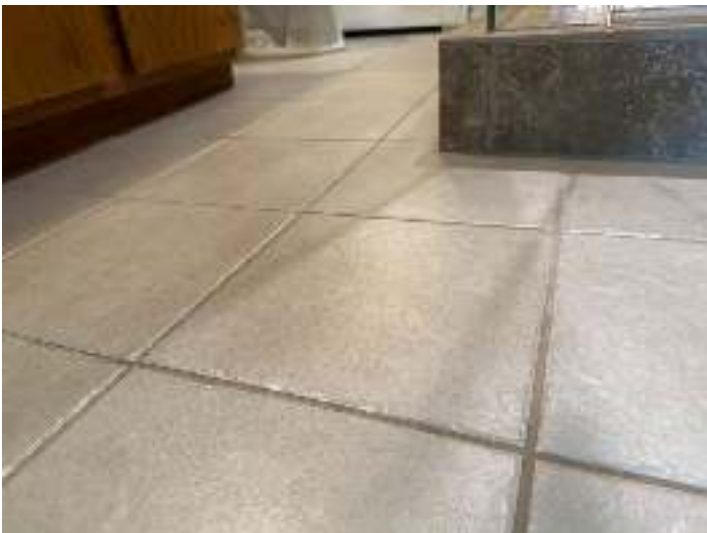
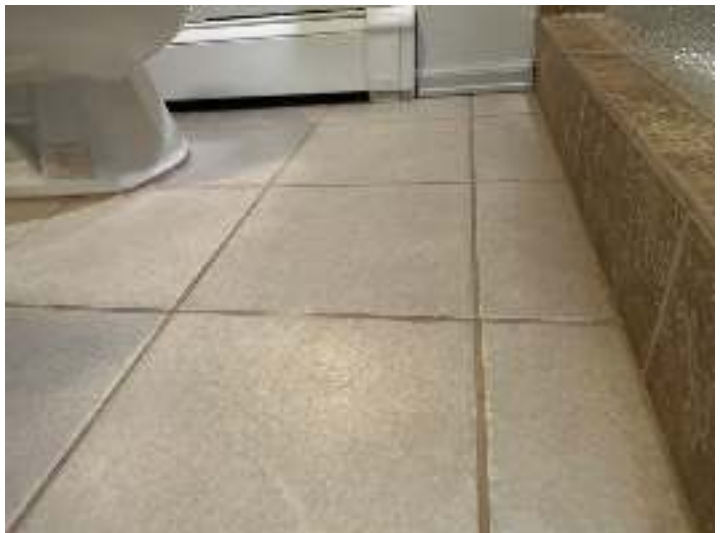
### Floors

- The tile floors in the interior rooms appeared to be in satisfactory condition at the time of inspection.

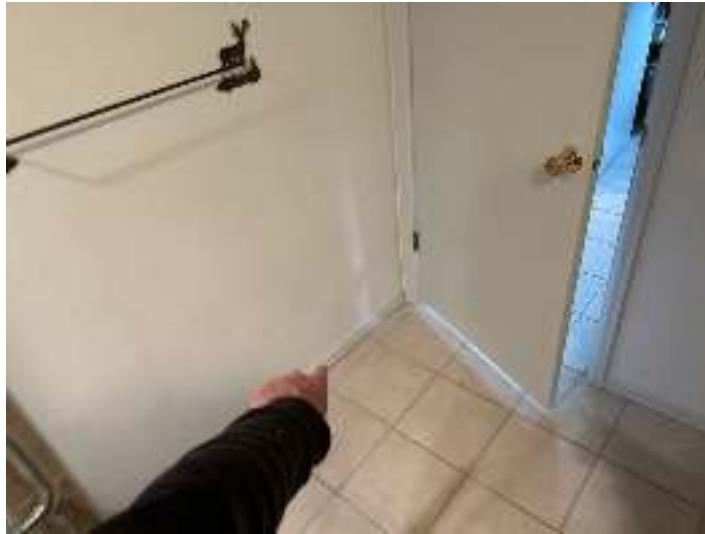
### Doors

- Interior hollow core doors and hardware appeared to be in satisfactory condition at the time of inspection. Door inspection includes examination for proper installation, operation and condition.
- The door had a damaged or missing doorstop. A qualified contractor should evaluate and repair or replace as necessary.
