# **AM Services**

## **Property Inspection Report**

~~1815 Midland Ave, Glenwood Springs, Co 81601~~

Date of Inspection: 4/21/2023 Time: 9:04am

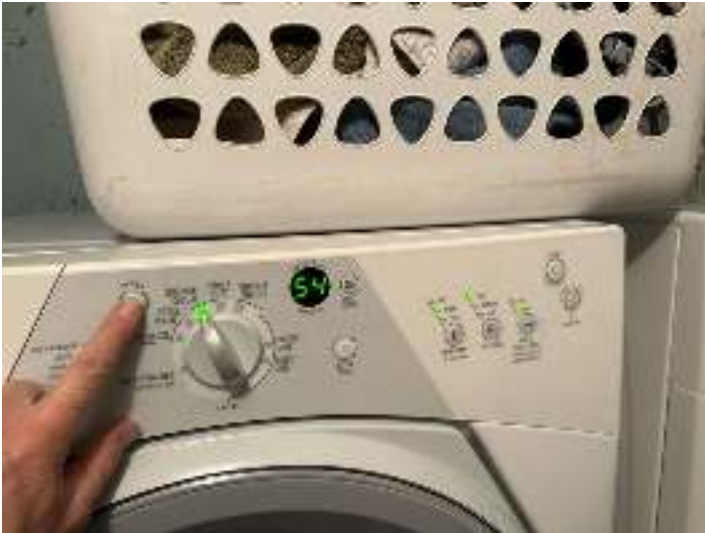
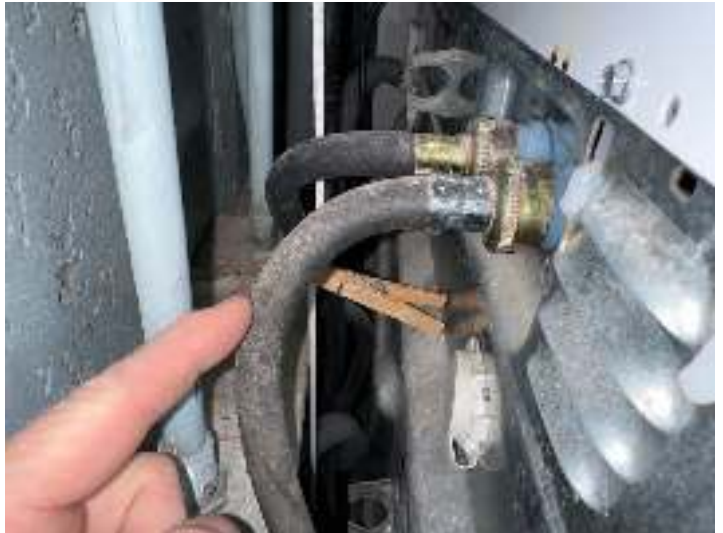
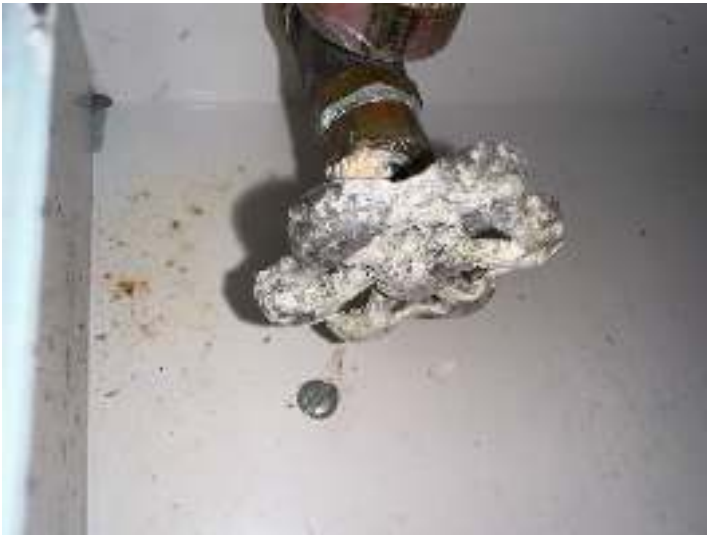
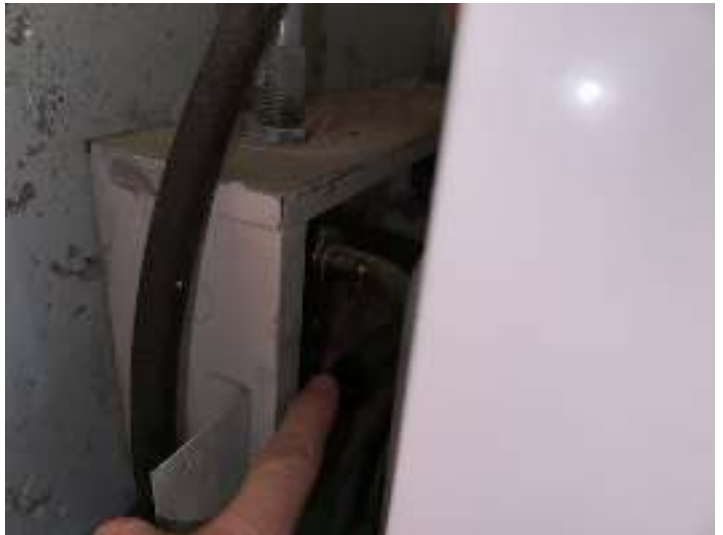
## Clothes Washer

- I did not inspect the clothes washer and dryer fully. These appliances are beyond the scope of a home inspection. I did not operate the appliances. The clothes dryer exhaust pipe must be inspected and cleaned every year to help prevent house fires.
- I observed hoses that were not reliable. Not pressure tested. Replacement of the hoses is recommended.
- The power and water supplies were not accessible at the time of the inspection. The power and water supplies were not inspected at the time of the inspection.
- I observed missing GFCI protection for all receptacle outlets in the laundry, as it is required by standards.
- The water supply valve was corroded at the time of inspection. A qualified contractor should evaluate and repair or replace as necessary.

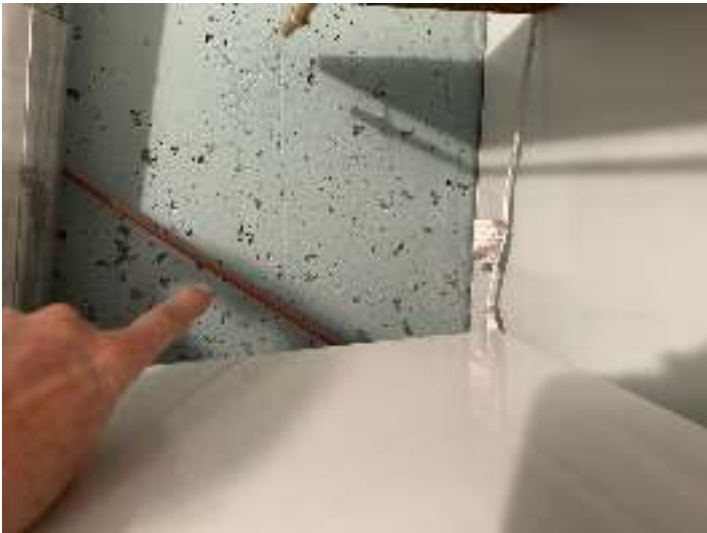
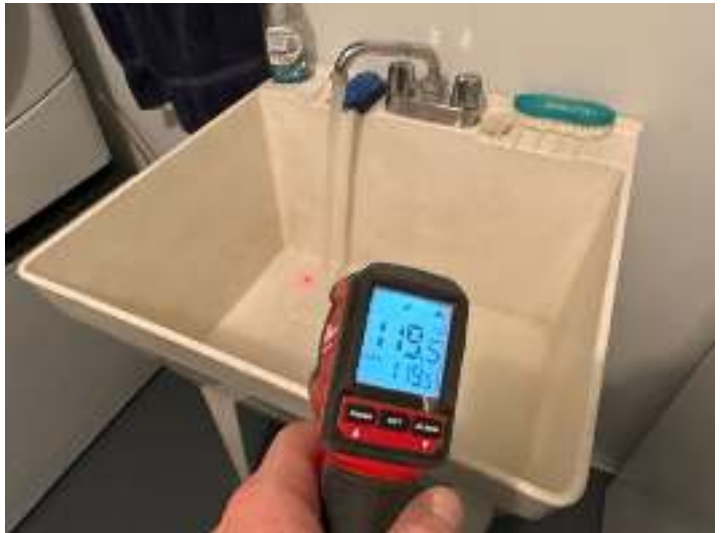
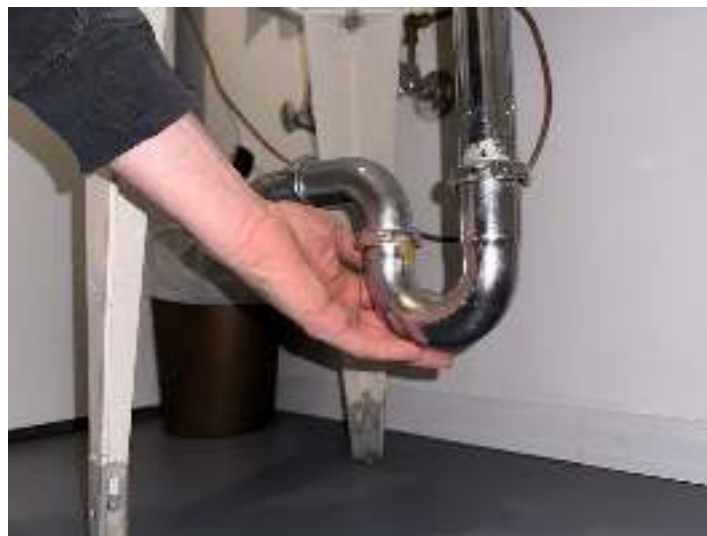
### Laundry Room, Electric, and Tub

- I observed a defect in the laundry room. Extension cord uses permanent wiring.

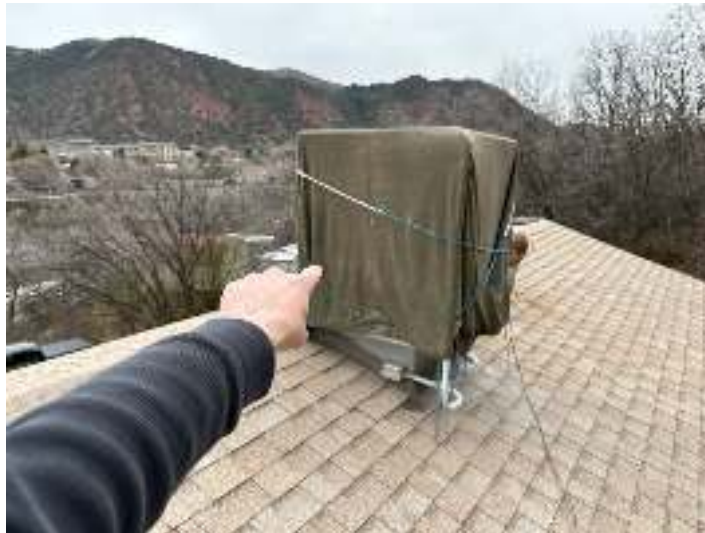
- The cooling system was not inspected at the time of the inspection. The inspection was weather restricted and limited by operational conditions. A qualified contractor should evaluate and repair/replace this cooling system as necessary prior to your inspection objection deadline.
- The property had a single stage evaporative cooler that was not operational at the time of the inspection due to winter weather conditions. Evaporative cooler's are not within the scope of the property inspection and the unit was not inspected. In low humidity areas, evaporating water into the air provides a natural and energy efficient means of cooling. Evaporative cooler's, also called swamp coolers, rely on this principle, cooling outdoor air by passing it over water saturated pads, causing the water to evaporate into it.

Evaporative cooler's require annual maintenance and require a specialist inspection. The inspector recommends inspection of the evaporative cooler by qualified contractor. Here are some items that should be checked at the beginning of each cooling season:

Water lines should be disconnected and blown free for the winter in cold climates. For further evaluation, the inspector recommends having the evaporative cooler serviced and certified by qualified HVAC contractor.

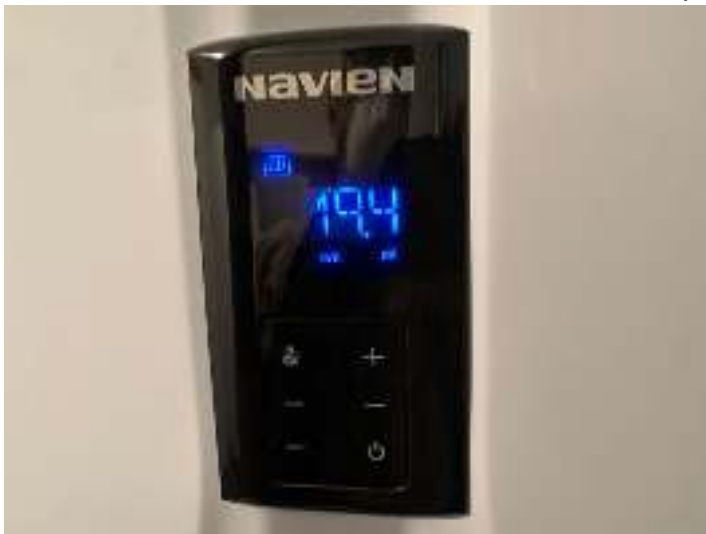
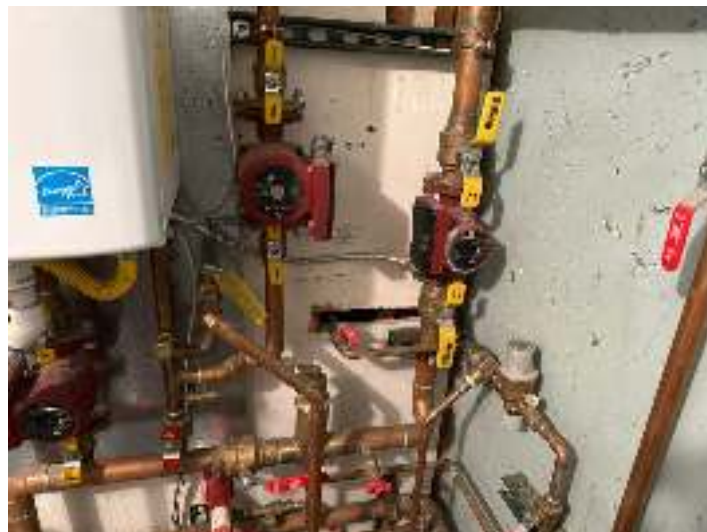
- Navien On Demand Boiler fired when called upon.

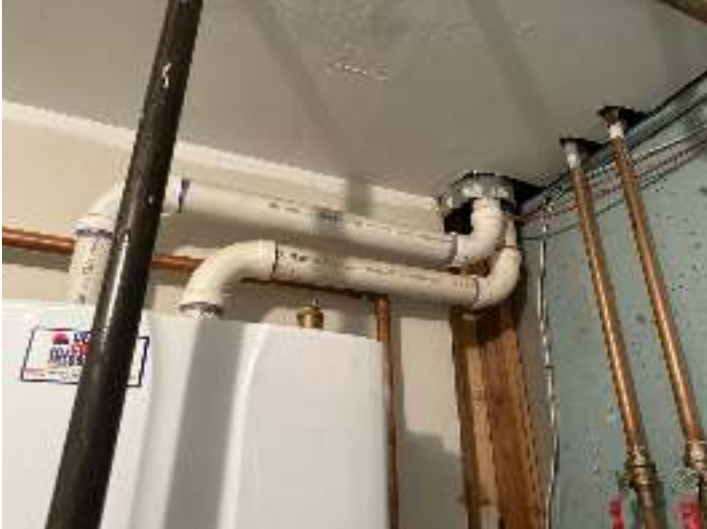
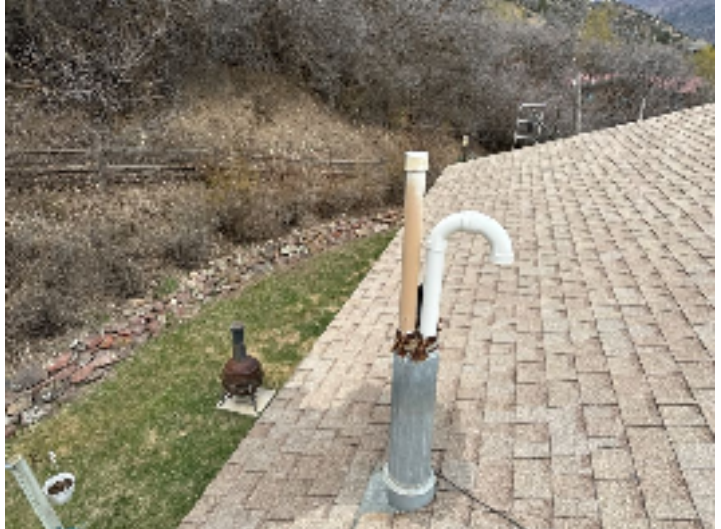
### Combustion Air Supply

- The **combustion air** supply for this appliance was present. Combustion air provides the oxygen needed for the safe and efficient operation of fuel burning appliances. An adequate supply of fresh air around all fuel burning appliances with open combustion compartments is vital for their safe operation. Years ago, the air could come from inside or outside the building, however, more recent standards prefer for combustion air to come from the outside only.

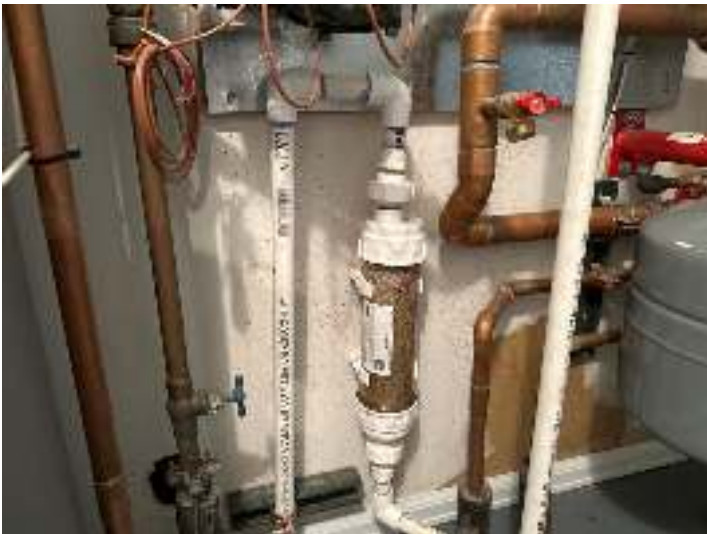
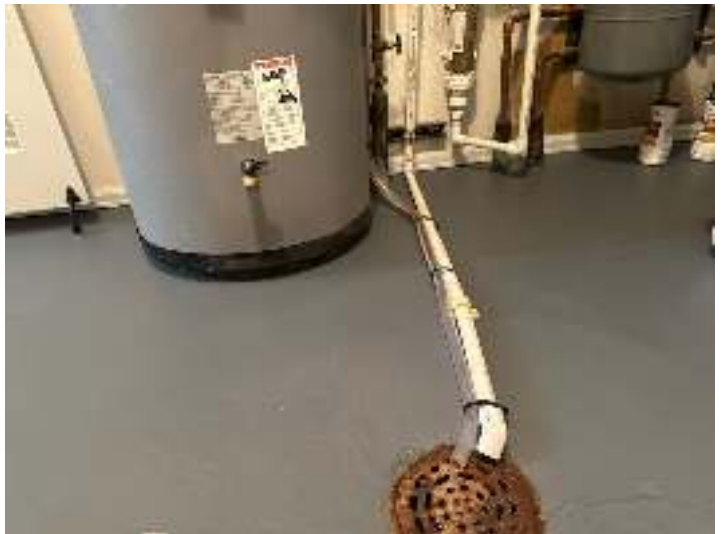
### Condensate

- The heating system had a discharge pipe connected to the drain or condensate pump installed at the heating system.

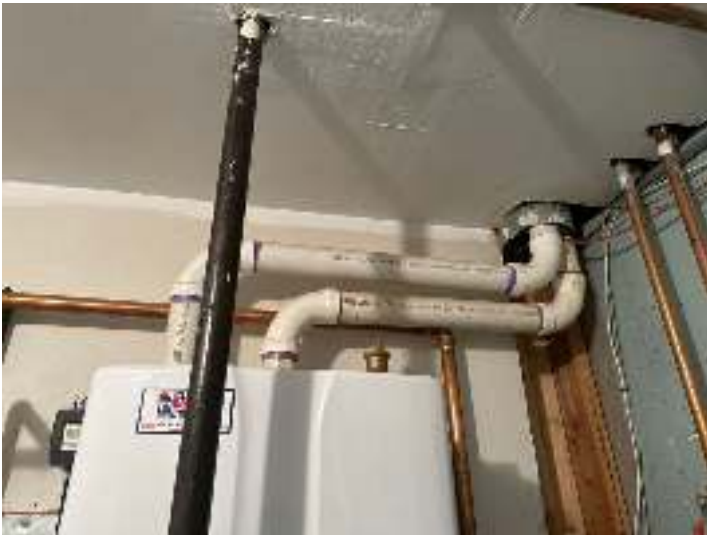
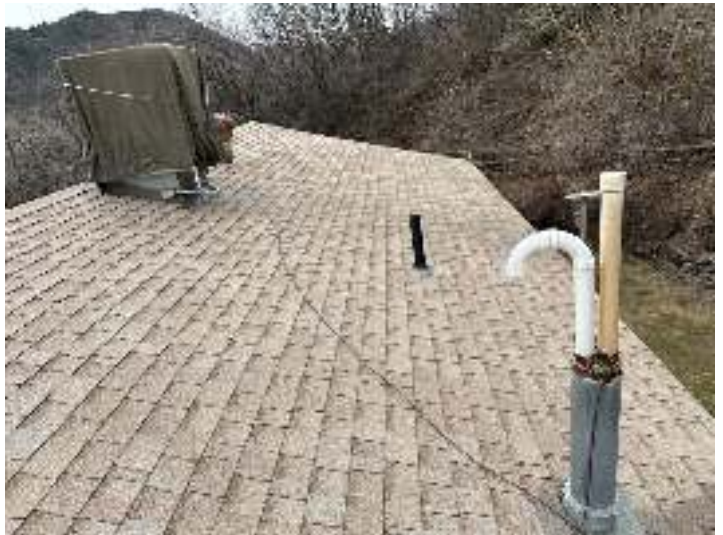
### Exhaust Flue

- The gas-fired heating system exhaust flue had proper connections, slope and clearance from combustibles.

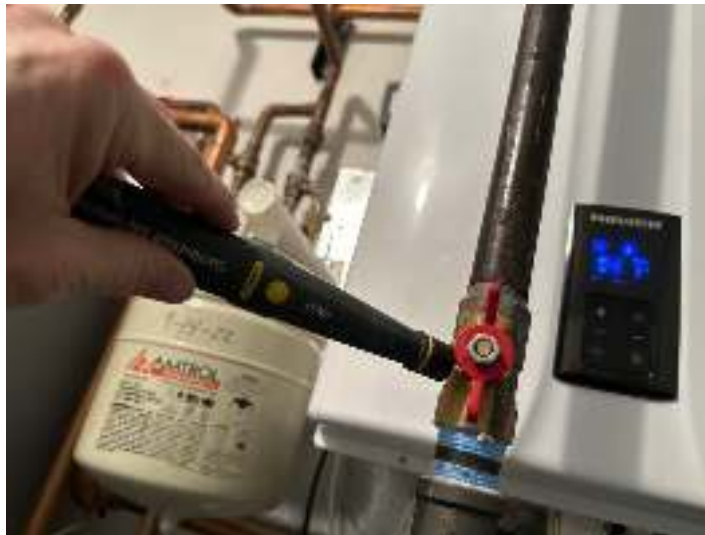
#### Gas Supply Shut-Off Valve

- The gas supply piping included a shutoff valve in the vicinity of the heating system for service personnel and emergency use. No evidence of leakage was detected at any of the exposed gas piping. The valve was not operated as part of the inspection.

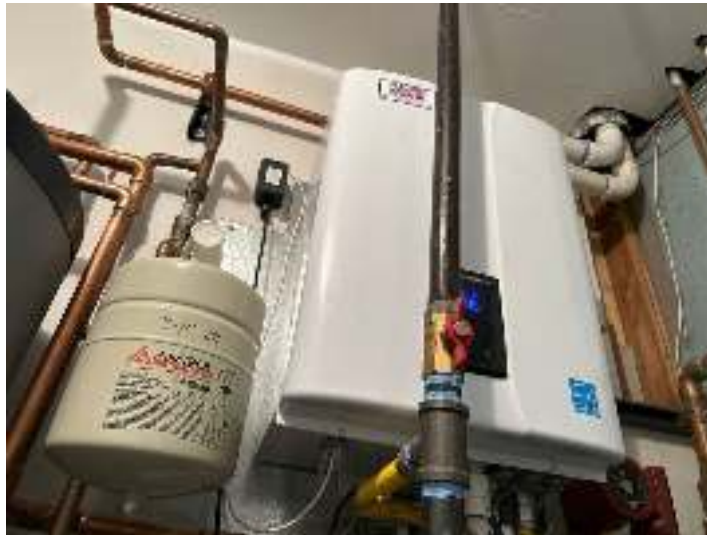
#### Heating System Cabinet

- The furnace cabinet exterior and interior appeared to be in serviceable condition at the time of the inspection.

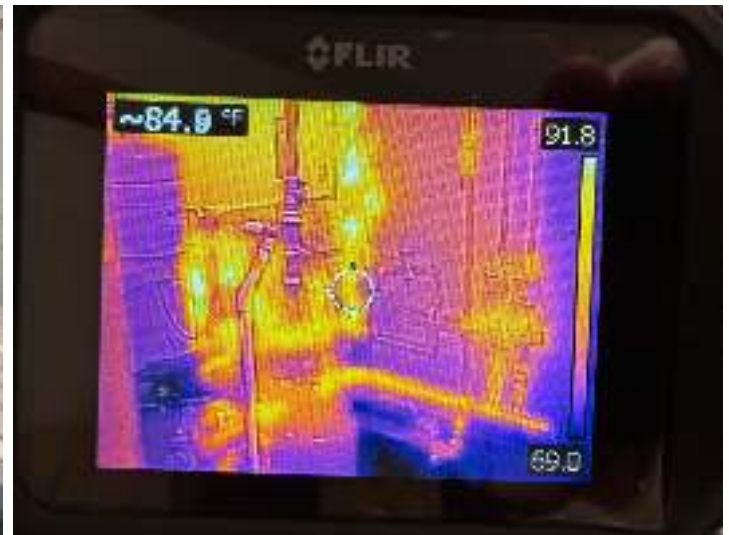
### Heating System Operation

- The furnace was inspected and was operational at the time of the inspection.

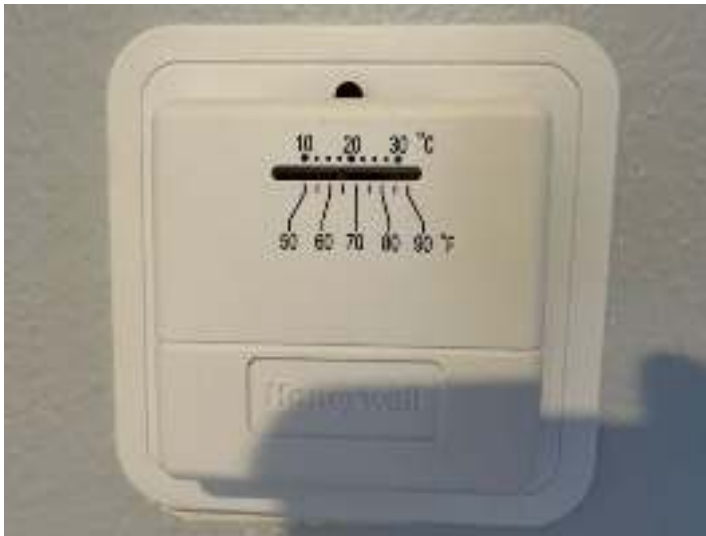
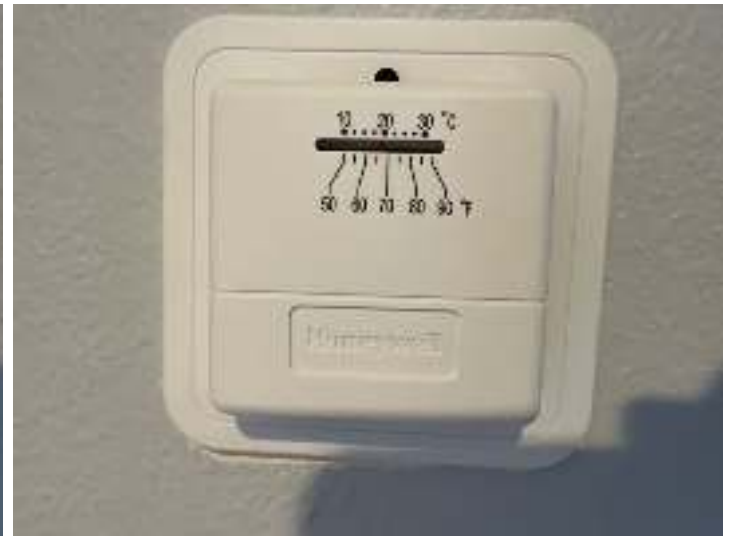
Thermostat Location: Multiple thermostats

- The thermostat(s) was installed at a location in the property, which appears to be adequate to operate the HVAC system efficiently. The thermostat(s) was fastened securely to the wall, activated the HVAC unit, and appeared to be in serviceable condition. The inspector takes two pictures of the thermostat. The first picture is to show all of the settings on the thermostat before the inspector operates it and the second picture shows that the inspector has reset the thermostat back to the original settings after operation.

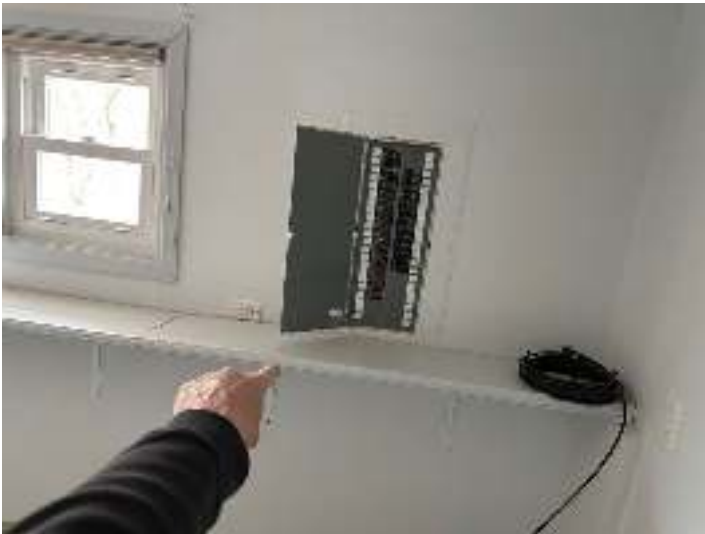
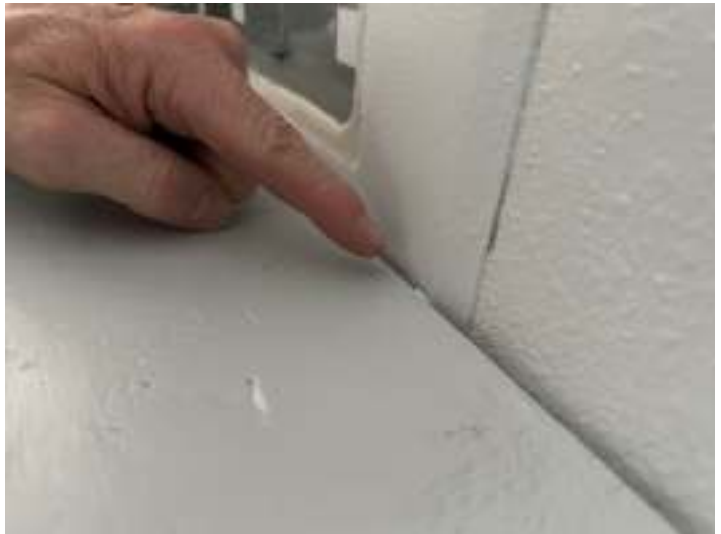
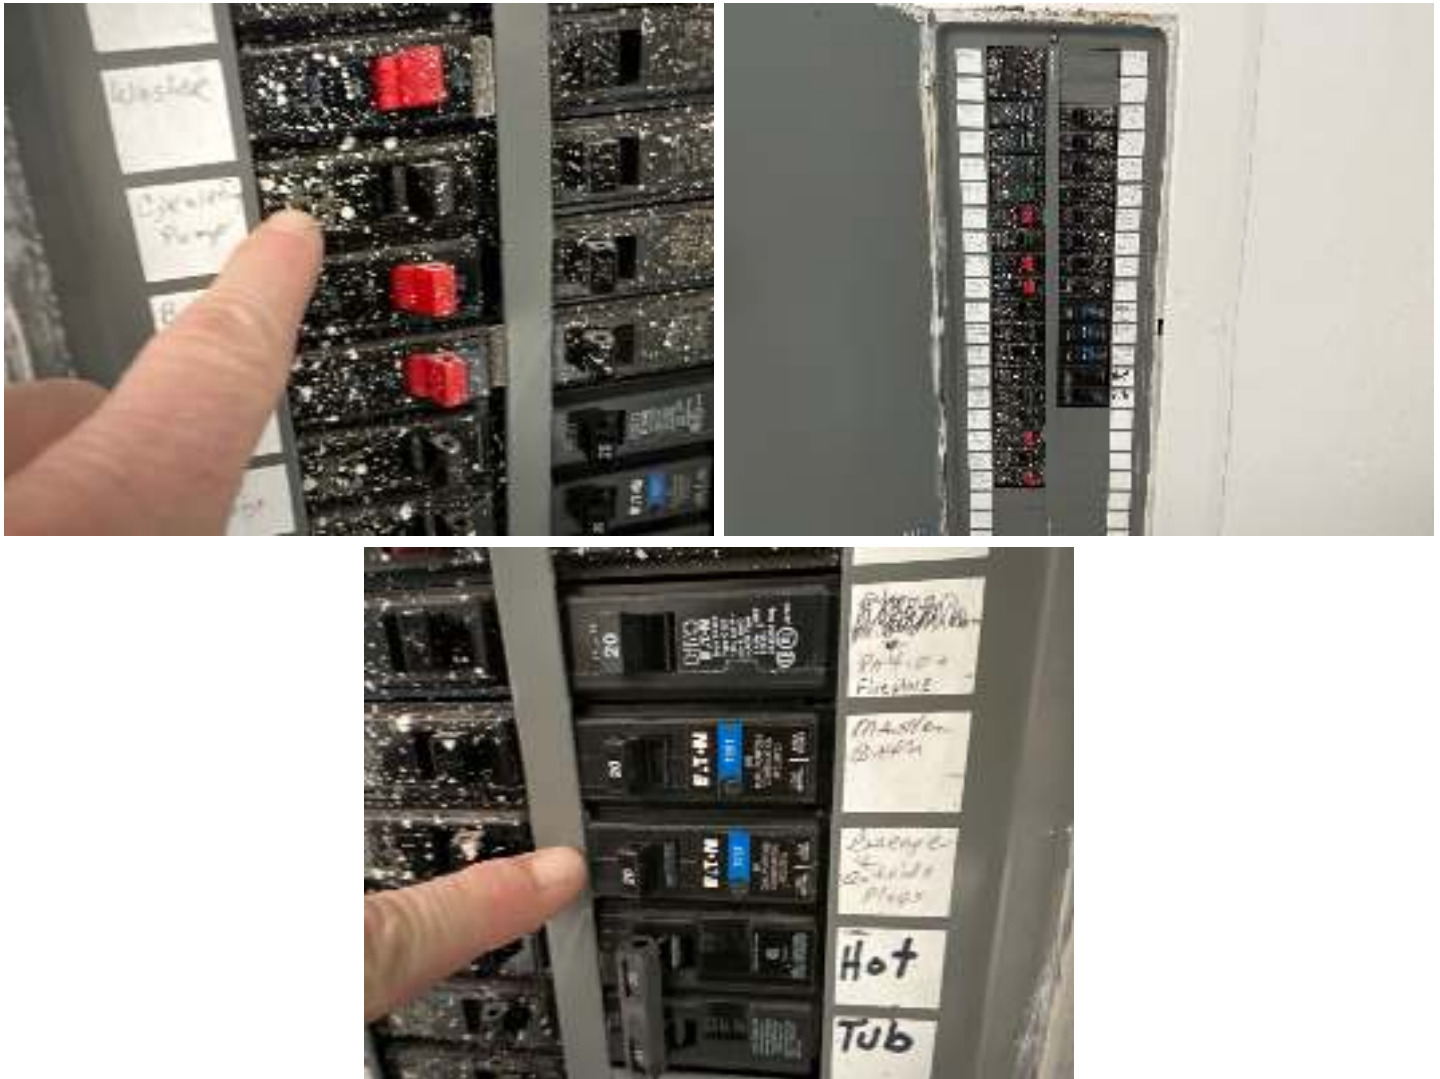
## Distribution Panels

- The manufacturer's label was missing, partial, or illegible at the electrical service panel. The manufacturer's label typically provides information describing the main panel such as the name of the panel manufacturer, the panel model number, the panel amperage rating, limitations related to the environment in which the panel was designed to be installed and grounding/bonding information for that particular model. The Inspector was unable to confirm the existence of proper conditions when confirmation would require information taken from this missing label.

- The Main/ sub distribution panel had inadequate clear space that is 3 feet deep, 30 inches wide, and 6' 6" in height in front of the equipment. The Main/ Sub electrical distribution panel was obstructed by personal effects and/or shelving at the time of the inspection. The Main/ Sub electrical panel was not accessible at the time of the inspection. The Main/ Sub service panel was not inspected at the time of the inspection. A qualified contractor should evaluate and repair or replace as necessary.

- The circuit label for the main electrical service panel is shown in the photo. Circuits in the main service panel were labeled. The accuracy of the labeling was not verified. When the opportunity arises, we recommend verifying the accuracy of the labeling by actually operating the breakers.

- Inspector noted that basement bathroom and the garage and exterior outlets shared the same or common electrical circuit. This is an outdated practice that can cause an overload of electrical circuitry possibly causing an electrical service interruption at the bathrooms electrical fixtures. A qualified electrical contractor should evaluate and repair or replace as necessary and according to current standards.

- Foreign objects and contamination was present inside the electrical panel. A qualified contractor should evaluate and repair or replace as necessary.

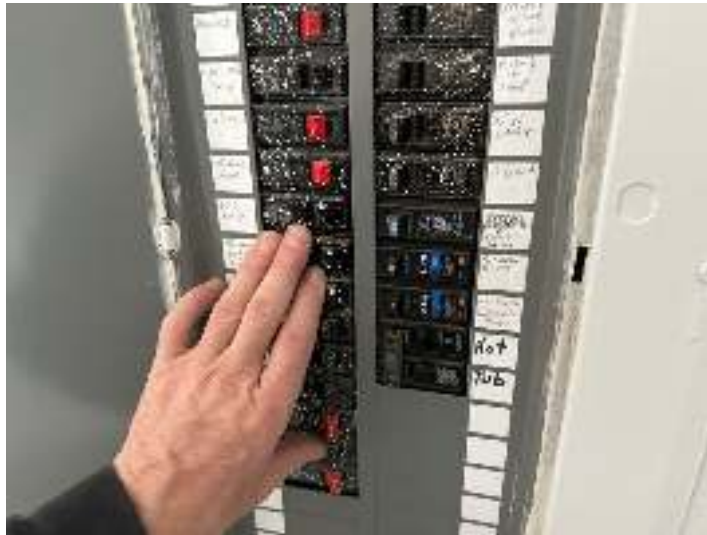
#### Electrical Circuit Breakers

- I inspected the electrical over-current protection devices (circuit breakers and fuses).

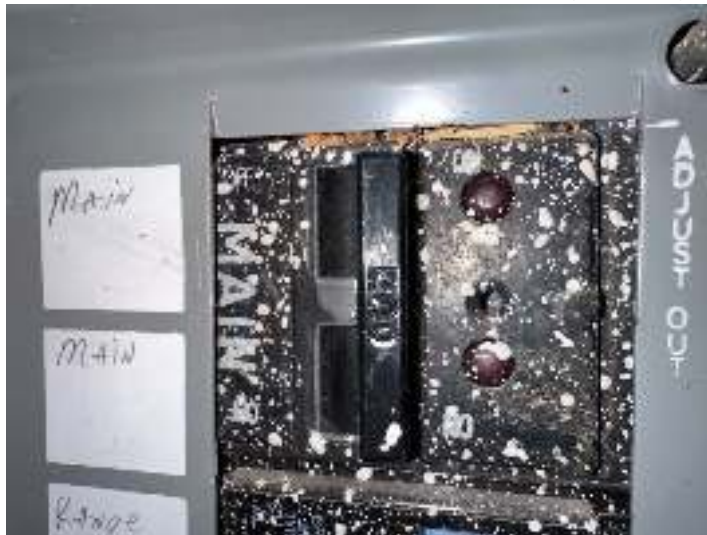
Main Service Disconnect Rating: 200 amps

- The main electrical disconnect was provided by a two-pole circuit breaker mounted in the main distribution panel on the exterior of the home by the electric meter. The breaker appeared to be in good condition, although it was not tested during this inspection.
- I observed indications of the main service disconnect's amperage rating. It was labeled.

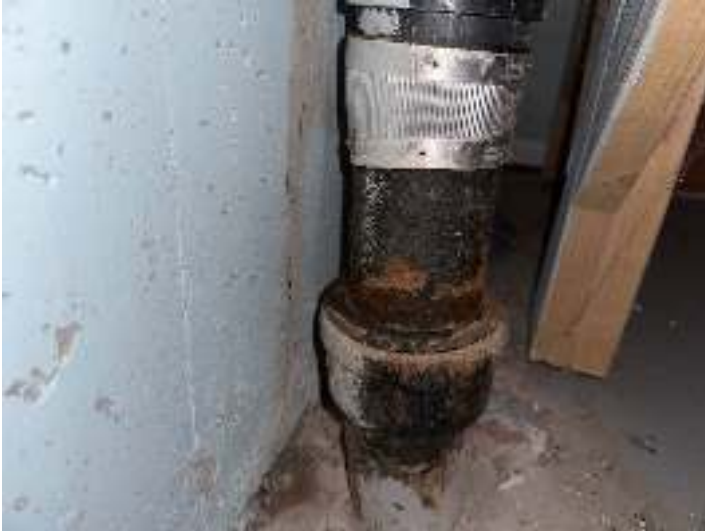
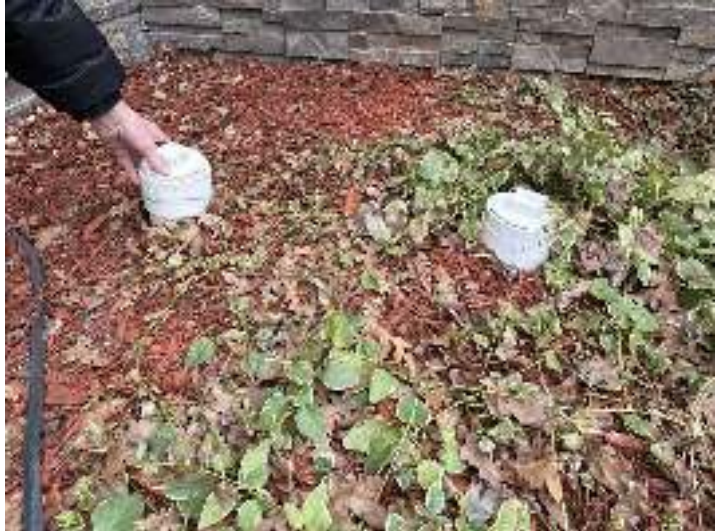
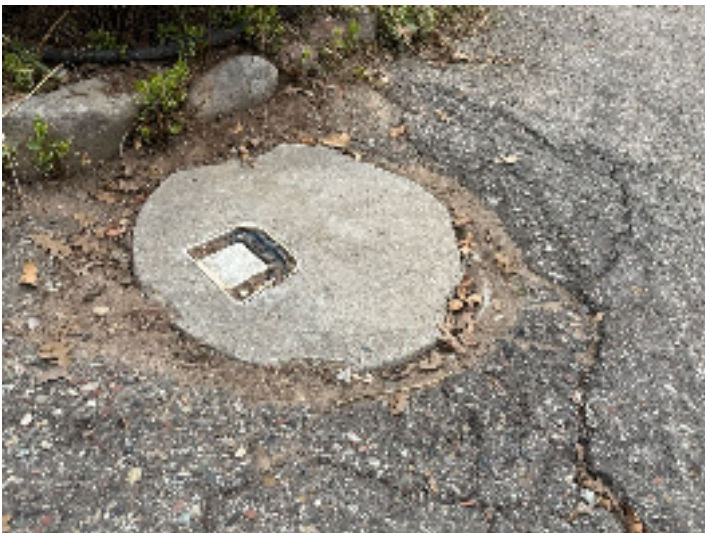
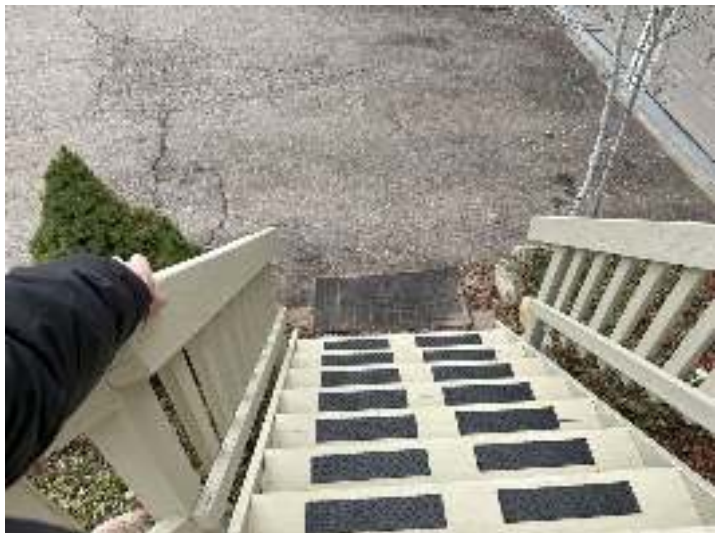
Drain, Waste, & Vent Systems Material: **PVC** • Cast Iron

- The visible drain, waste and vent piping material is listed above. The system was in satisfactory condition at the time of inspection. The drains from all functioning plumbing fixtures were tested during the inspection and each emptied in a reasonable amount of time and did not overflow when other fixtures were drained simultaneously. Inspector noted in conversation with the owner that the cast-iron sewer line I've been repaired to the septic system and clean out installed.

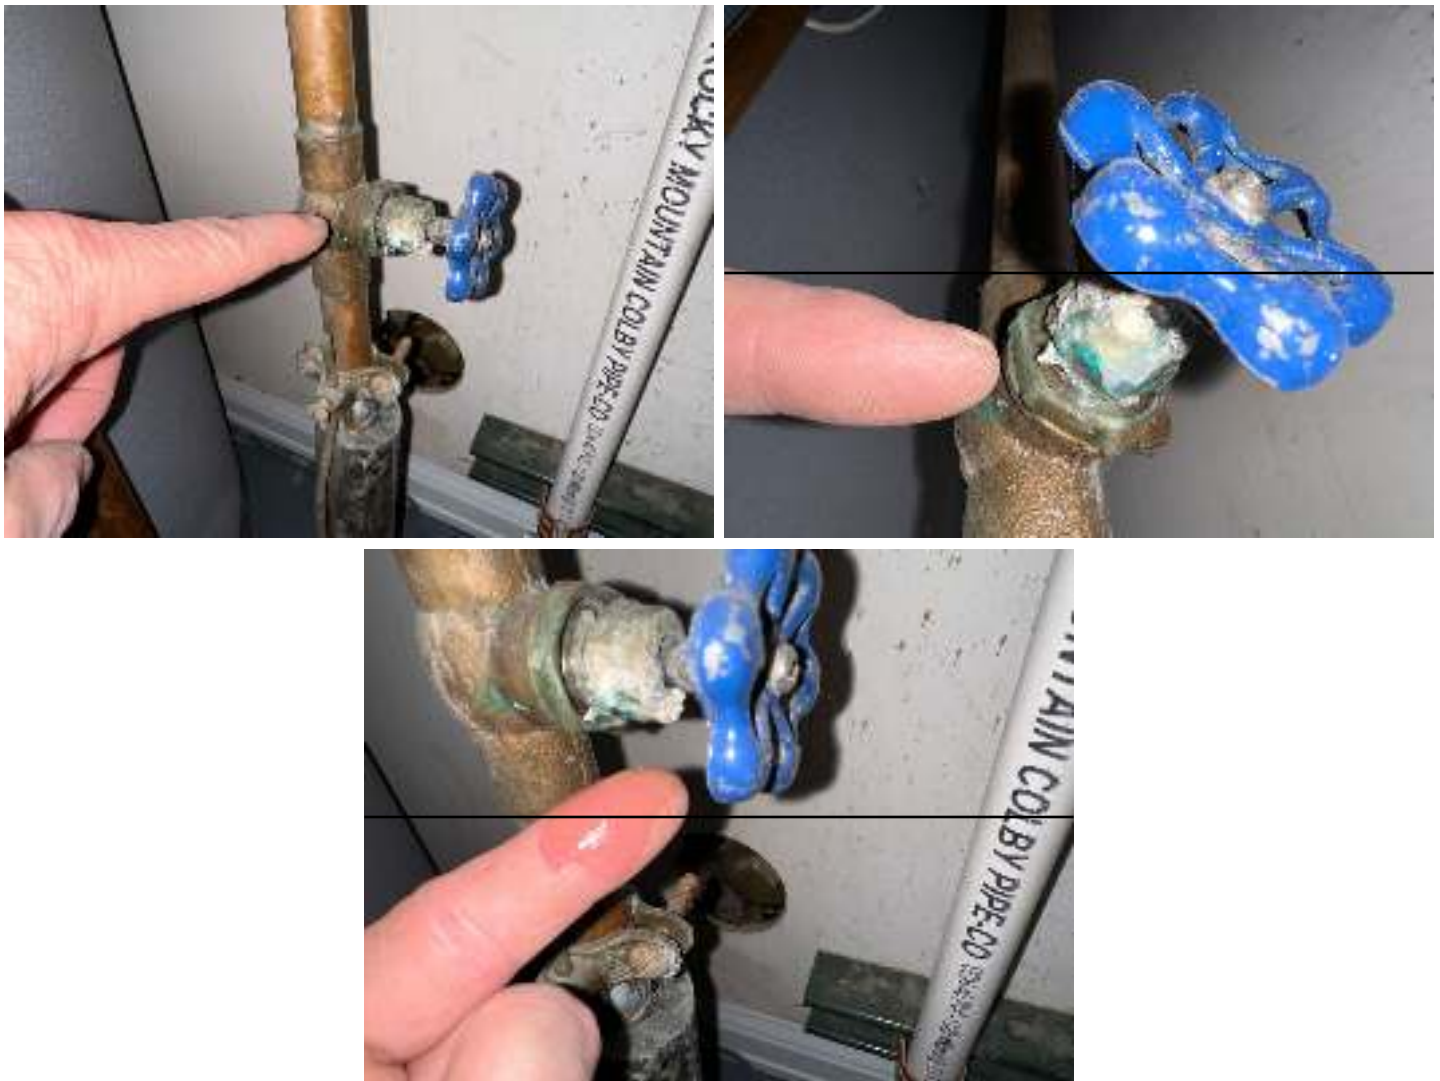
- Inspector recommends replacing this gate style valve with modern ball valve. Gate valves are known to leak and fail unexpectedly. A qualified contractor should repair or place as needed and according to current standards.
- The main water shutoff valve was leaking. A qualified contractor should evaluate and repair or replace as necessary.
- The main water shutoff valve was corroded. A qualified contractor should evaluate and repair or replace as necessary.

Plumbing		
Page 92	Main Water Shut-Off Valve	<ul style="list-style-type: none"> <li>• The main water shutoff valve was leaking. A qualified contractor should evaluate and repair or replace as necessary.</li> <li>• The main water shutoff valve was corroded. A qualified contractor should evaluate and repair or replace as necessary.</li> </ul>
Page 93	Plumbing Water Pressure	<ul style="list-style-type: none"> <li>• The property water supply pressure (95 psi) measured at the exterior hose bib. Property water supply pressure exceeded the 80 pounds per square inch (PSI) limit considered the maximum allowable by generally accepted current standards. Excessively high water pressure is likely to cause leaks. A qualified contractor should evaluate and repair or replace as necessary and according to current standards.</li> </ul>

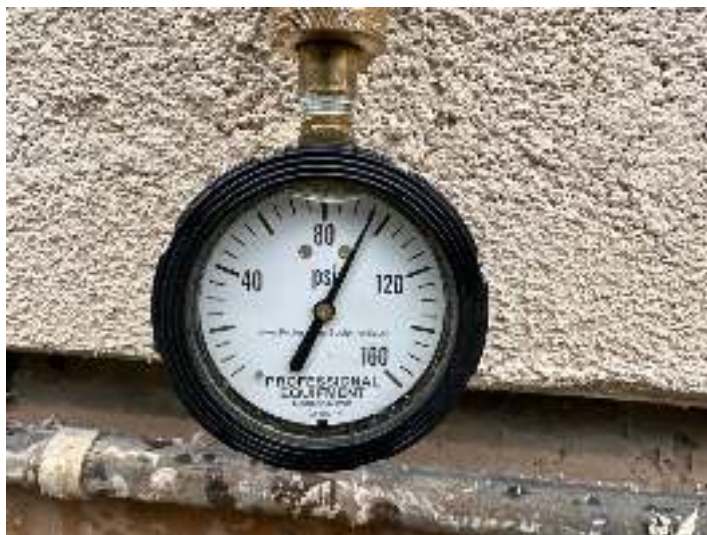
### Plumbing Water Pressure

- The property water supply pressure (95 psi) measured at the exterior hose bib. Property water supply pressure exceeded the 80 pounds per square inch (PSI) limit considered the maximum allowable by generally accepted current standards. Excessively high water pressure is likely to cause leaks. A qualified contractor should evaluate and repair or replace as necessary and according to current standards.

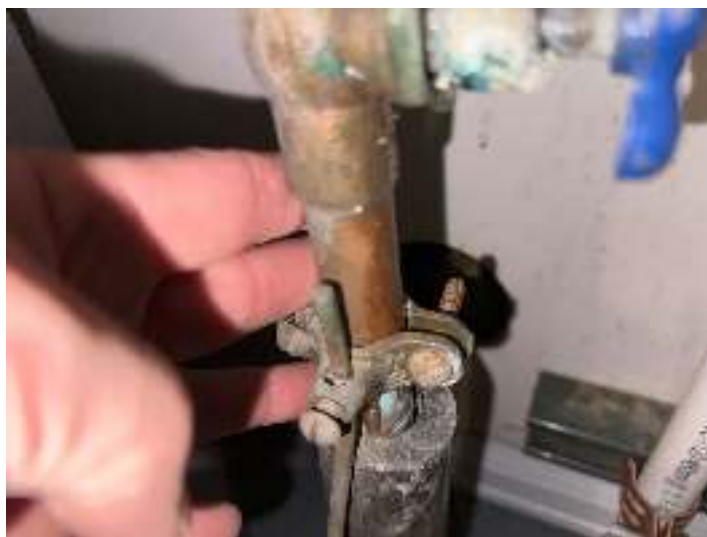
### Water Supply

- The water supply to the house appeared to be from the public water supply source based upon the observed indications at the time of the inspection. To confirm and be certain, it is recommended to ask the homeowner for details.

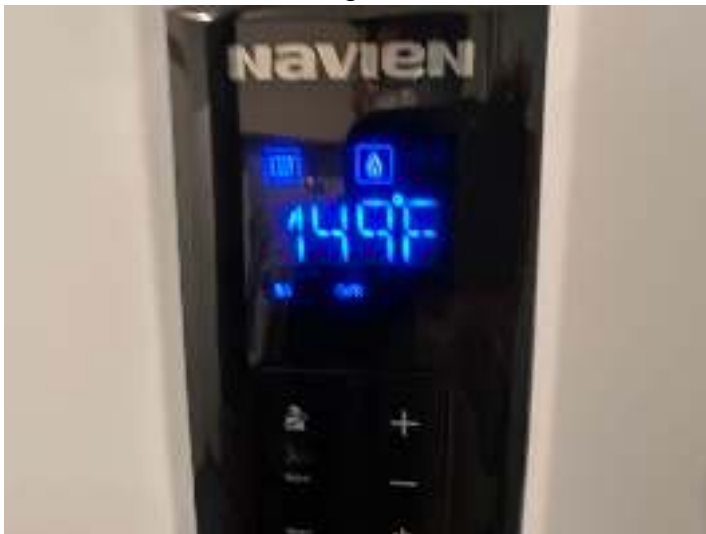
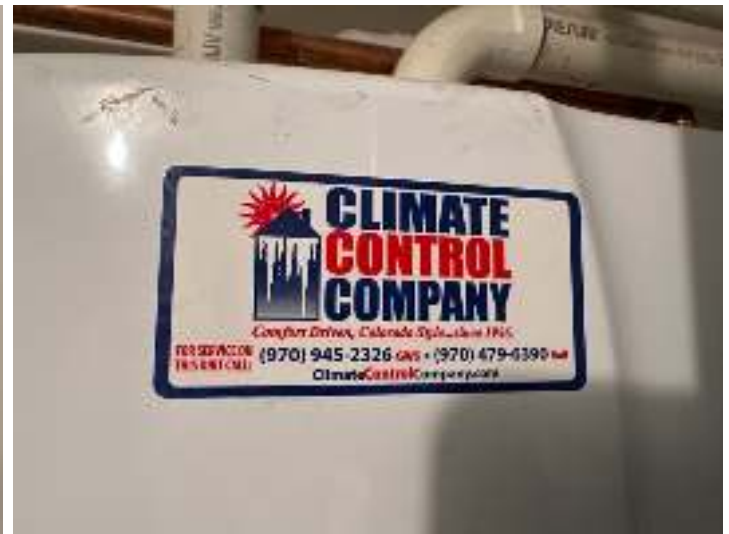
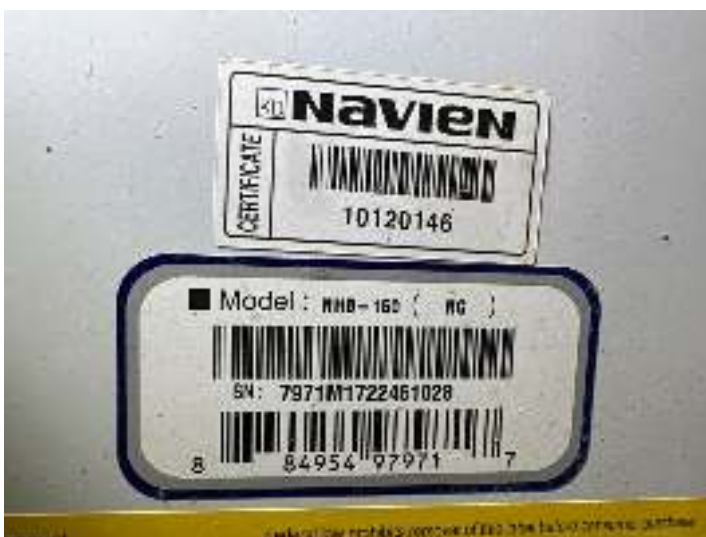
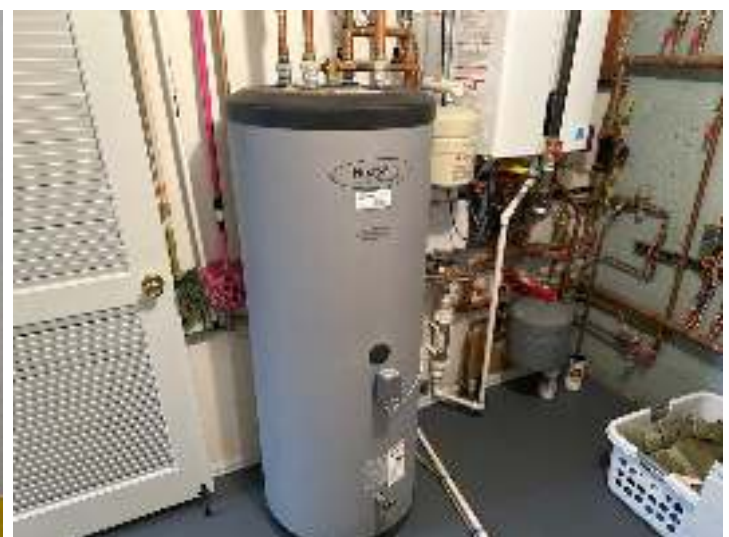
- The water in an indirect fired water heater is heated by a copper coil located inside the hot water tank. The internal coil is in turn heated by circulating water inside the coil to and from the boiler. The lifespan of water heaters depends on the following: -The quality of the water heater -The chemical composition of the water -The long term water temperature settings -The quality and frequency of past and future maintenance. Flushing the water heater tank once a year and replacing the anode rod every 4 years will help extend its lifespan. You should keep the water temperature set at a minimum of 125 degrees Fahrenheit to kill microbes and a maximum of 130 degrees to prevent scalding.

- The capacity of the water heating equipment is listed above.
- The water heater age was determined by the photo included in this report. According to the U.S. Department of energy these major appliances are intended to run for between 8 and 12 years. Be advised that every water heater will age differently relative to the following life span factors: water quality, mineral buildup, frequency of flushing, volume of water utilized, size of tank, brand and quality of water heater. Although it was operating at the time of the inspection, the inspector can not determine the remaining life of the water heater.

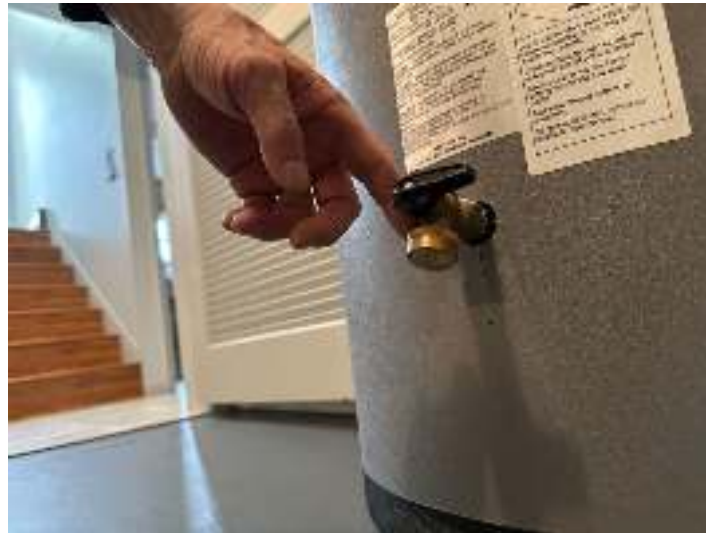
### Drain Valve & Drip Pan

- There was a drain valve which was in serviceable condition at the time of inspection.

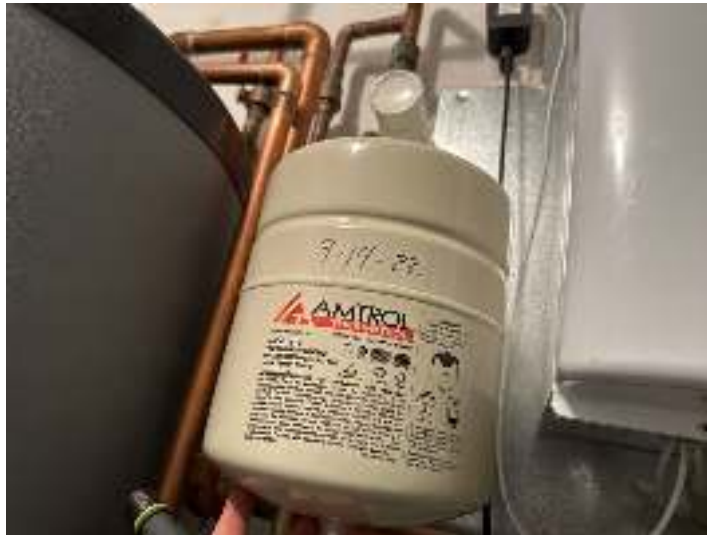
### Expansion Tank / Valve

- The water heater had an **expansion tank** / valve installed to allow for thermal expansion of water in the plumbing pipes. The expansion tank appeared to be properly installed and in serviceable condition. We do not dismantle, drain or inspect inside of the tank.

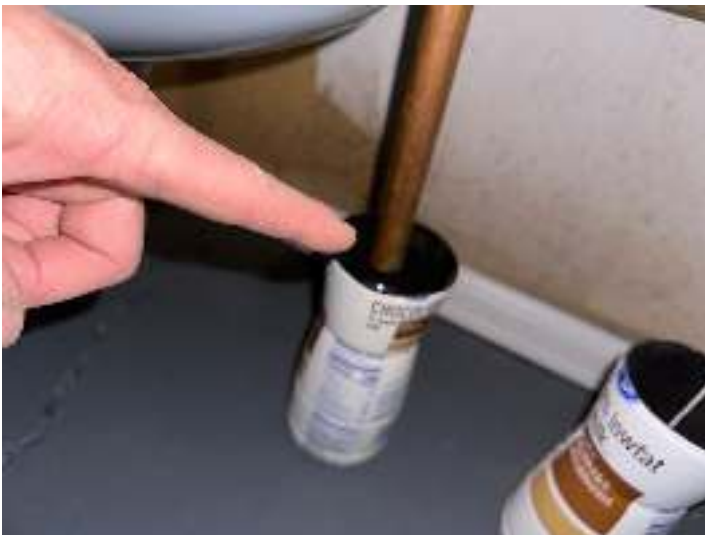
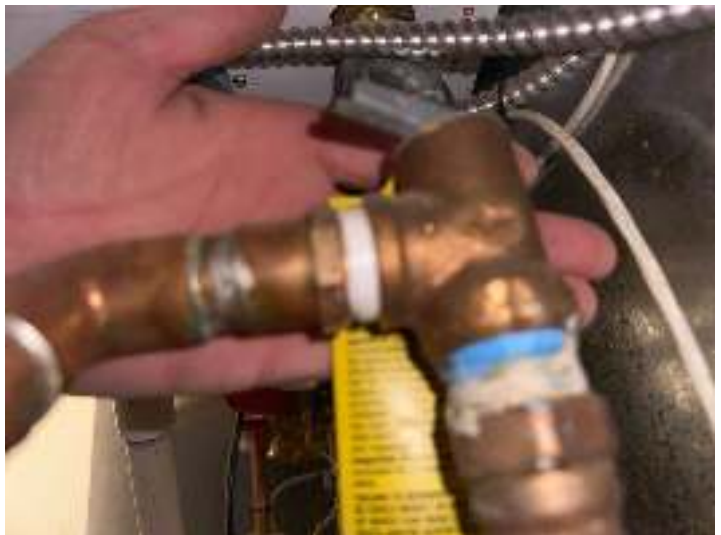
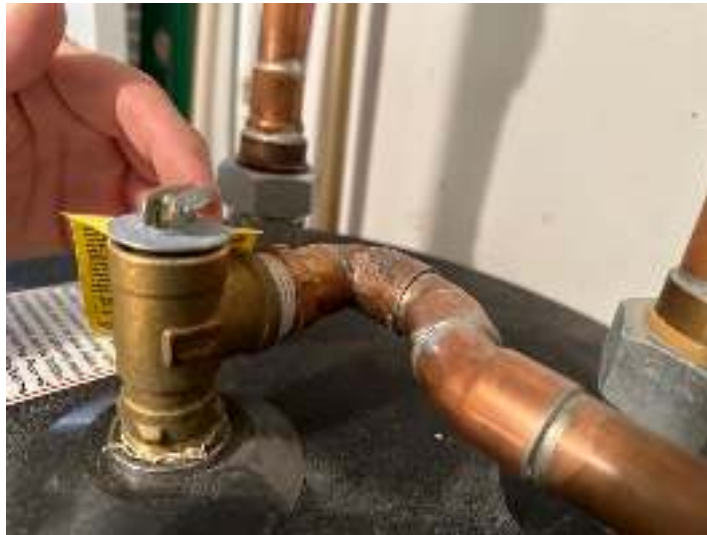
#### Temperature & Pressure Relief Valve

- The water heater was equipped with a TPR (Temperature Pressure Relief) valve and a properly-configured **TPR valve** discharge pipe which was properly connected to the T&P relief valve and terminated within 6" from the floor. This device is an important safety feature and should not be altered or tampered with, and was not tested as part of the inspection. No adverse conditions were observed.

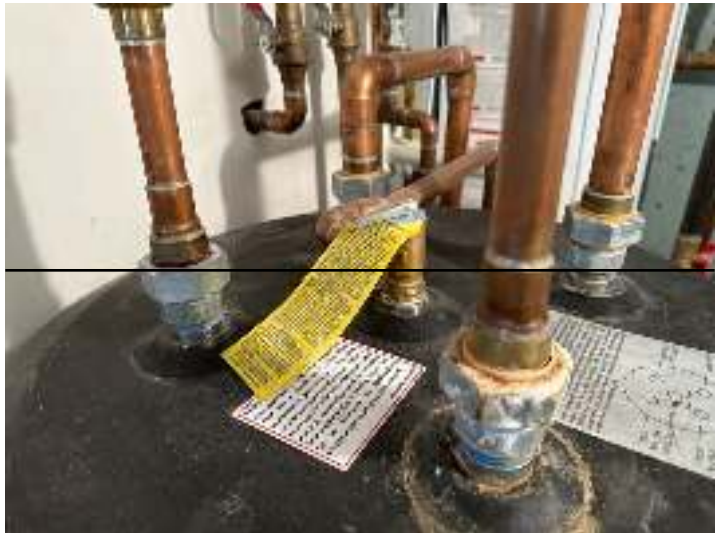
### Water Shut-Off & Pipe Connections

- The water heating equipment had a cold water supply shutoff valve installed. The valve was not operated during the inspection; however, it should be "exercised" periodically so that it will remain functional when the need arises.
- Water pipe fittings connected to the water heating equipment appeared to be in serviceable condition at the time of the inspection.

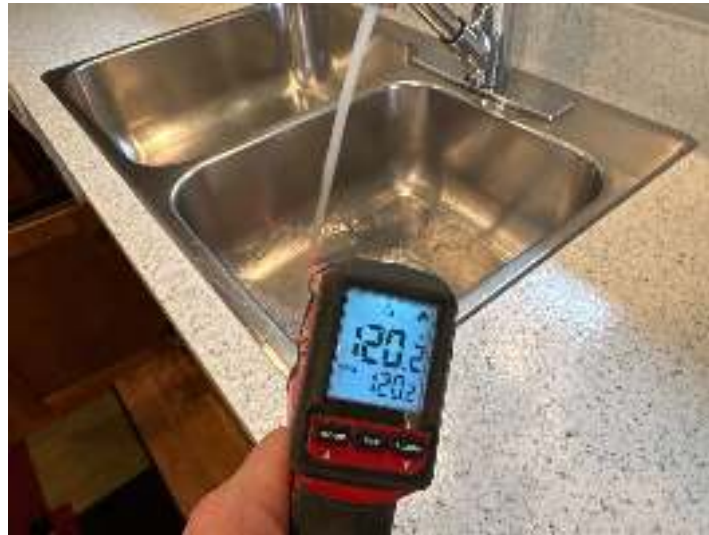
### Water Temperature

Water Temperature Measurement: 110-120 Degrees

- The water temperature was within the acceptable range of 120-130 degrees.
